DRA INARA- Monthly Construction Photos - October 2024

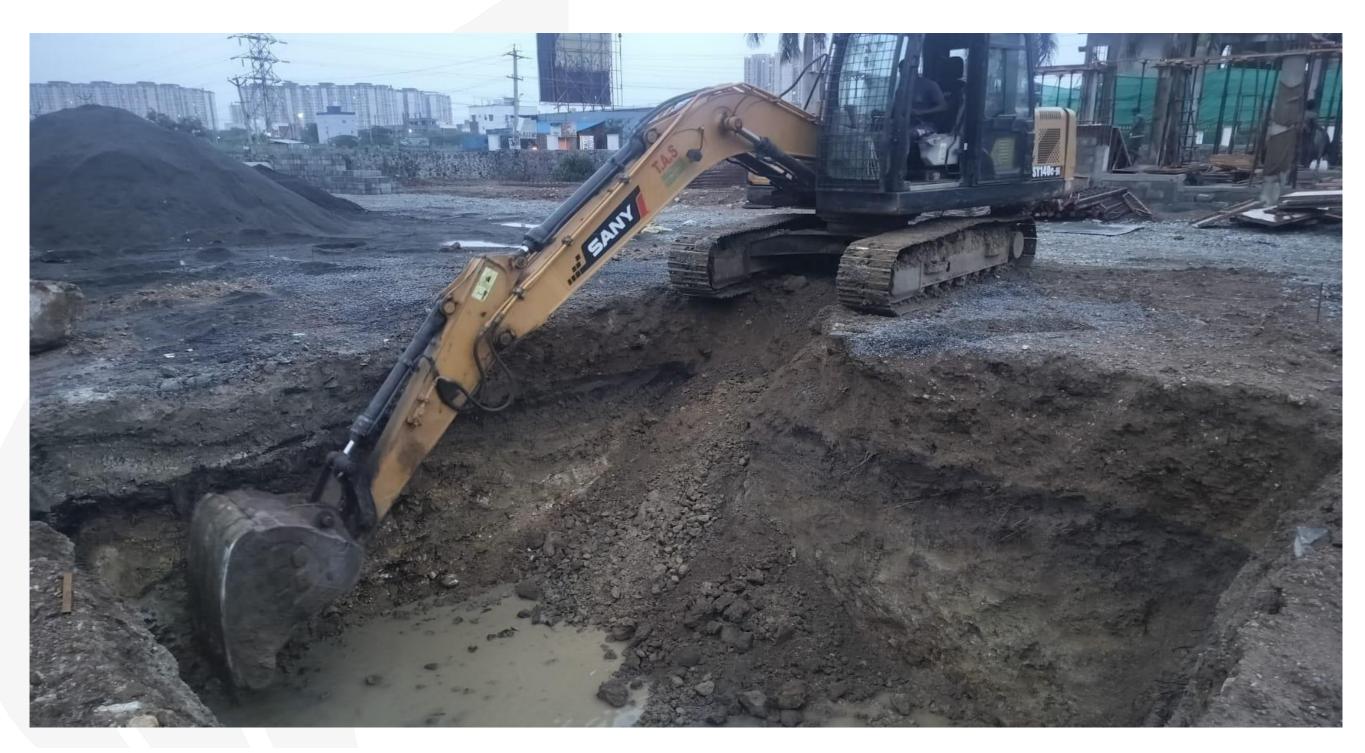
Villa No 17 Earthwork Excavation completed

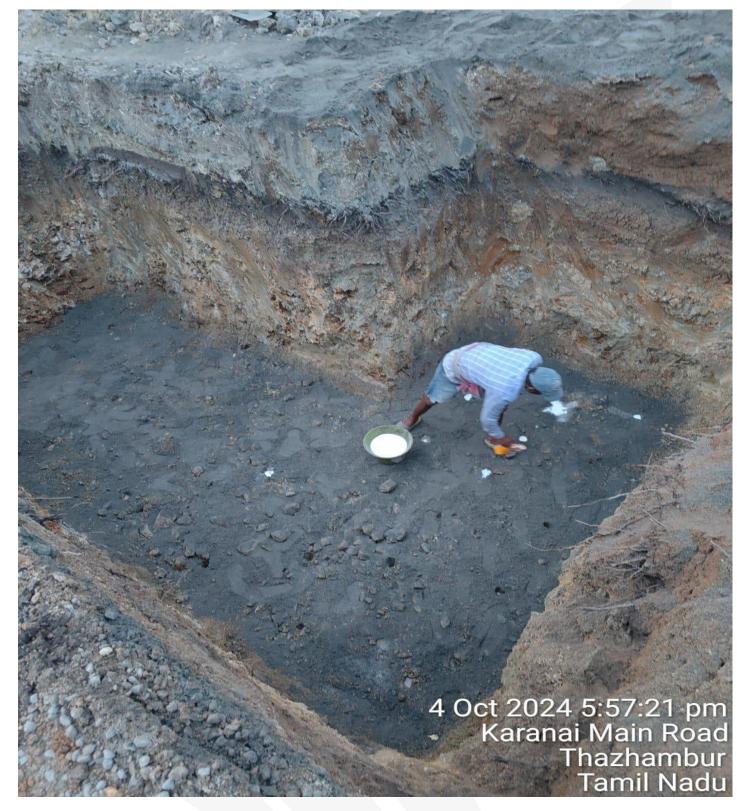
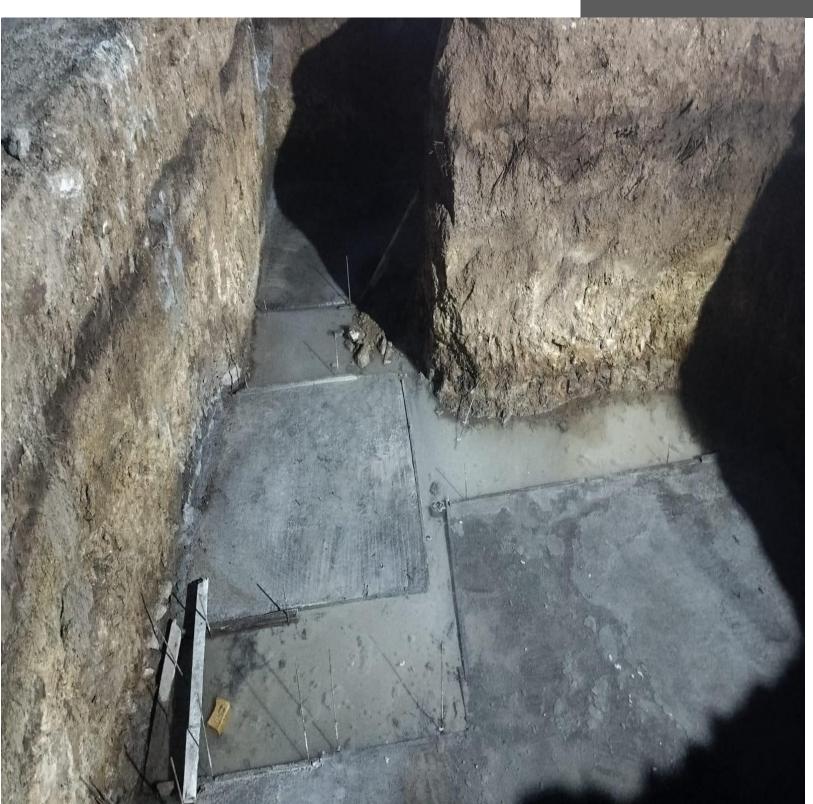
Villa no 17 & 9 PCC work completed

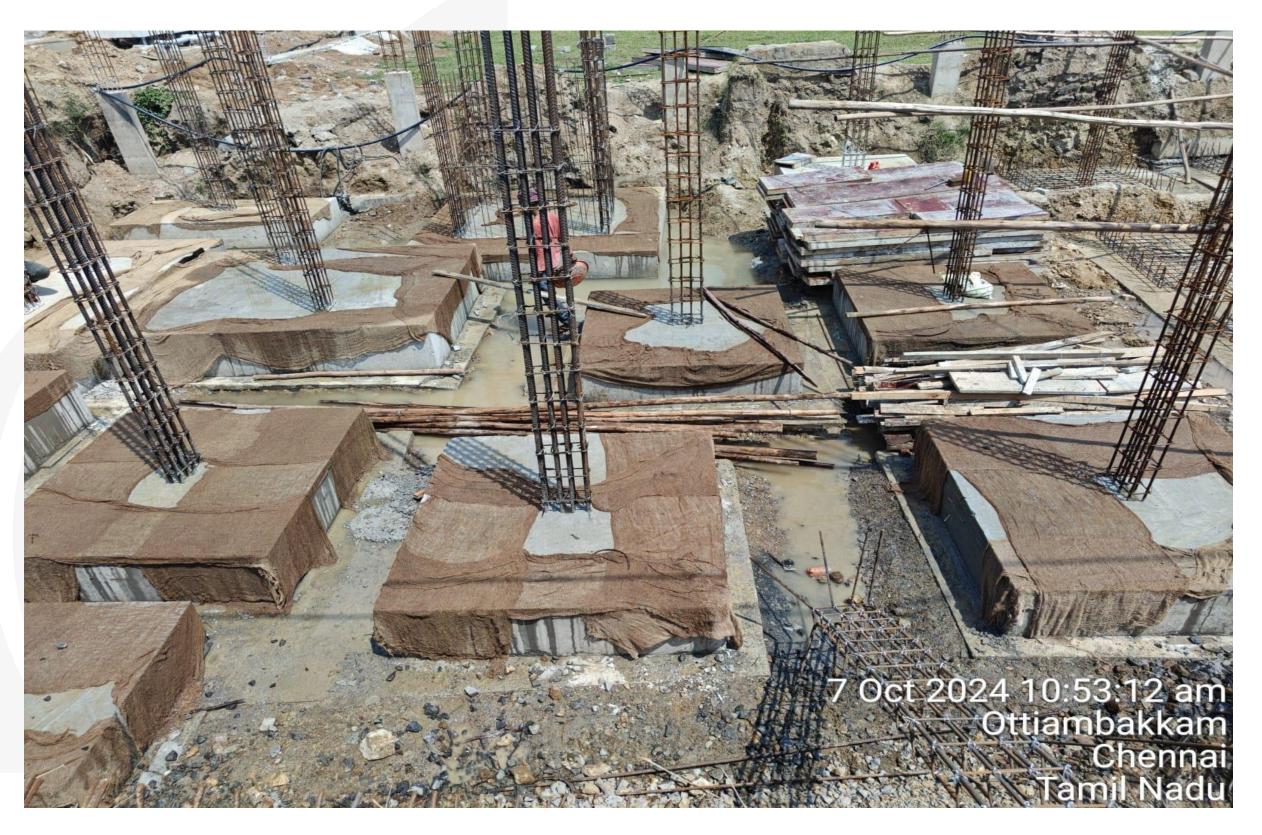
Villa No 12 Footing concrete completed

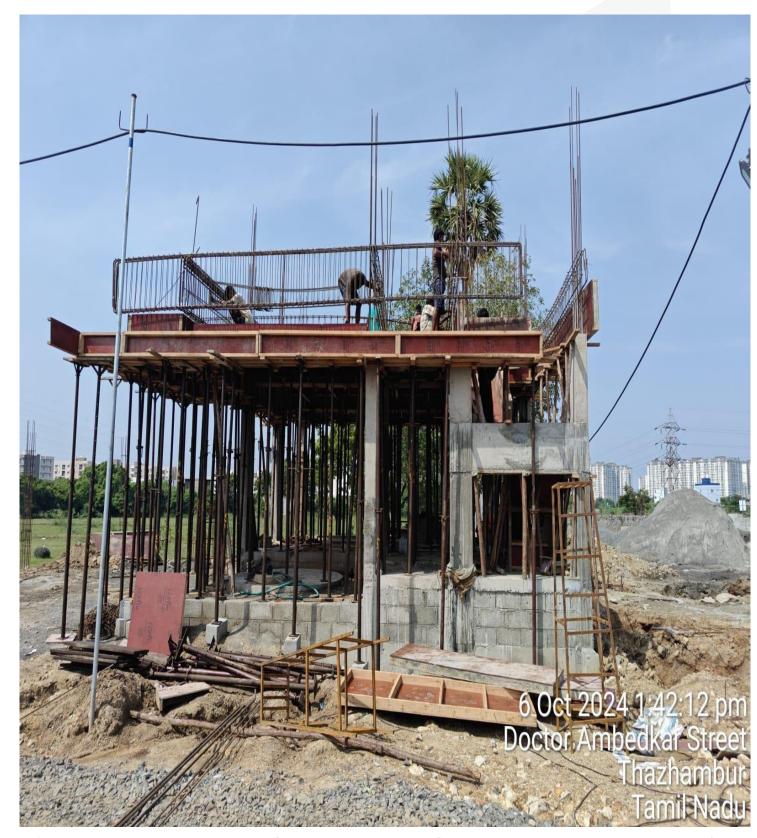
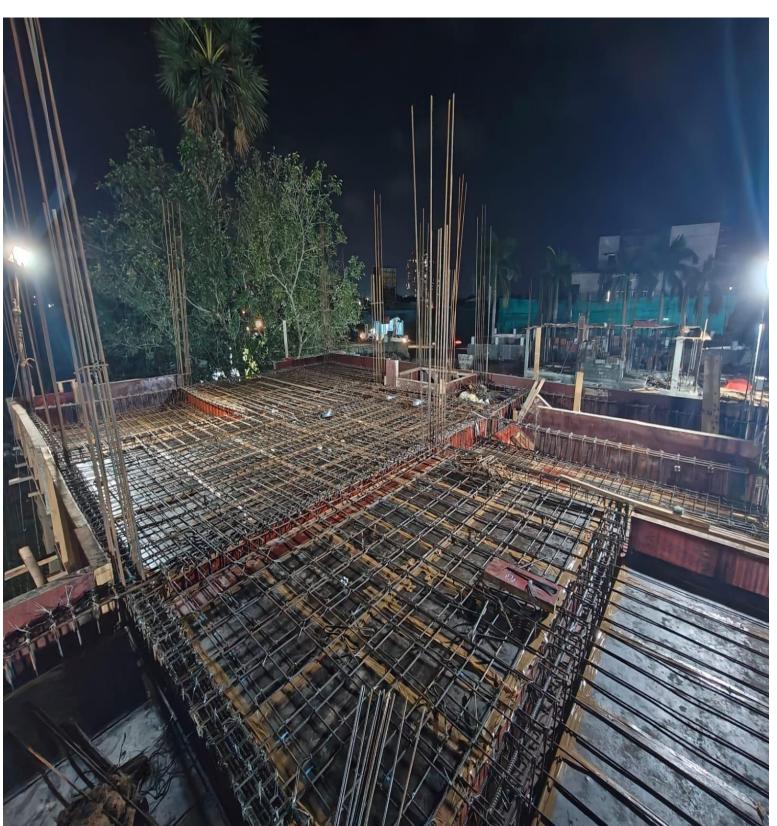
Villa No 16 GF Roof slab shuttering and Reinforcement work in progress

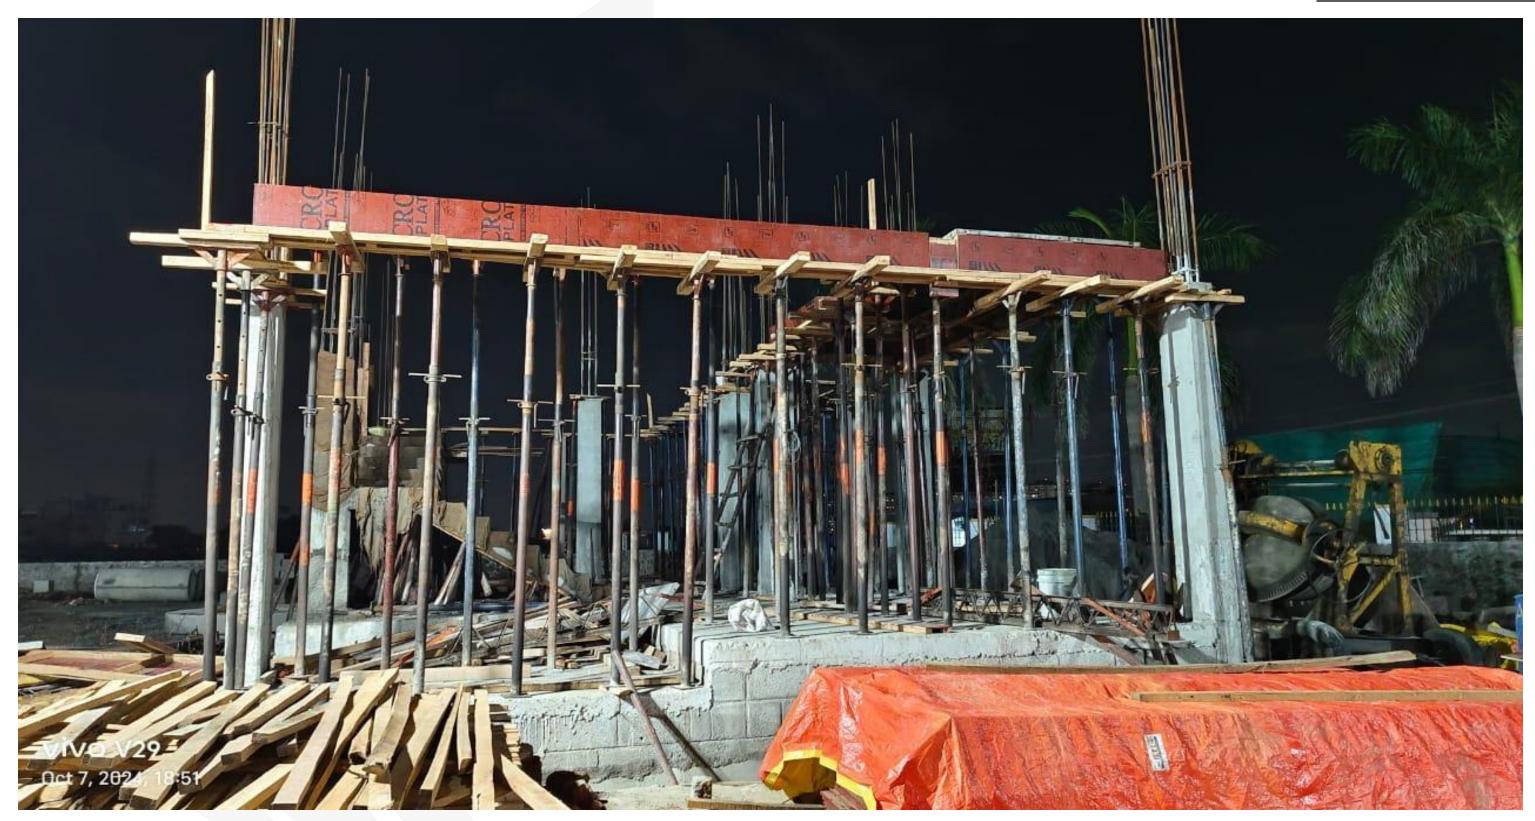
Villa No 20 GF Roof Slab Shuttering work in Progress

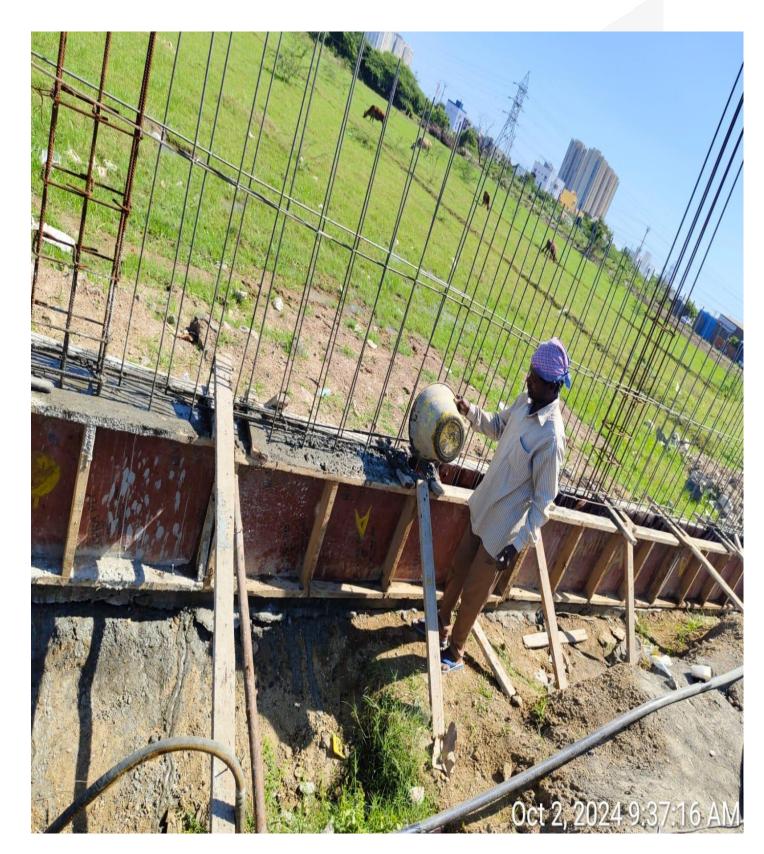
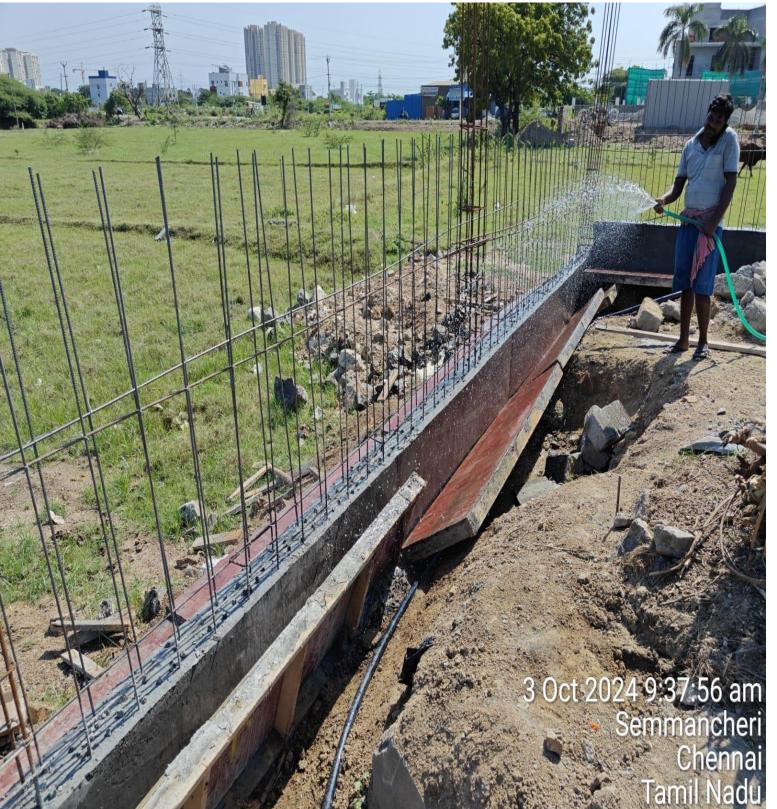
Compound wall - RCC Wall concrete work in Progress

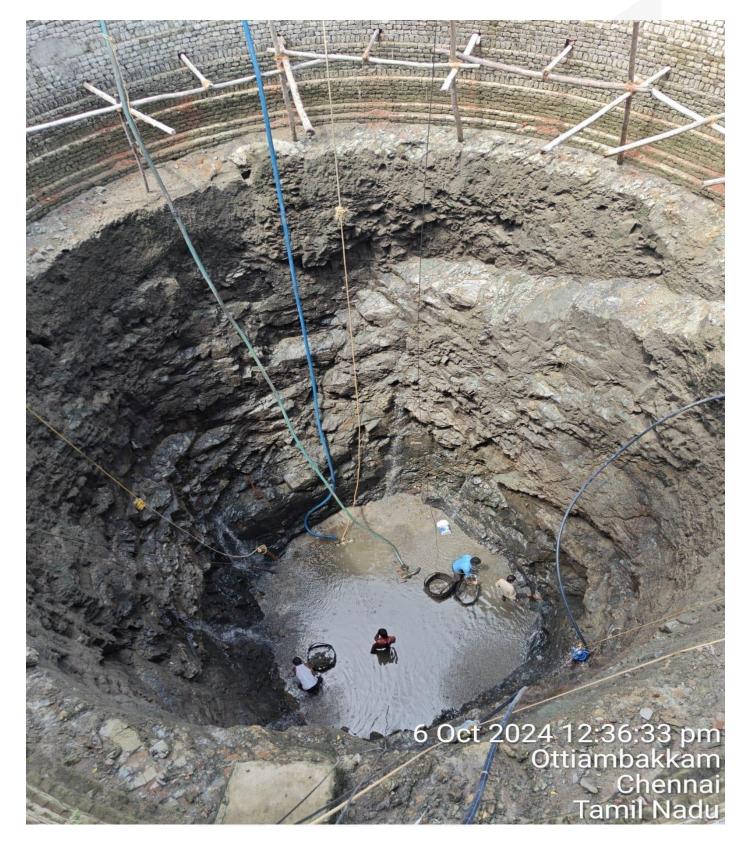
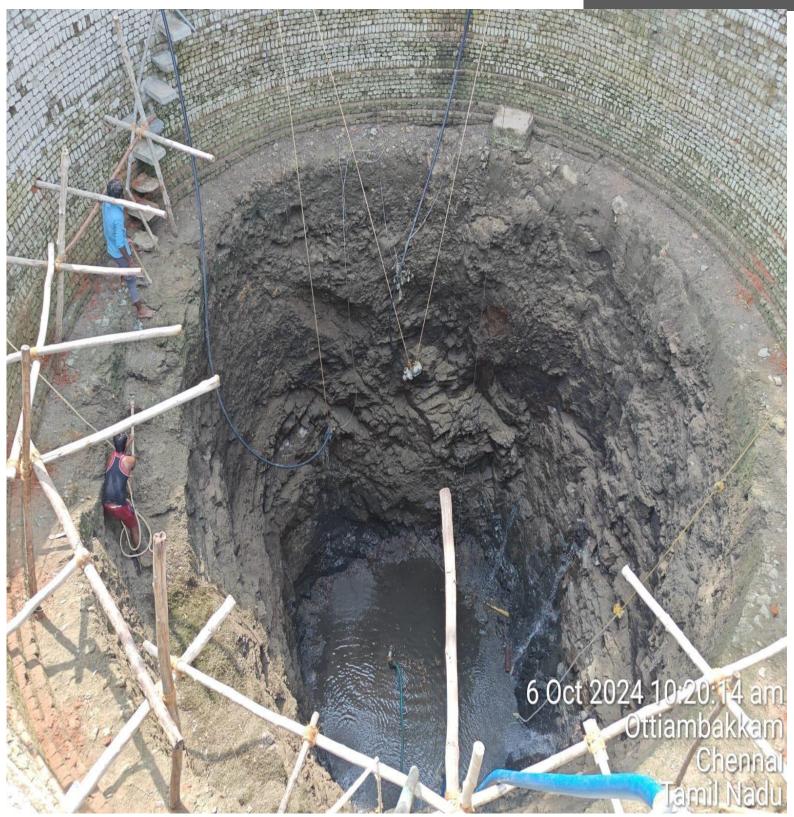
Well Slush Cleaning work in Progress

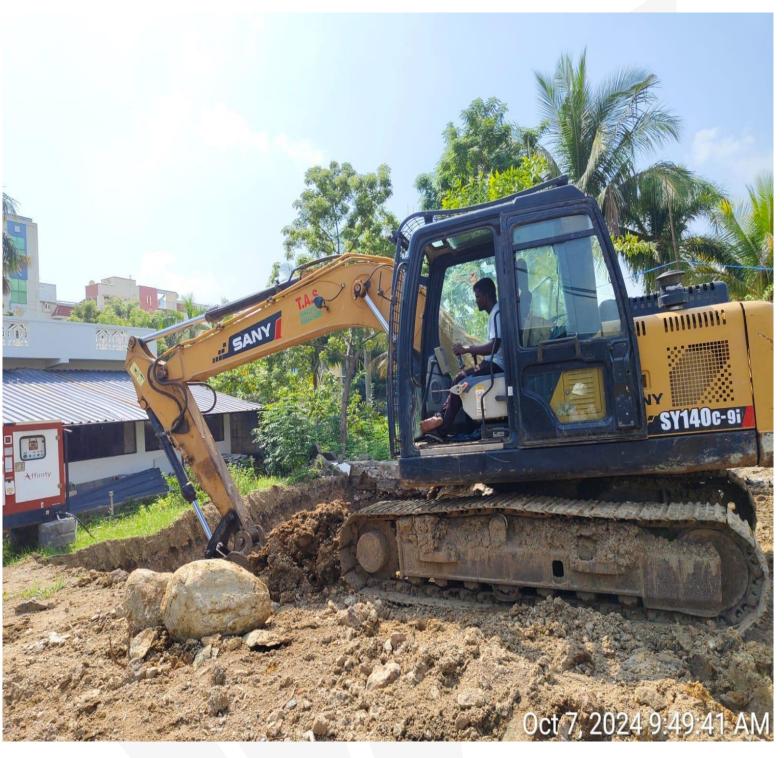
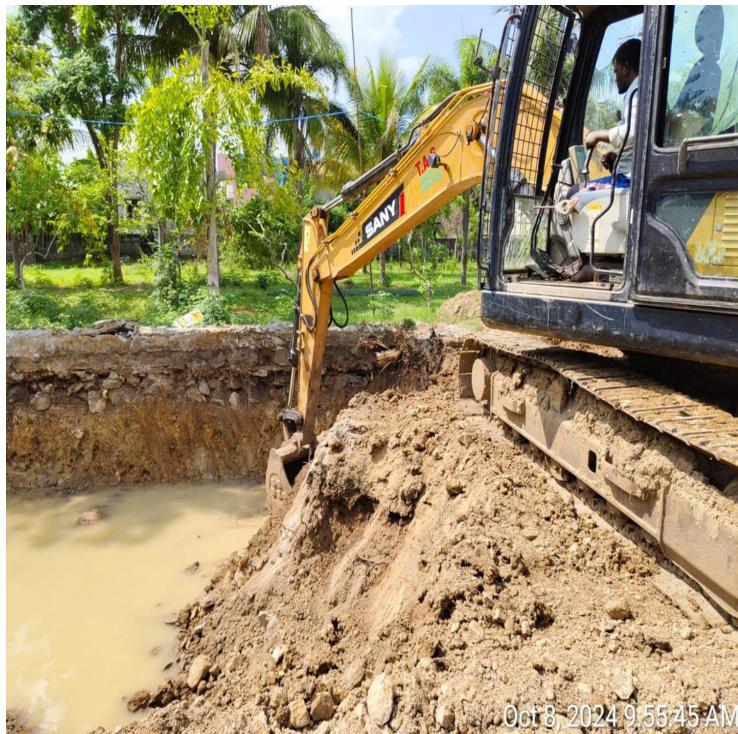
Villa No.03 Earthwork Excavation completed

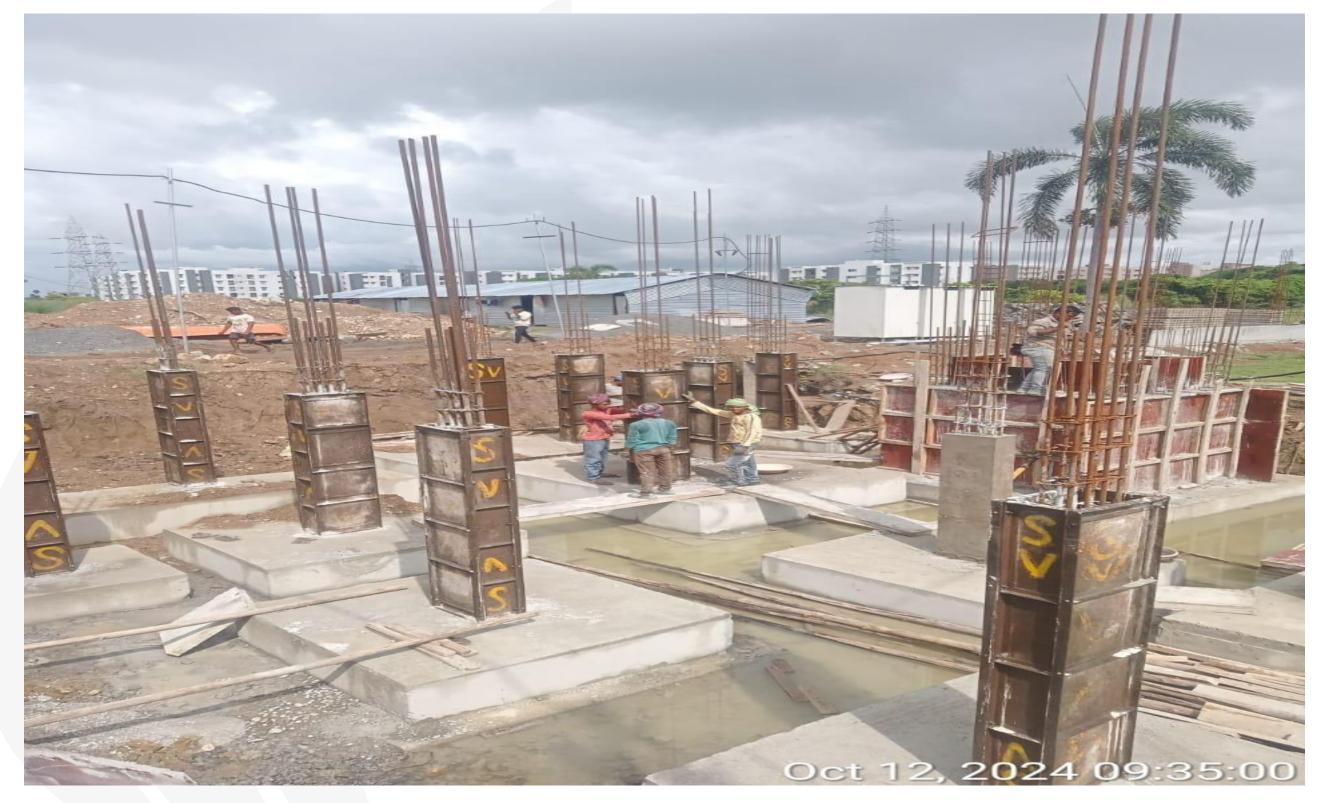
Villa No.12 Pedestal Column Shuttering & Concrete Completed

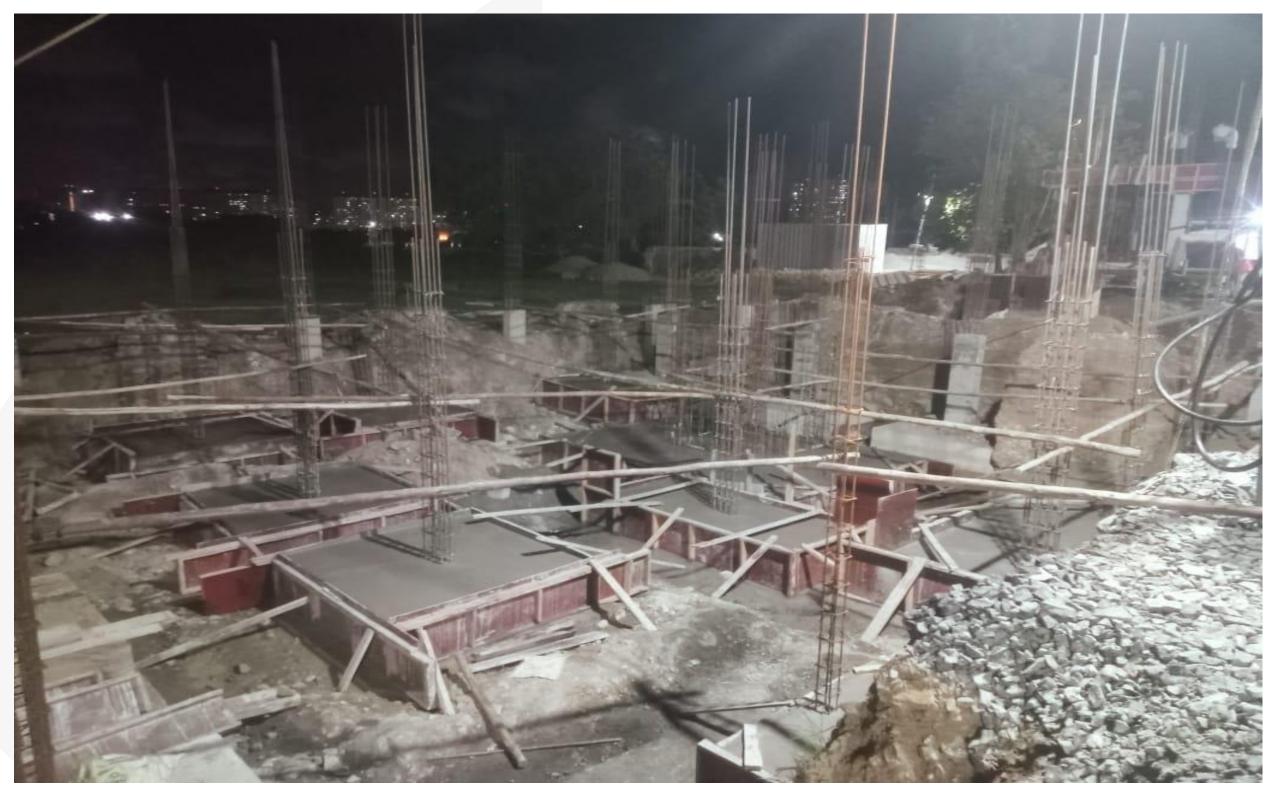
Villa No.13 Footing concrete completed

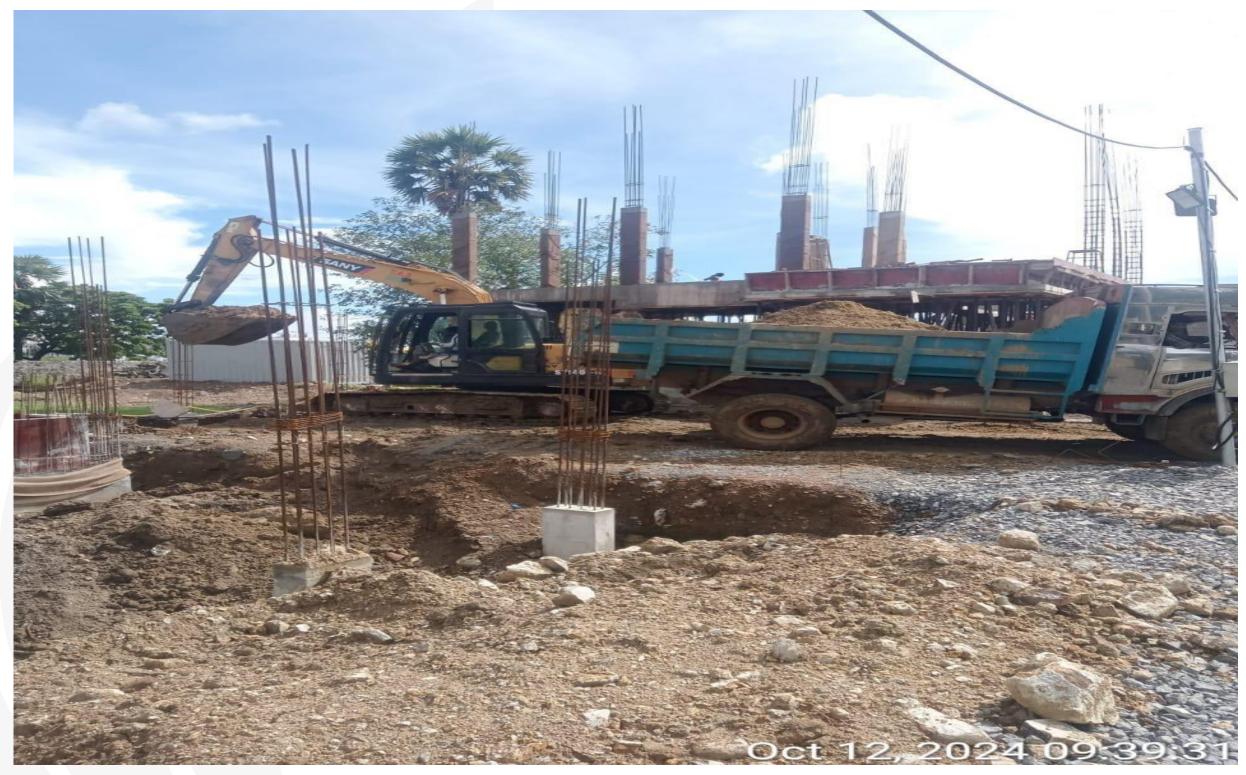
Villa no 15 Earth work Excavation in progress

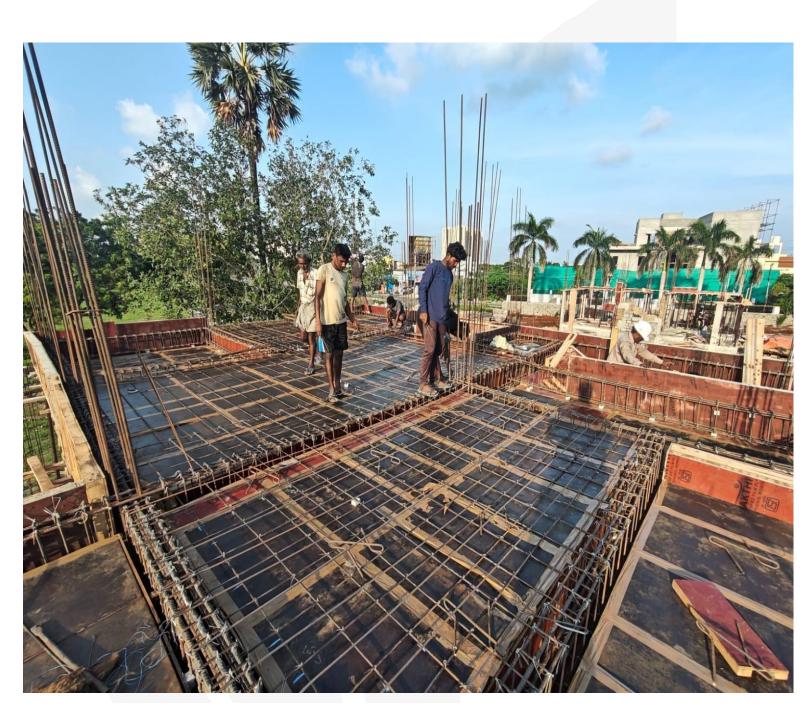
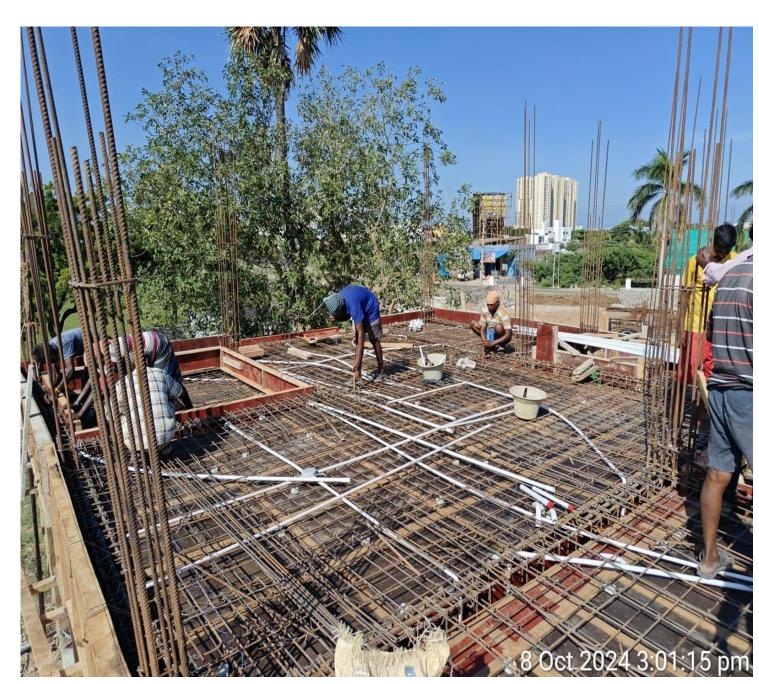
Villa No.16 GF Roof Slab Reinforcement & Electrical Conduit Pipe Laying work in Progress

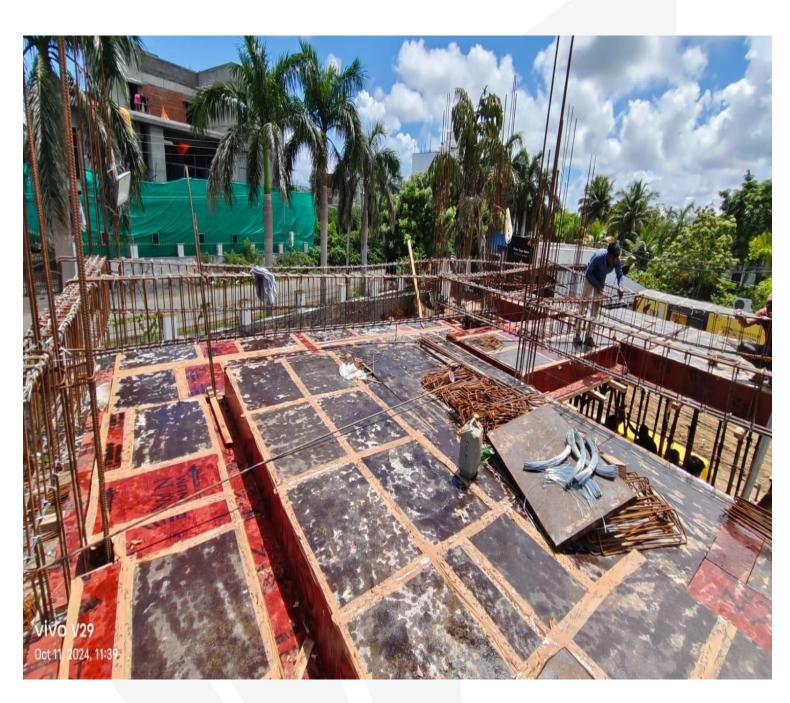
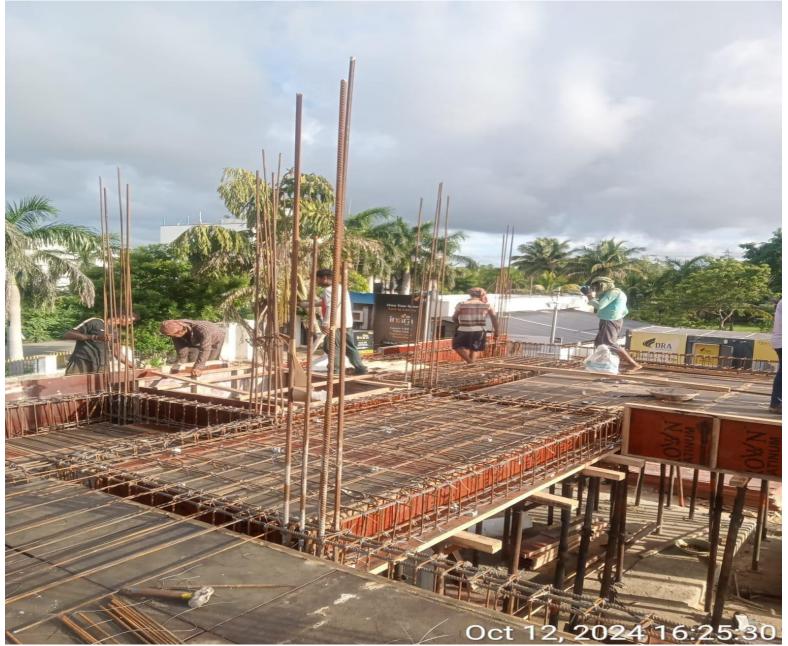
Villa No 20 GF Roof Slab Shuttering Completed and Reinforcement work in Progress

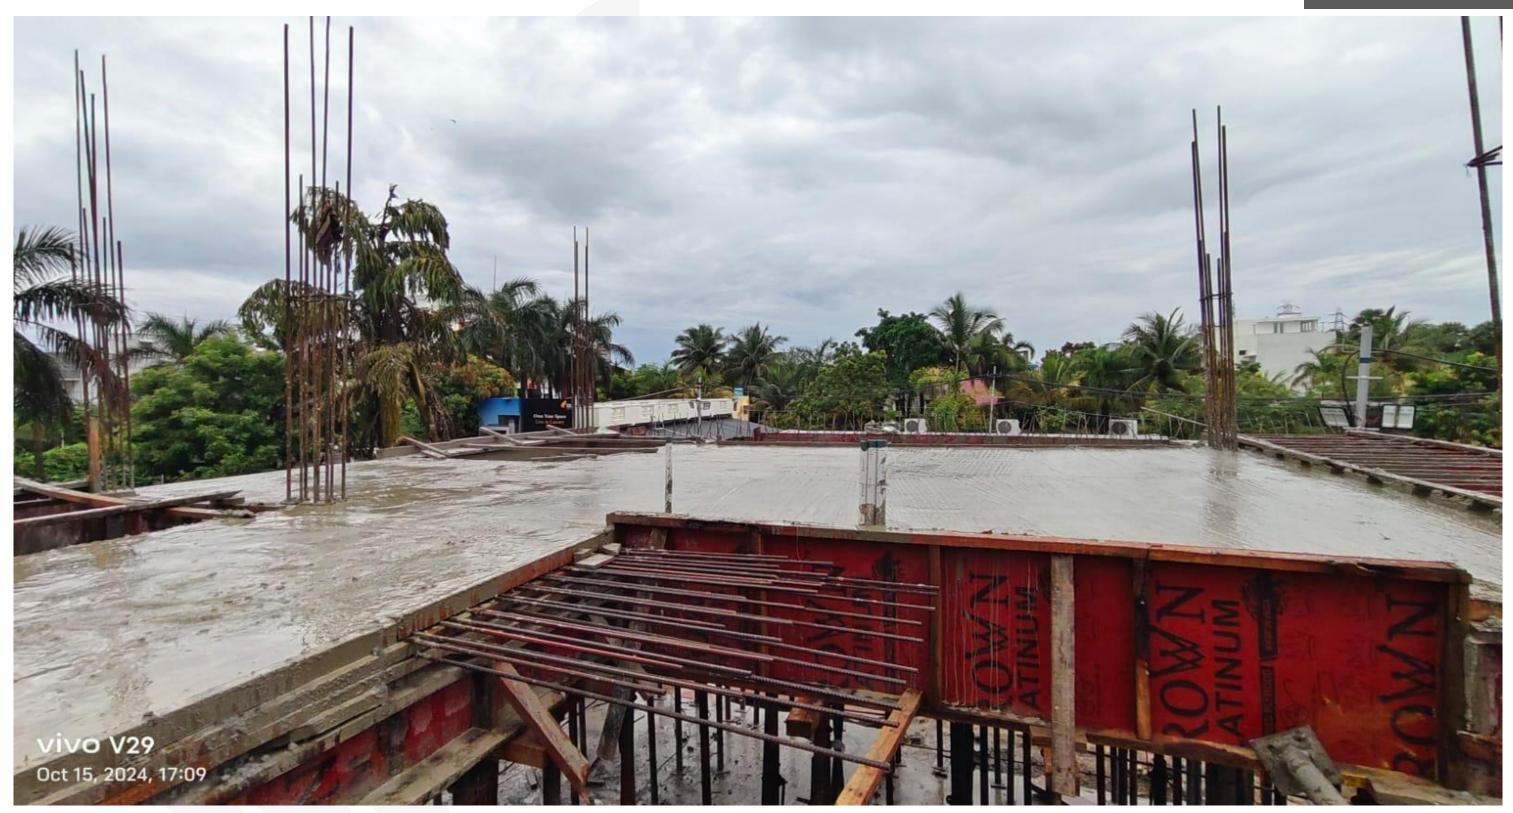
Villa No 20 GF Roof Slab Concrete Completed

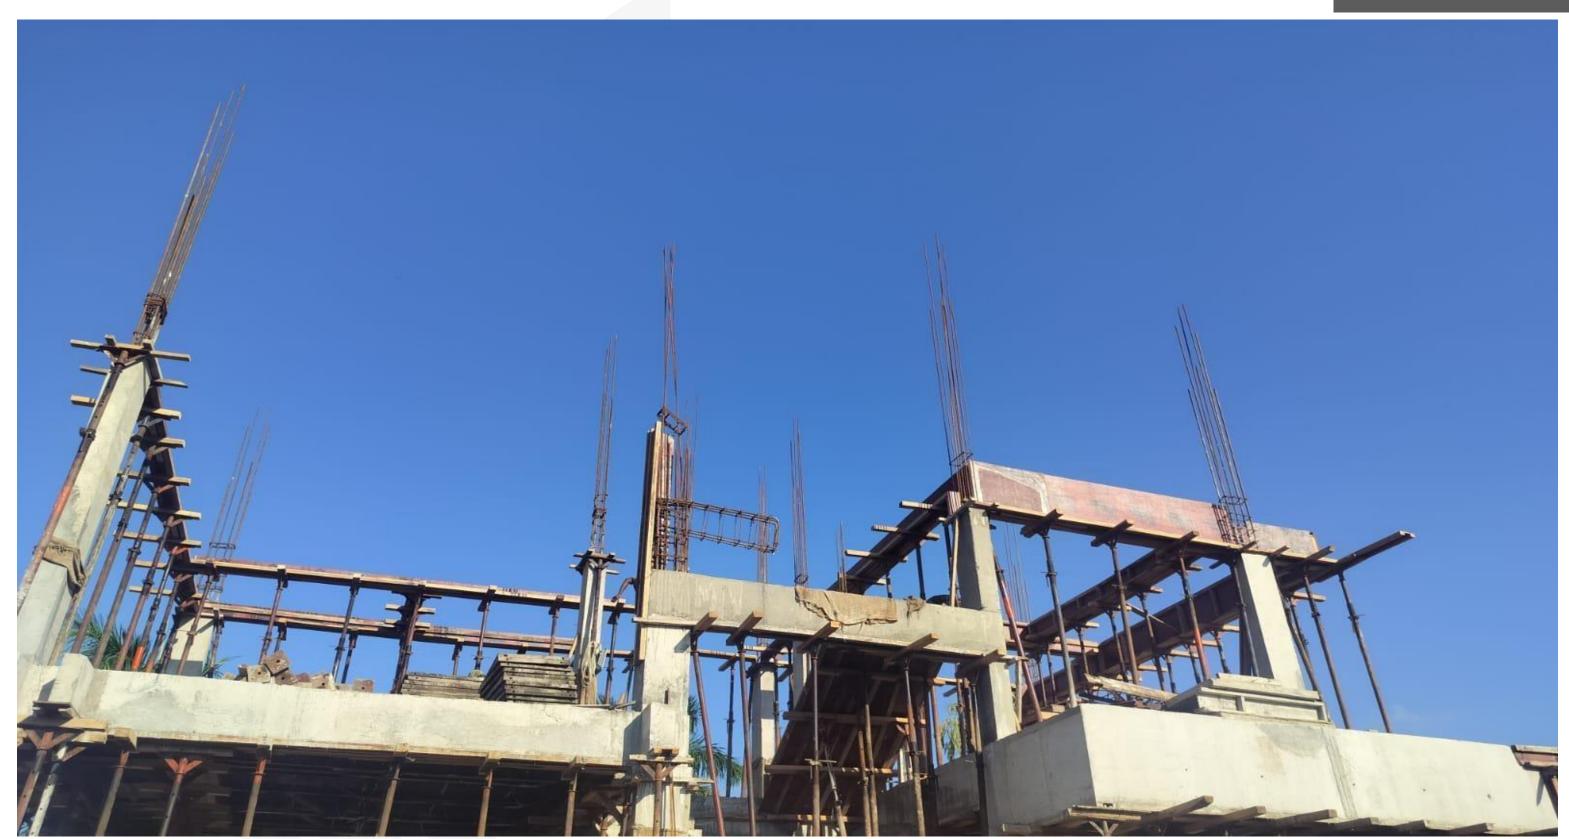
Villa No 20 FF Roof Slab shuttering work in Progress

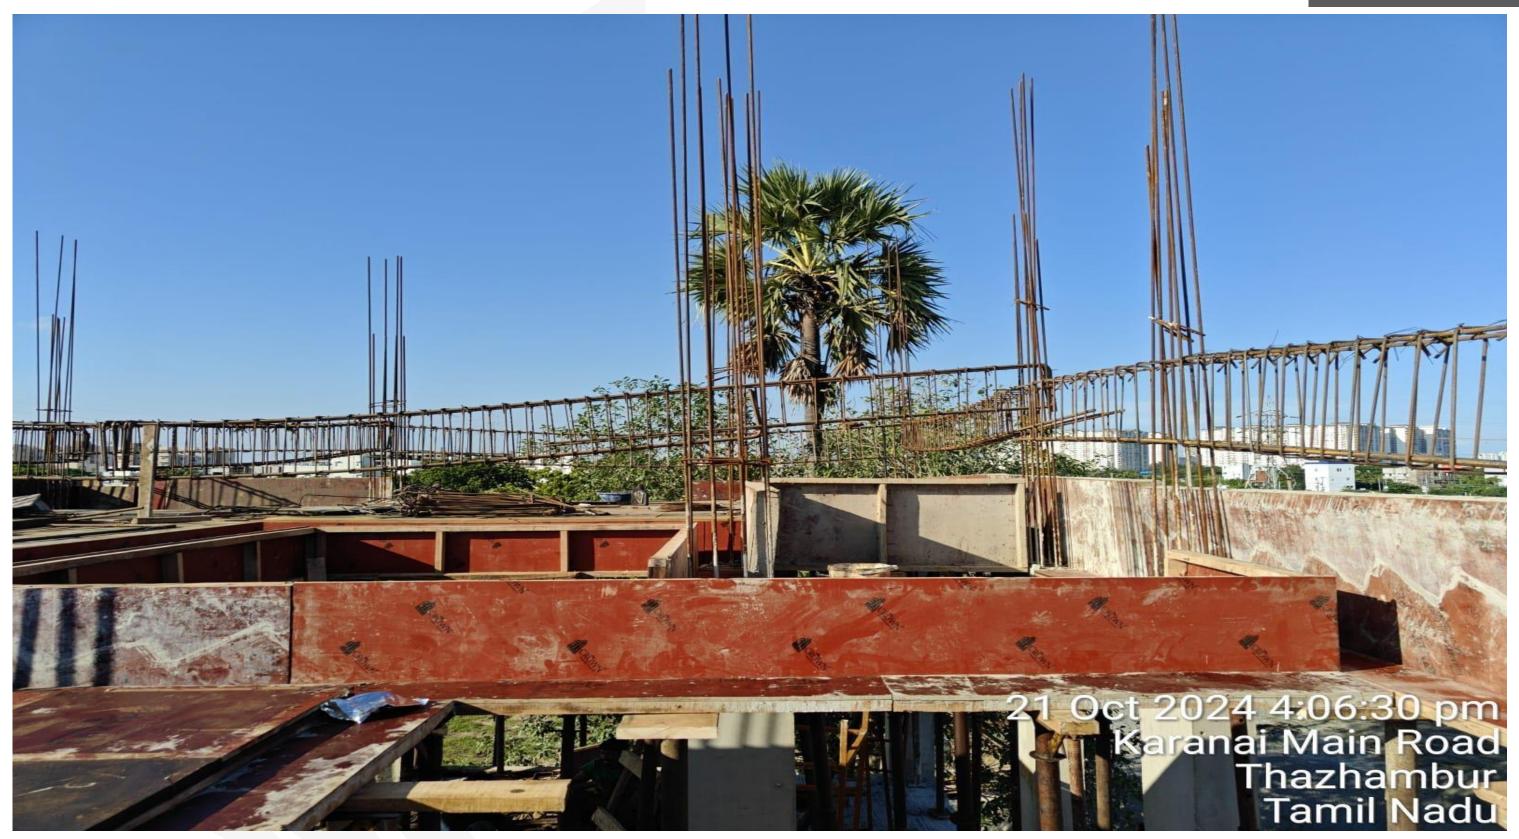
Villa No 16 FF Roof Slab shuttering and Reinforcement work in Progress

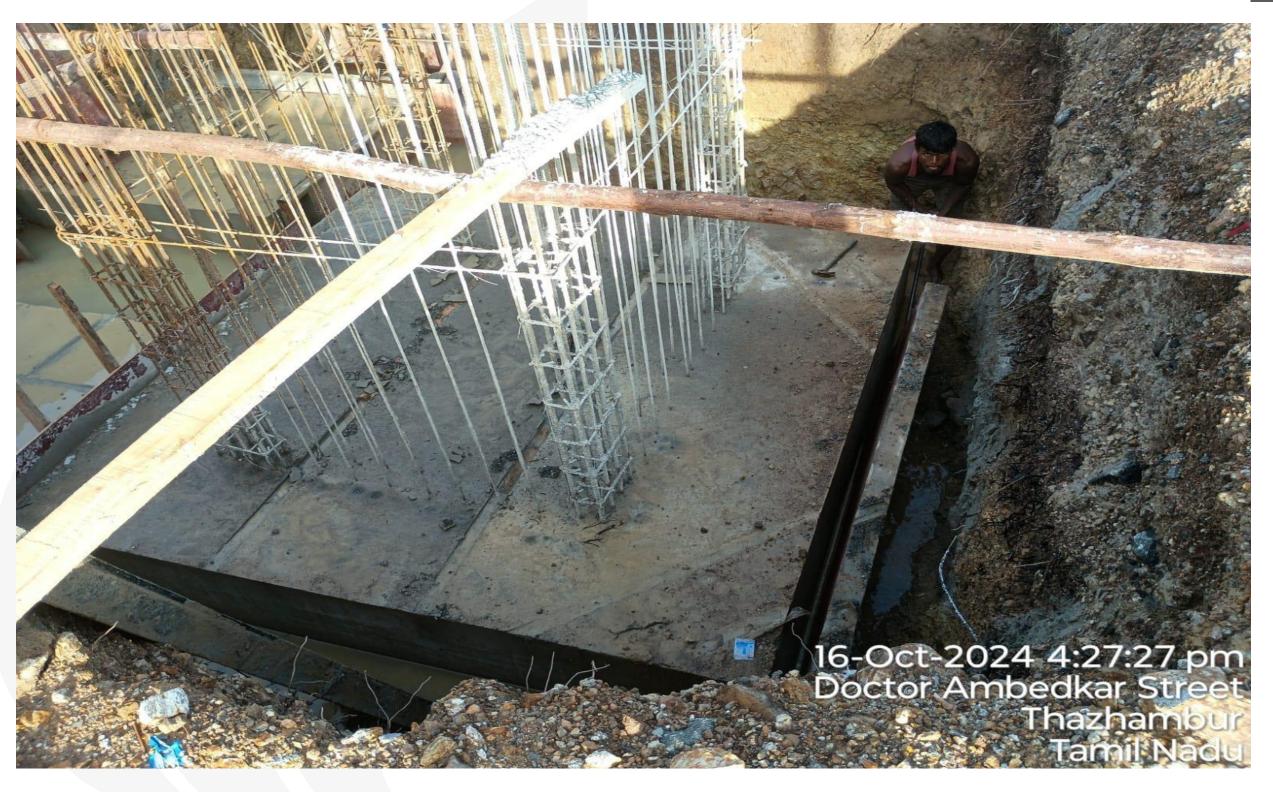
Villa no 17 Footing concrete work completed

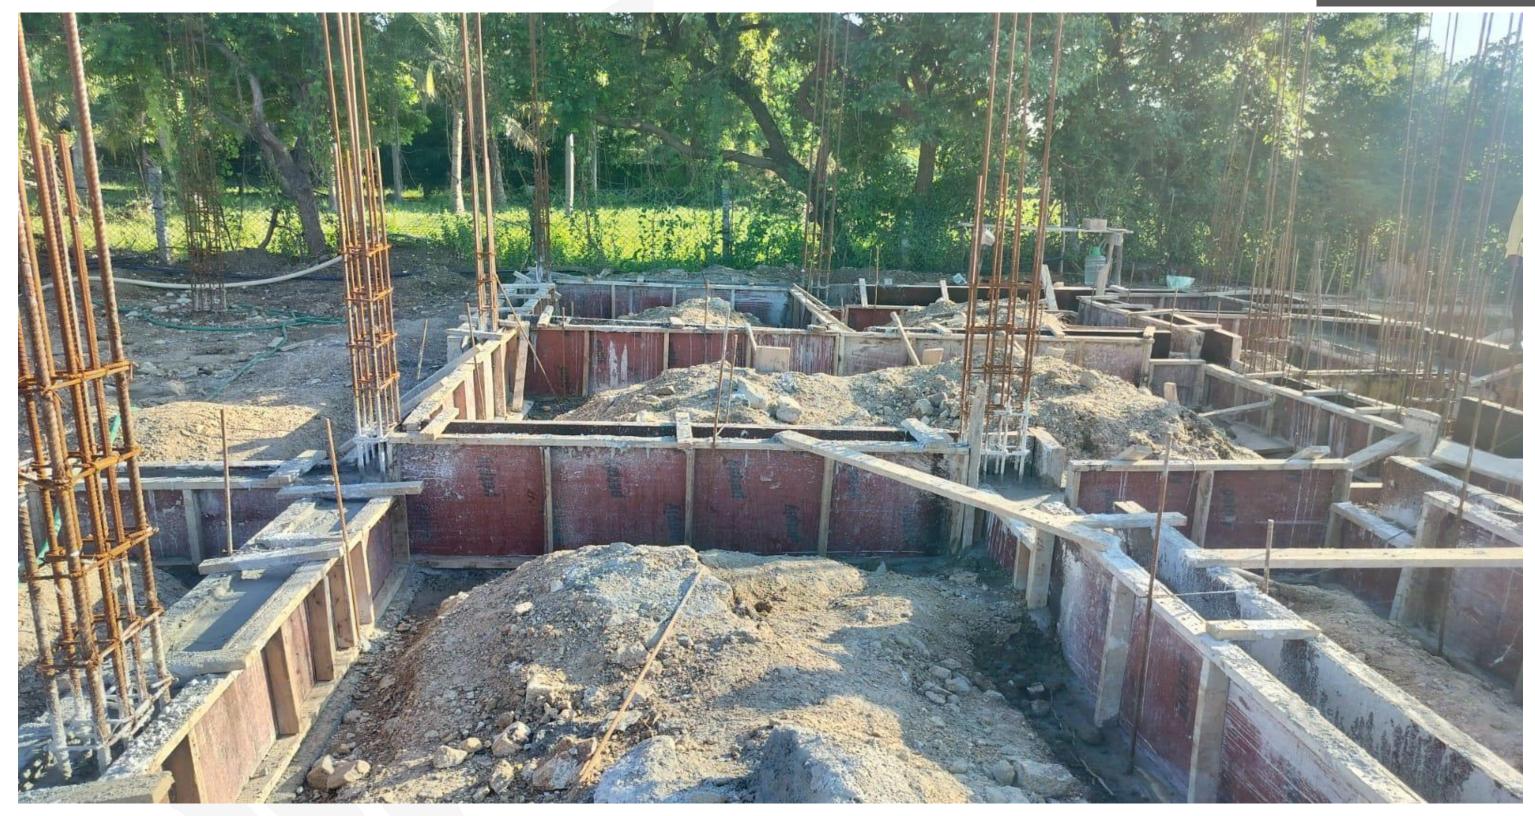
Villa no 11 Plinth beam concrete completed

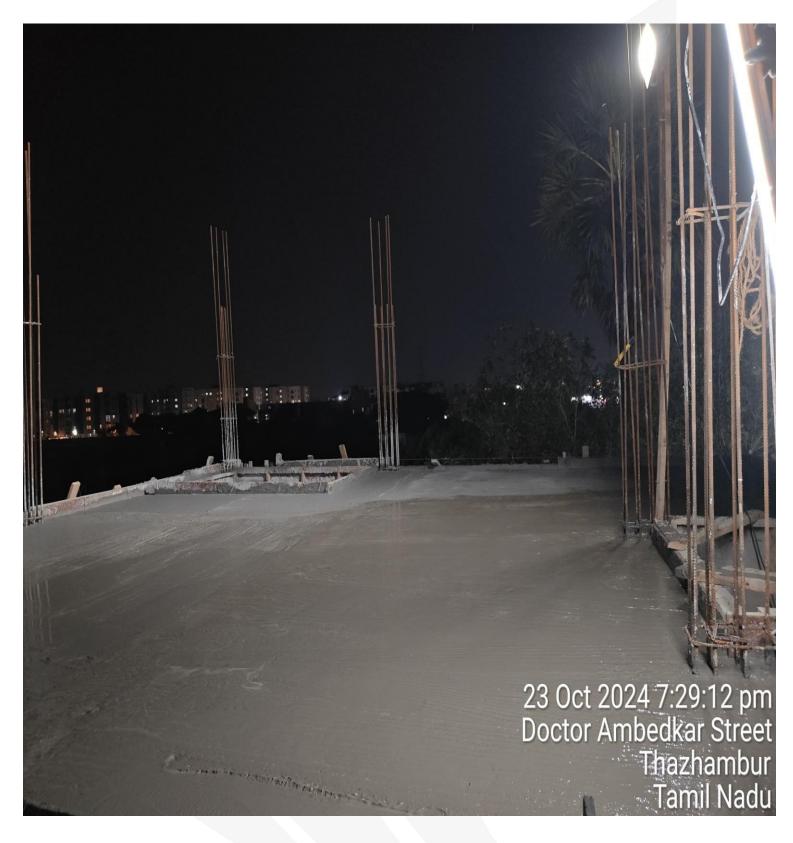
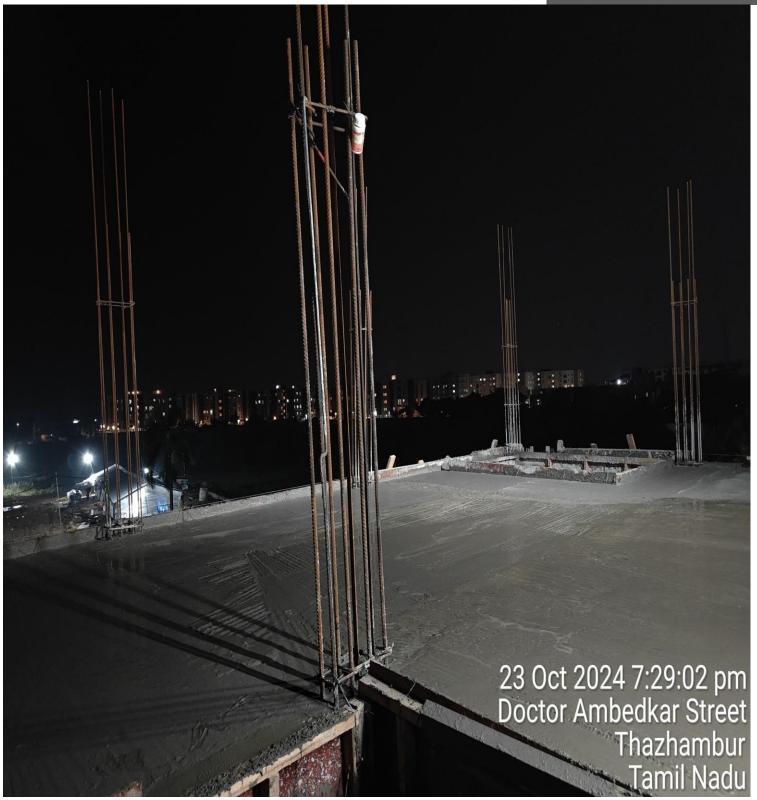
Villa No 16 FF Roof Slab Concrete Completed

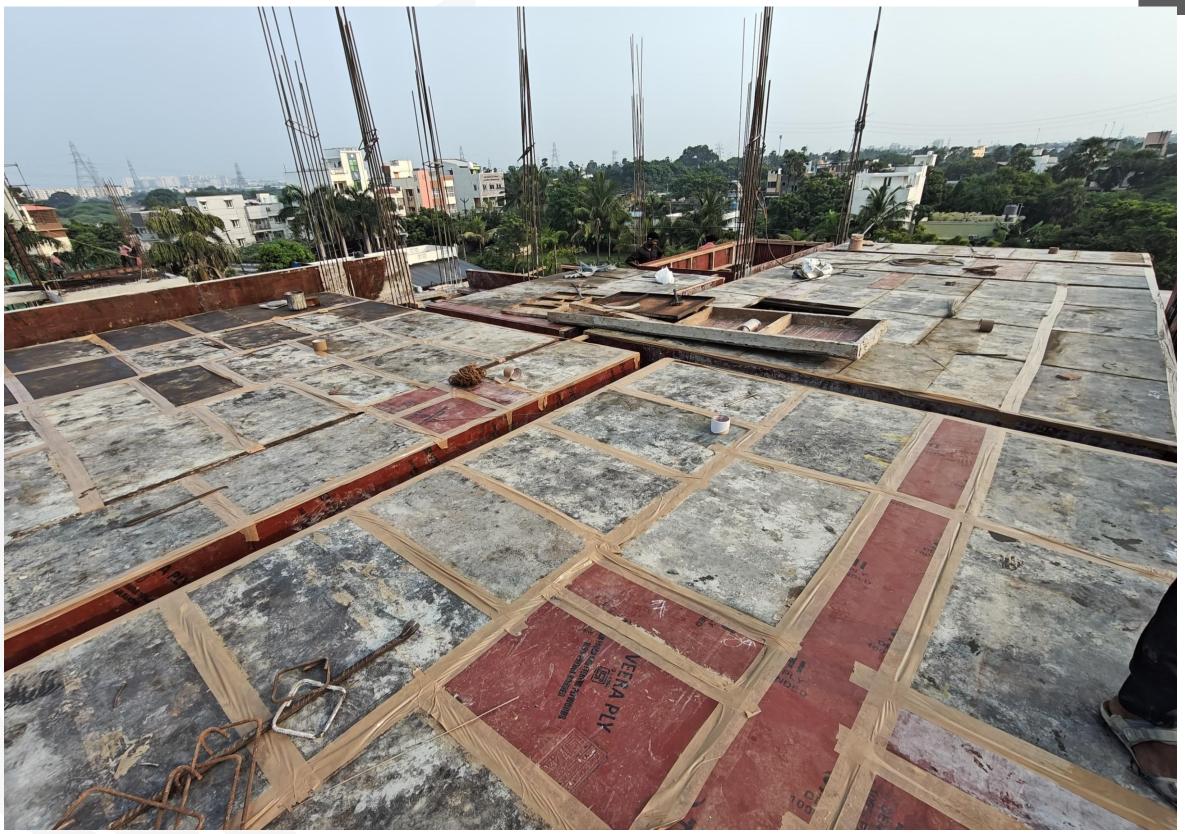
Villa No 16 Terrace Floor slab shuttering work in progress
