DRA INARA- Monthly Construction Photos - October 2024

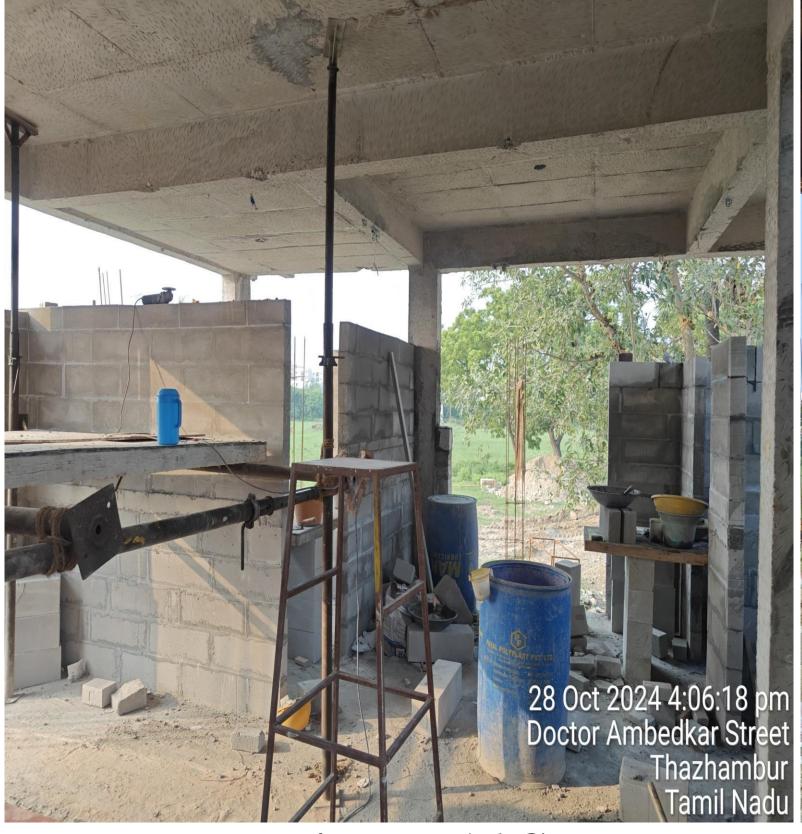
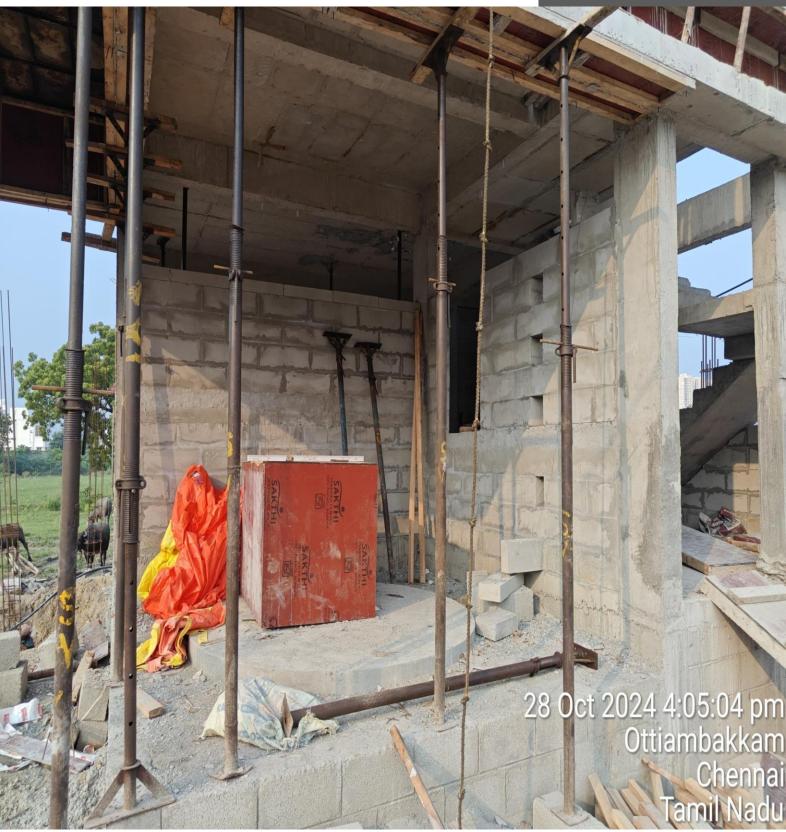
Villa No 16 Ground Floor Block work in Progress

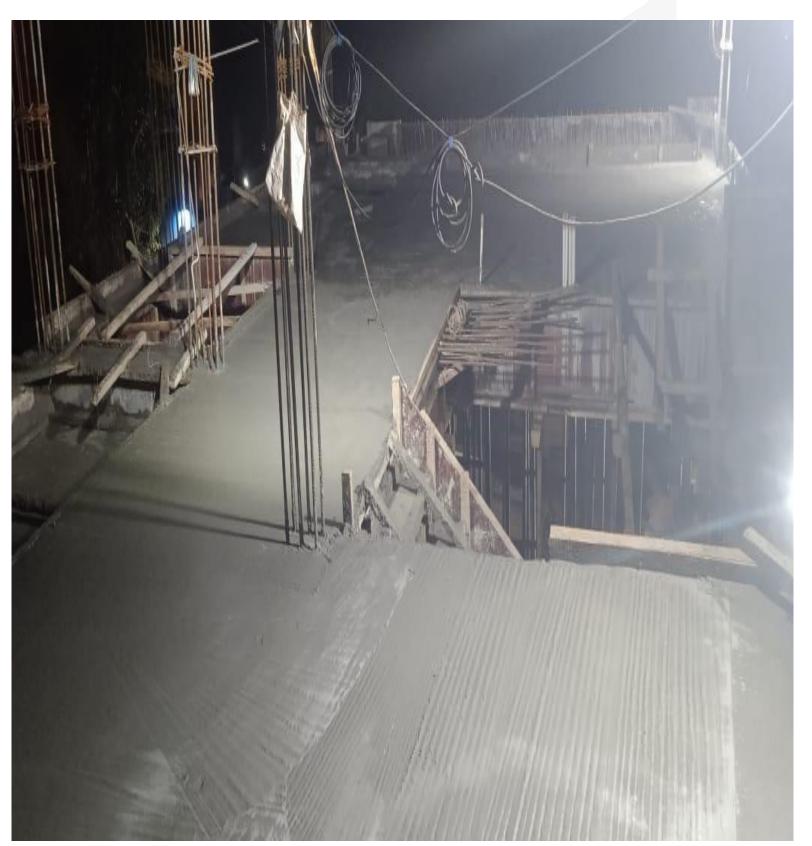
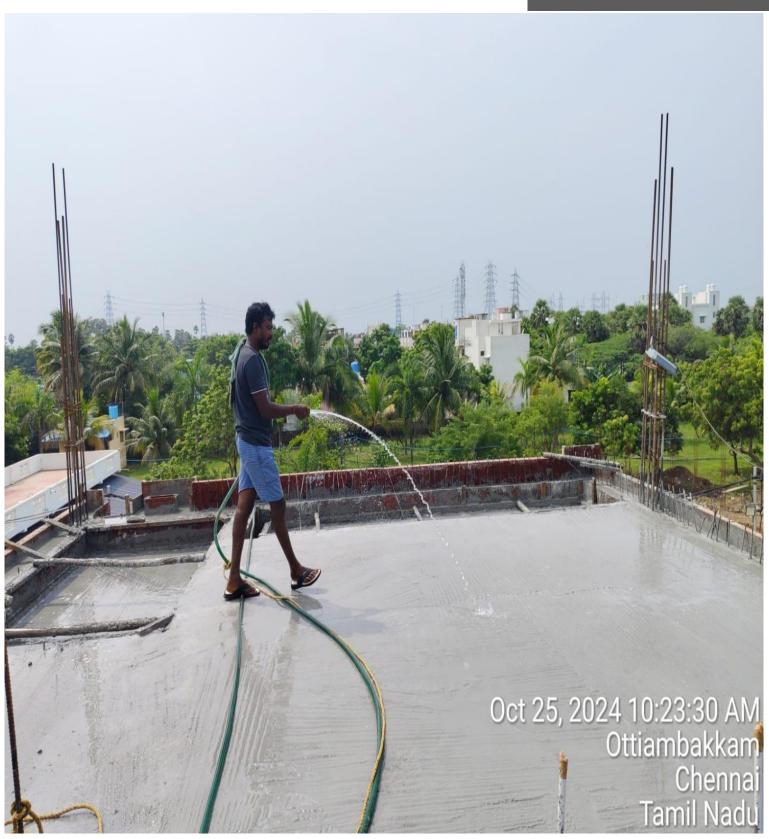
Villa No 20 FF Roof Concrete Completed

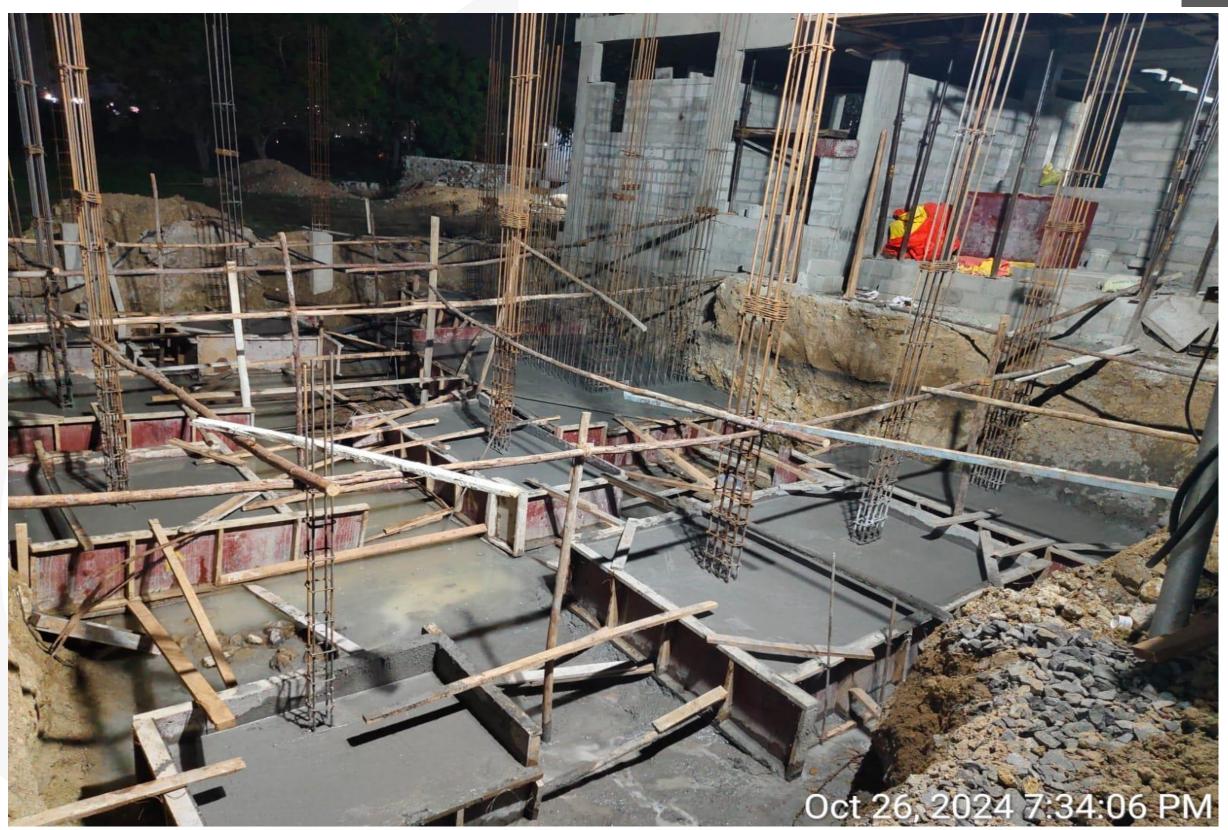
Villa No 15 All Footing Concrete Completed

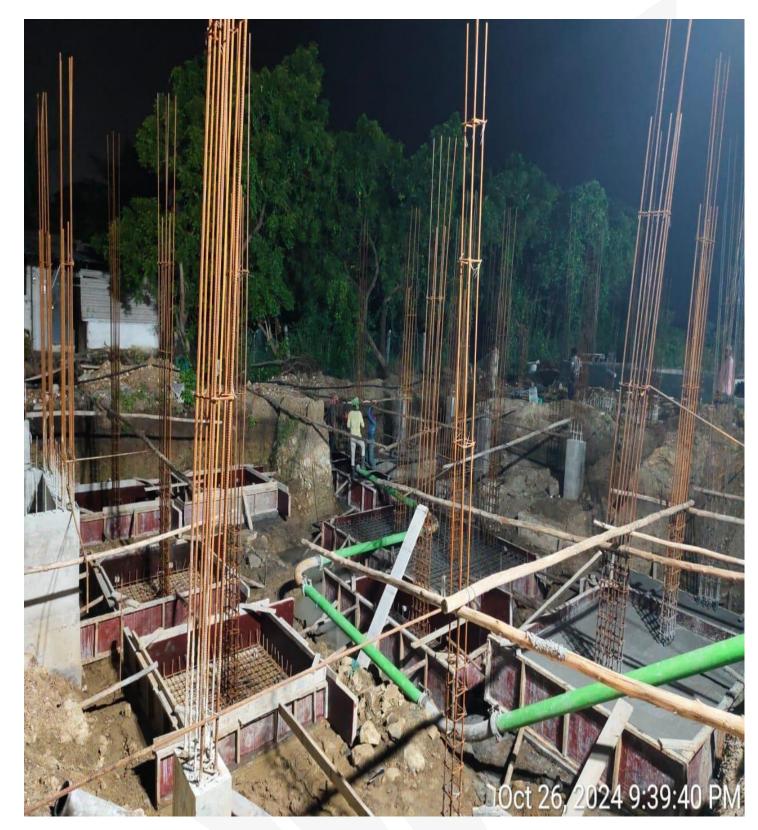
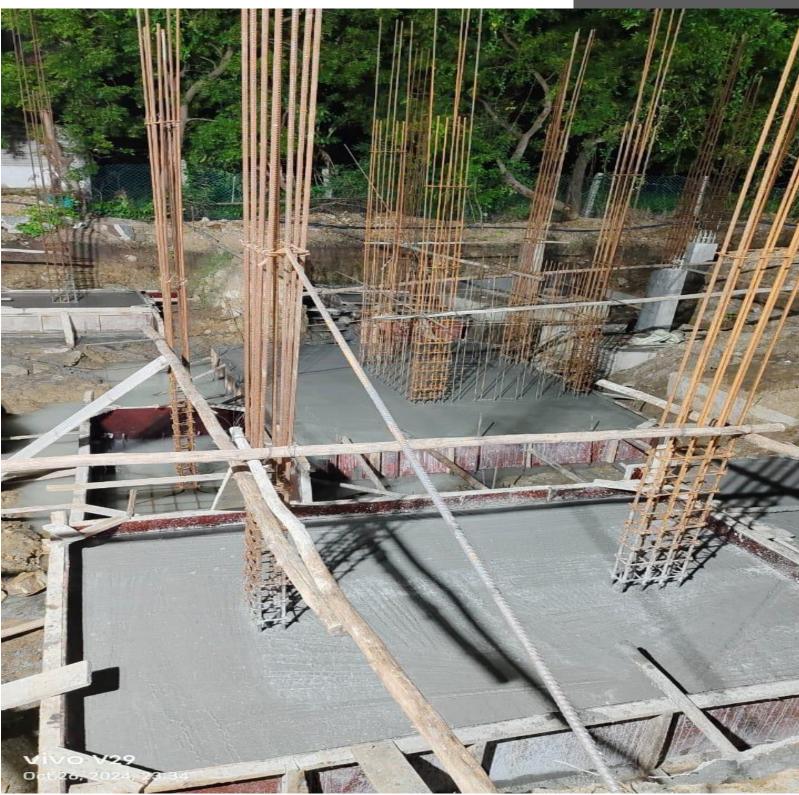
Villa no 9 All Footing Concrete Work Completed

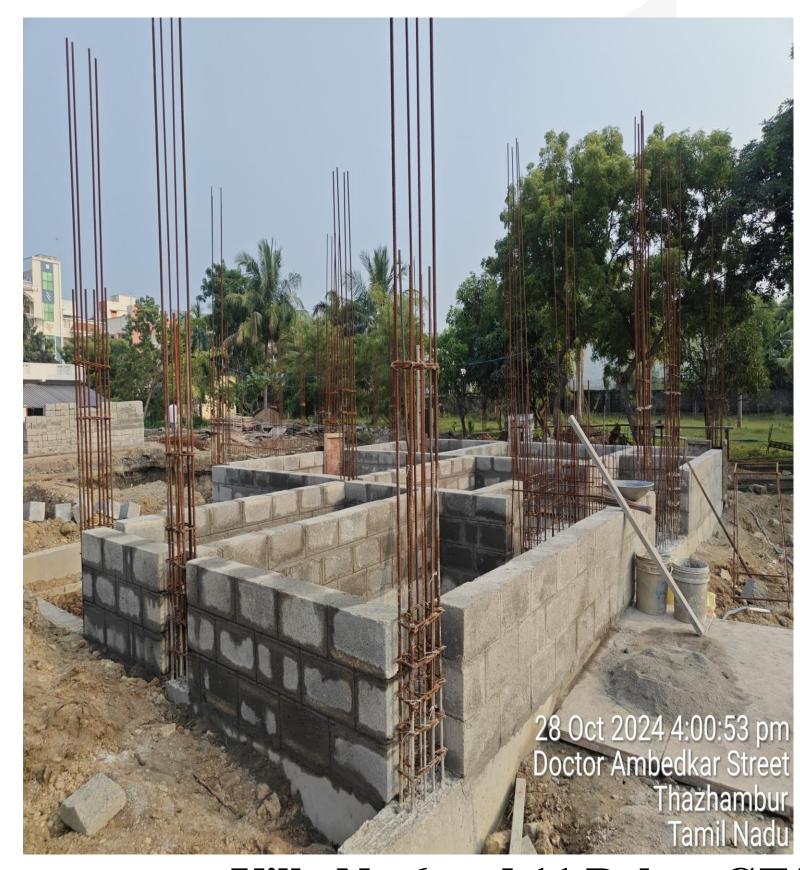
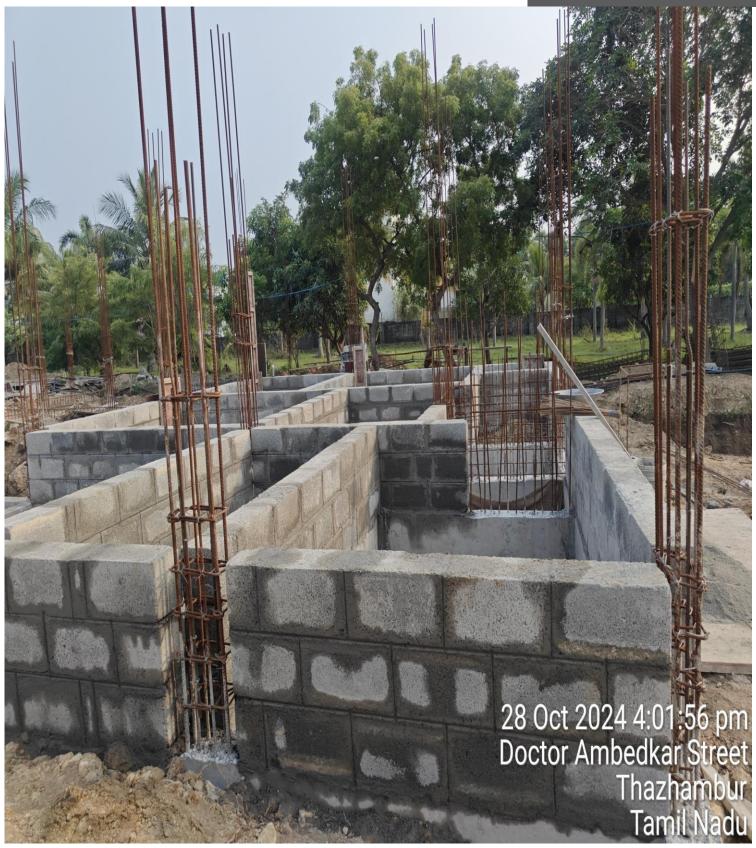
Villa No 6 and 11 Below GF level Block work in progress
