DRA INARA
Monthly Construction Updates – January 2025

Over all percentage of Completion

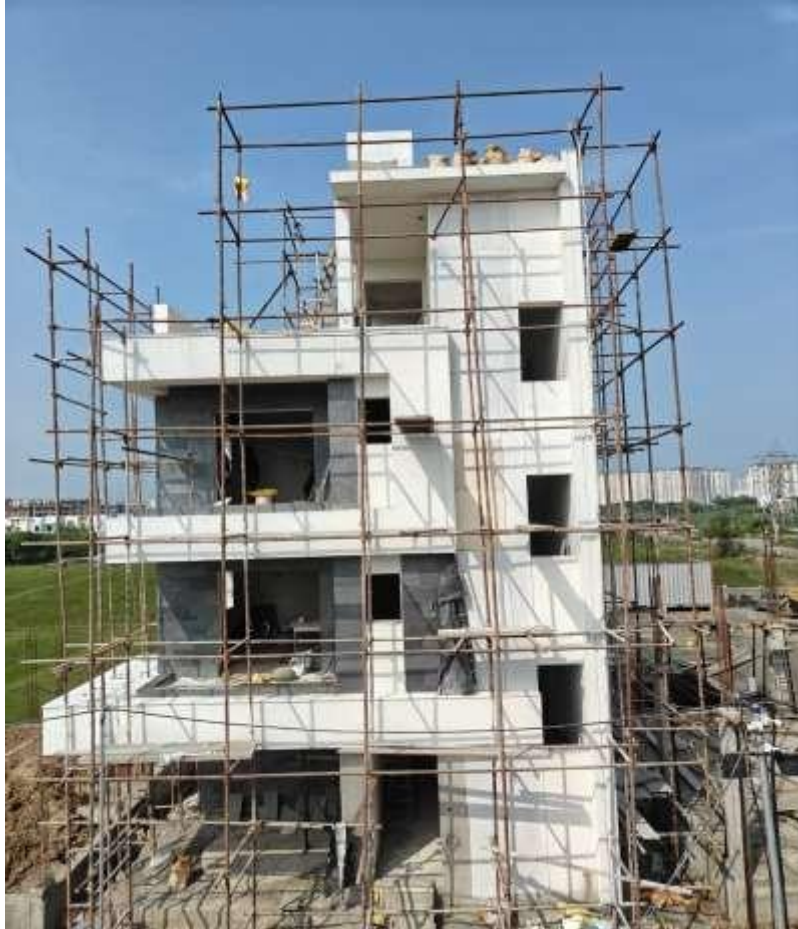
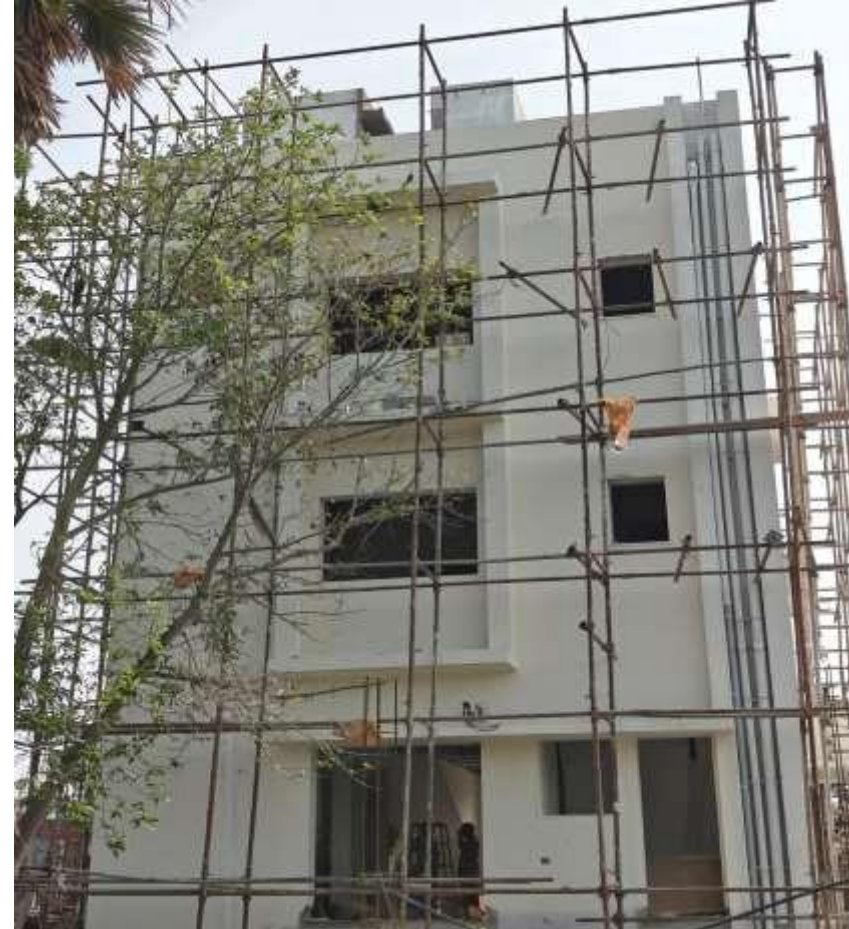
Villa no 16 – External Wall Pebble Texture and Painting work in Progress

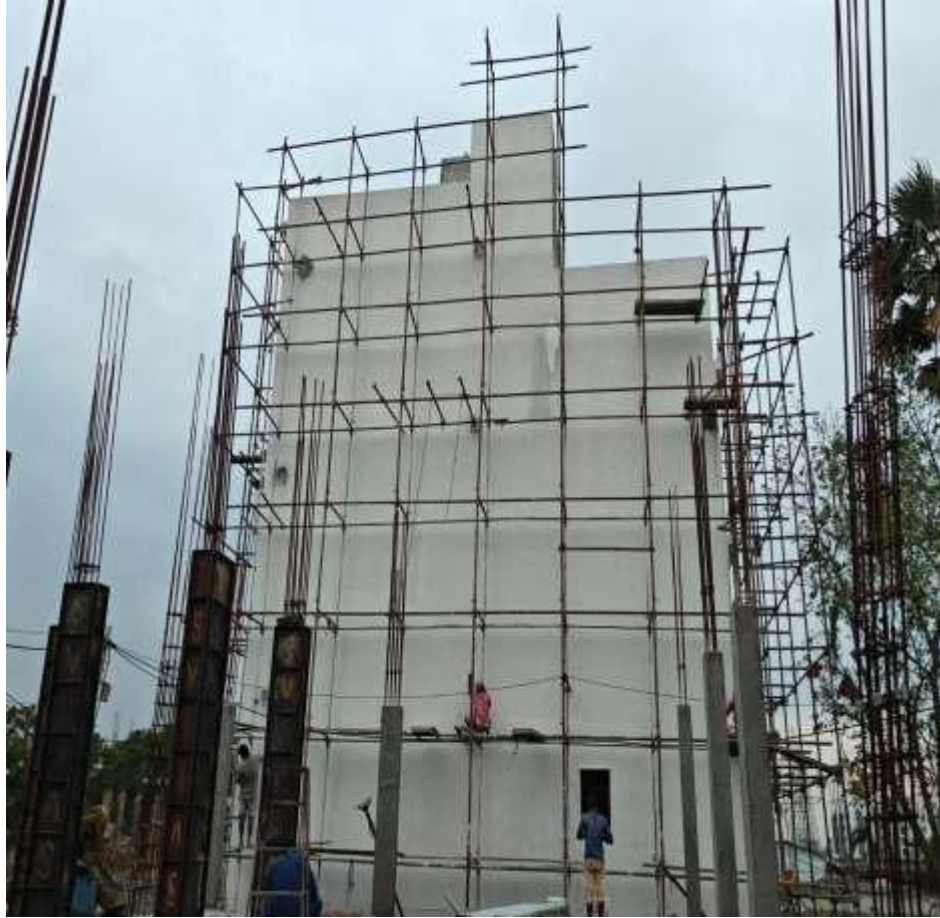
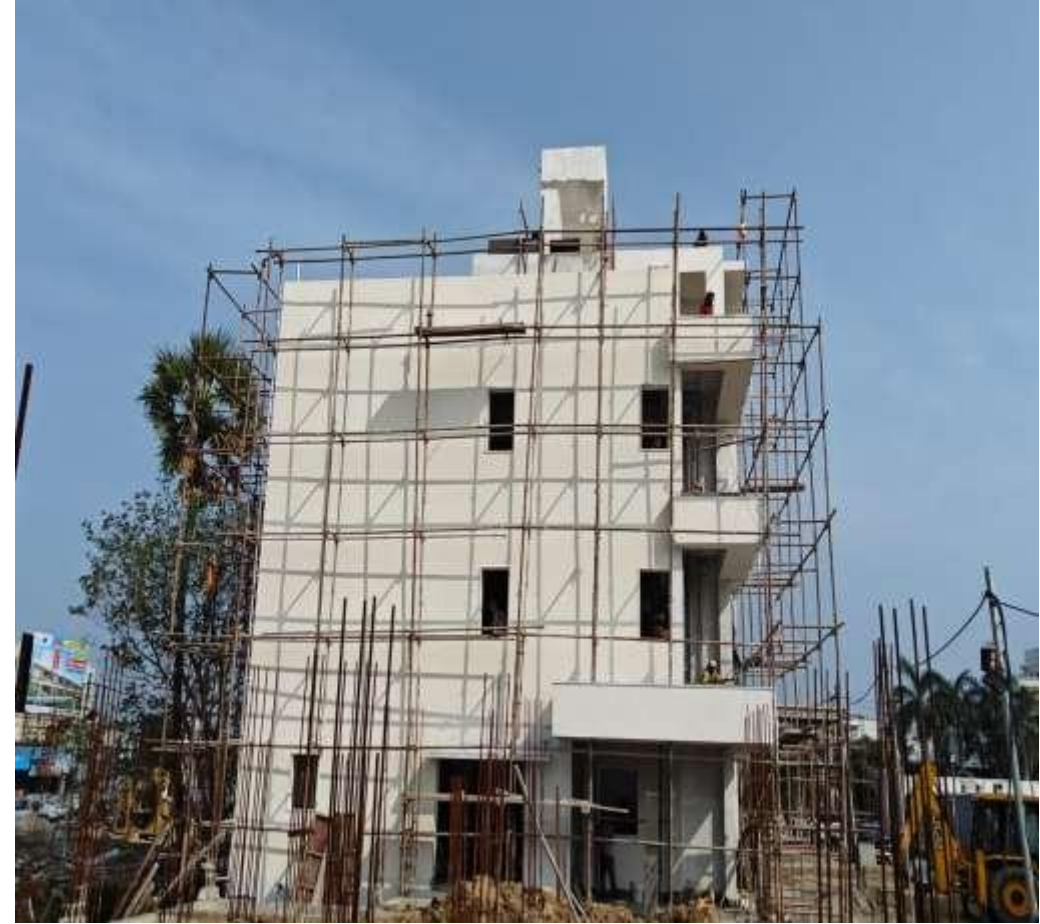
Villa no 16 - External Wall Bubble Texture and Painting work in Progress

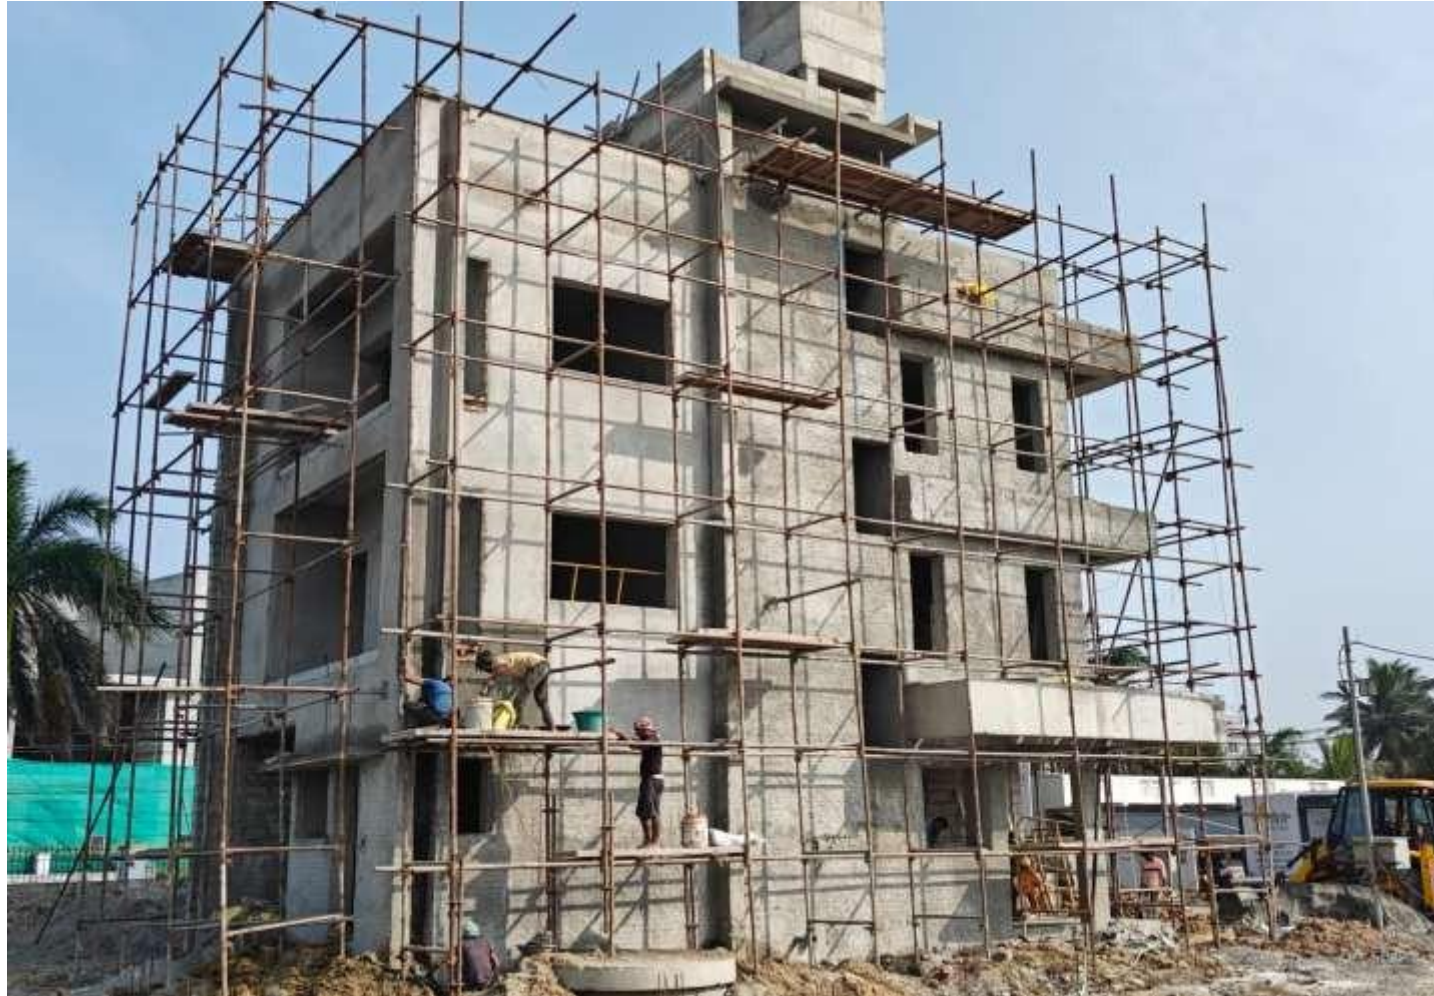
VillaNo 20– External wall plastering work in progress

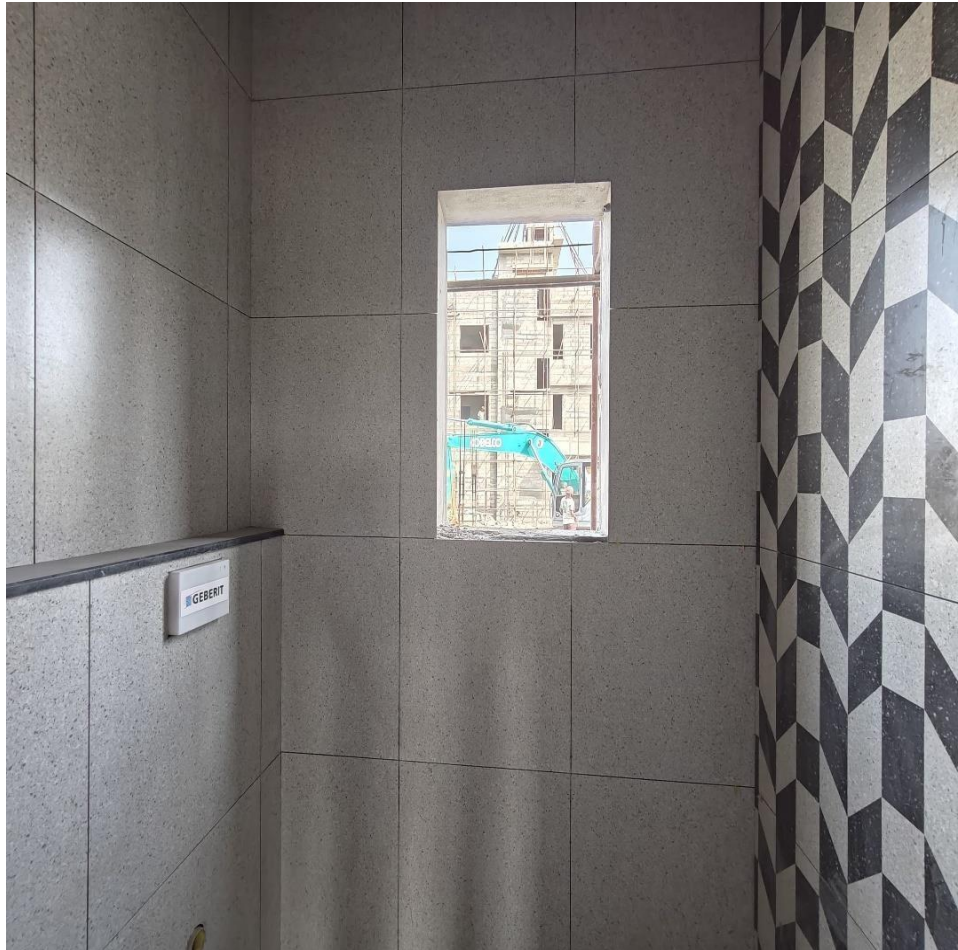
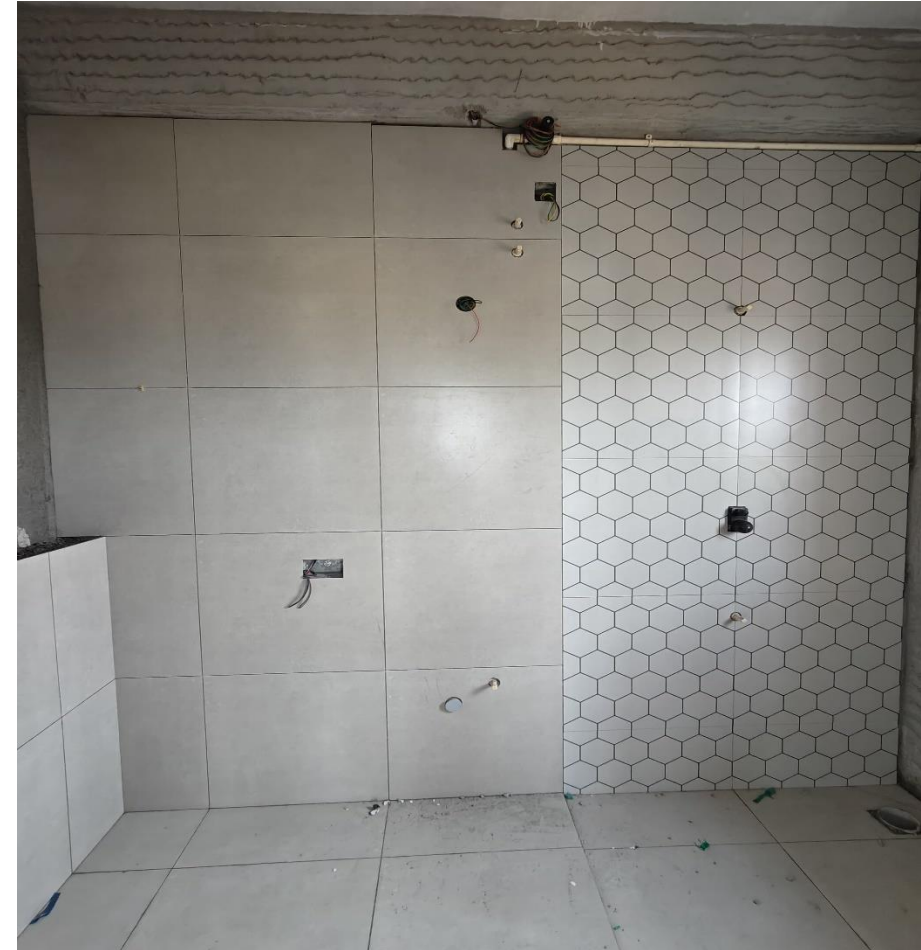
VillaNo 16– FF,SF Toilet Wall Tile laying Work in progress

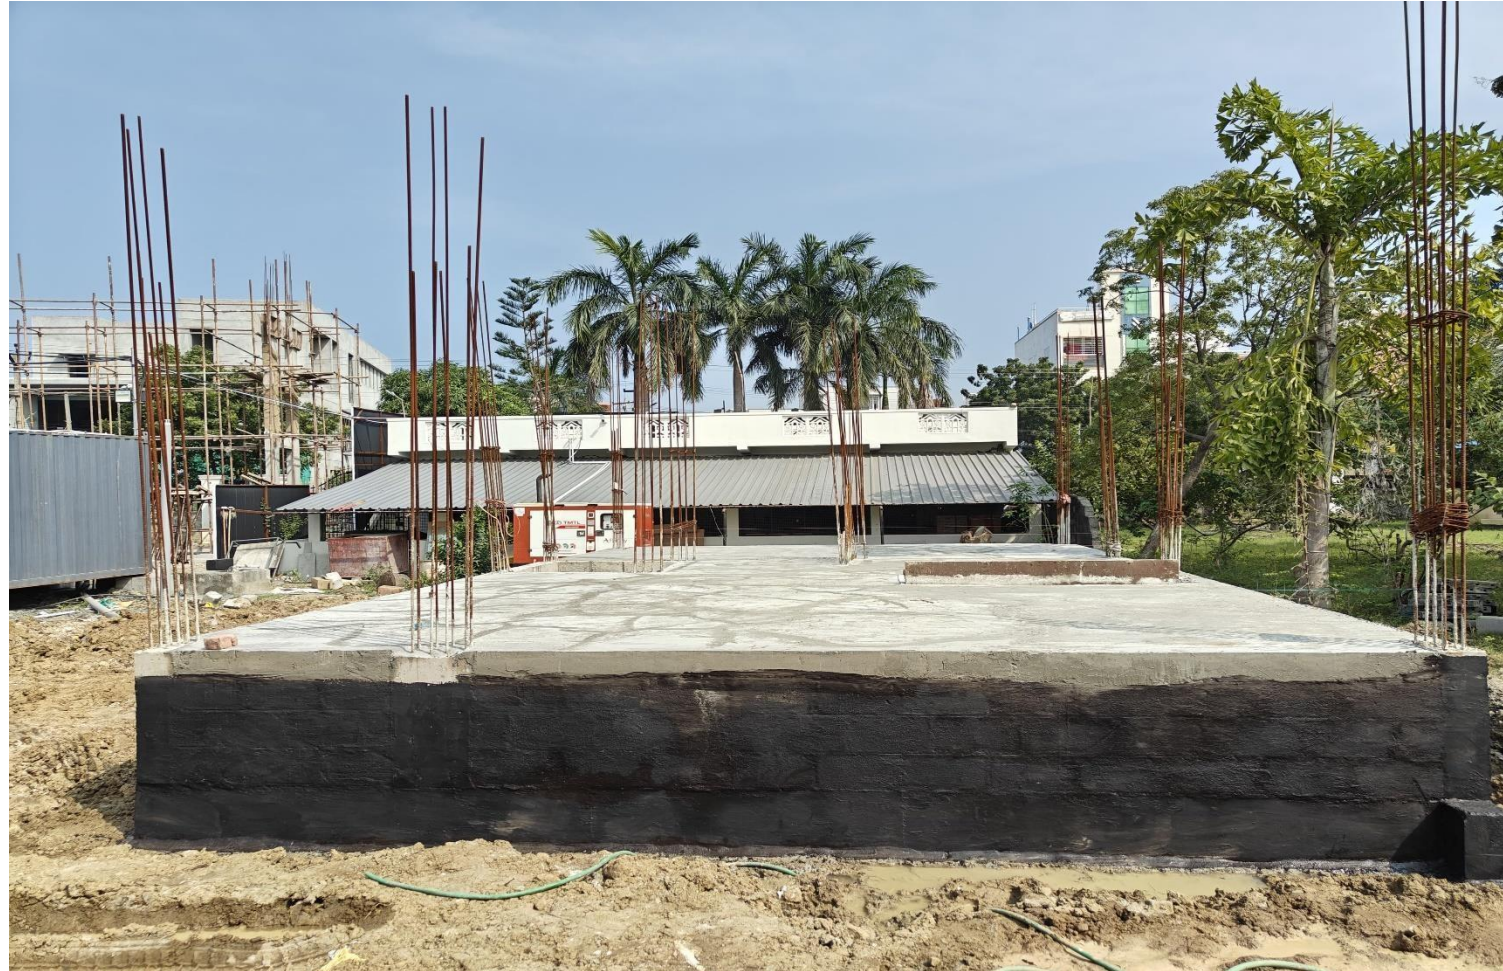
Villa no 03 – Ground Floor Flooring PCC work completed

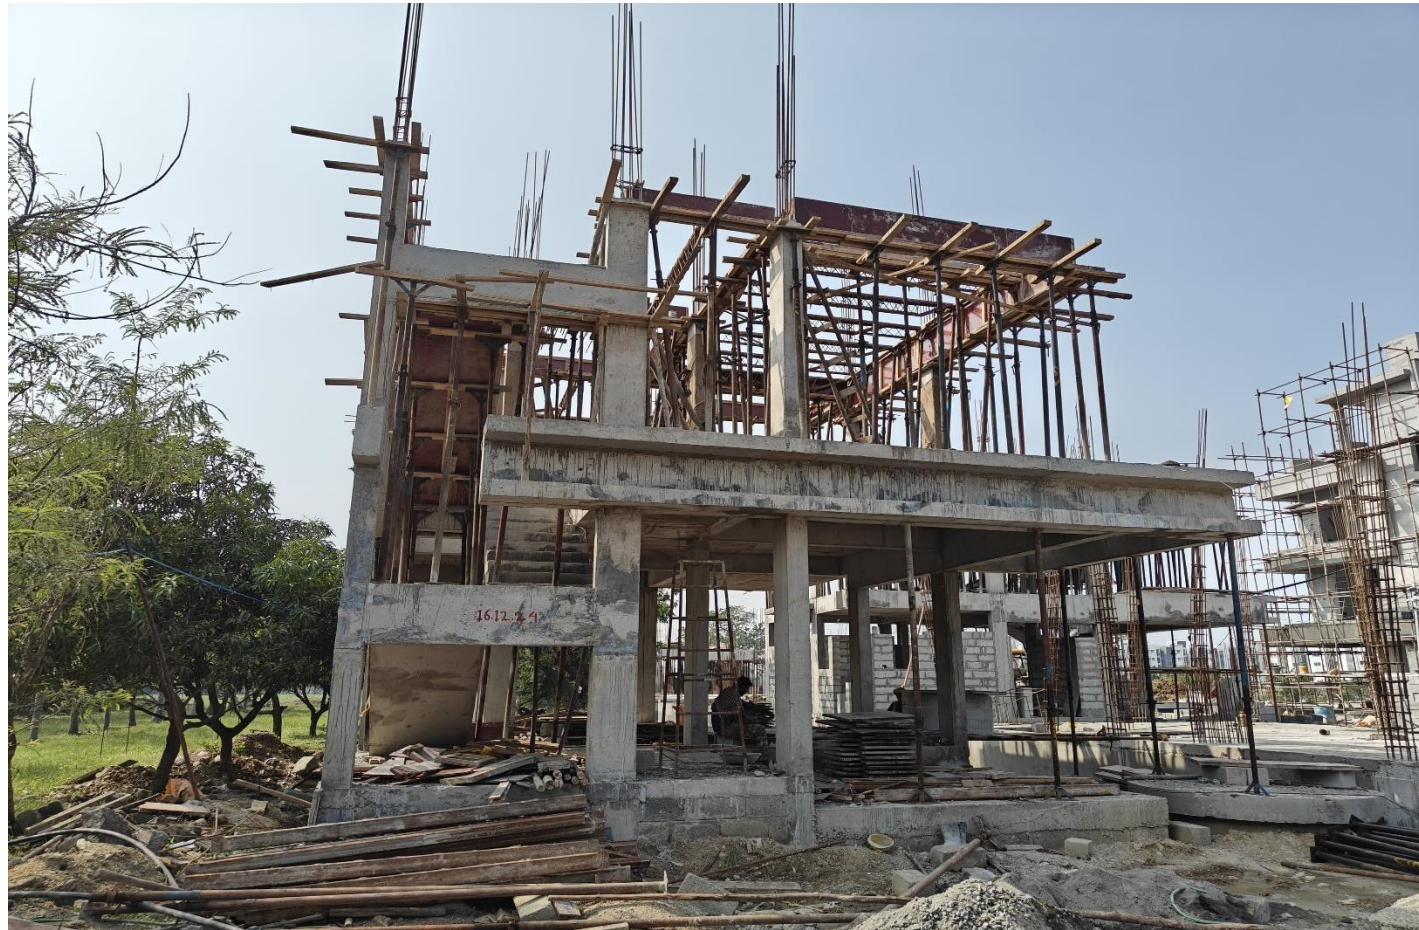
VillaNo 4 – First Floor Roof Slabshuttering work in Progress

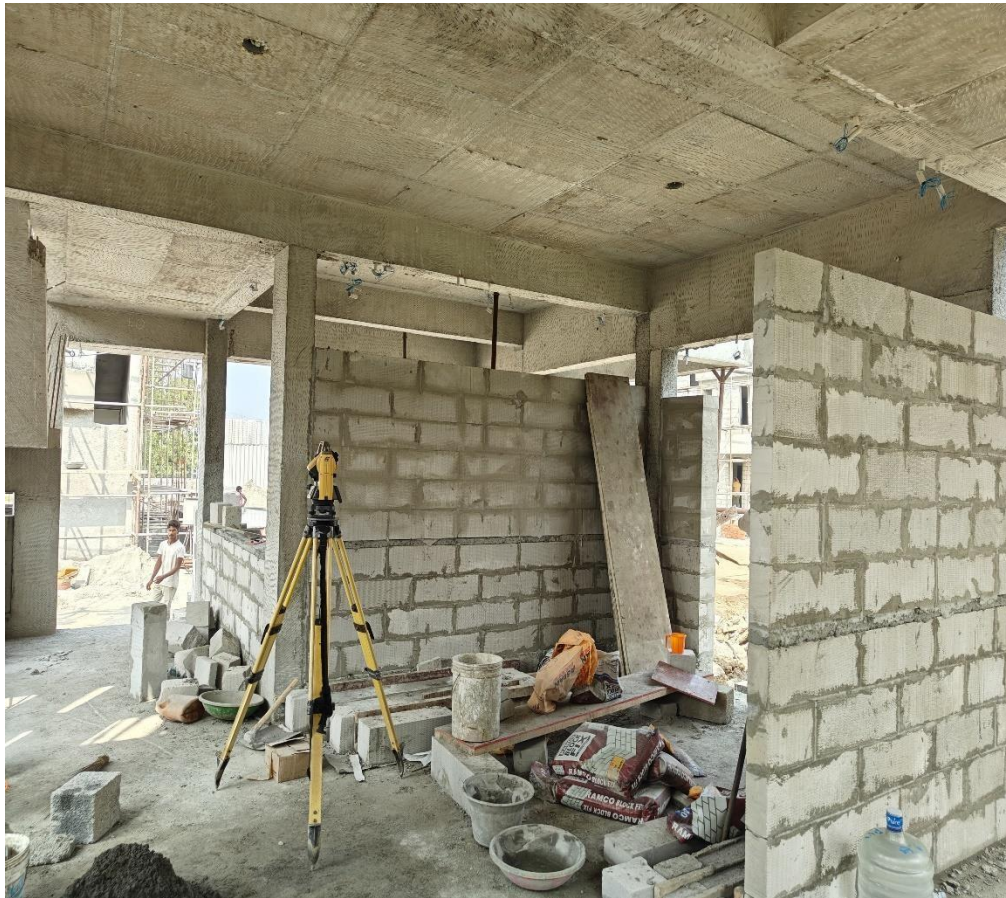
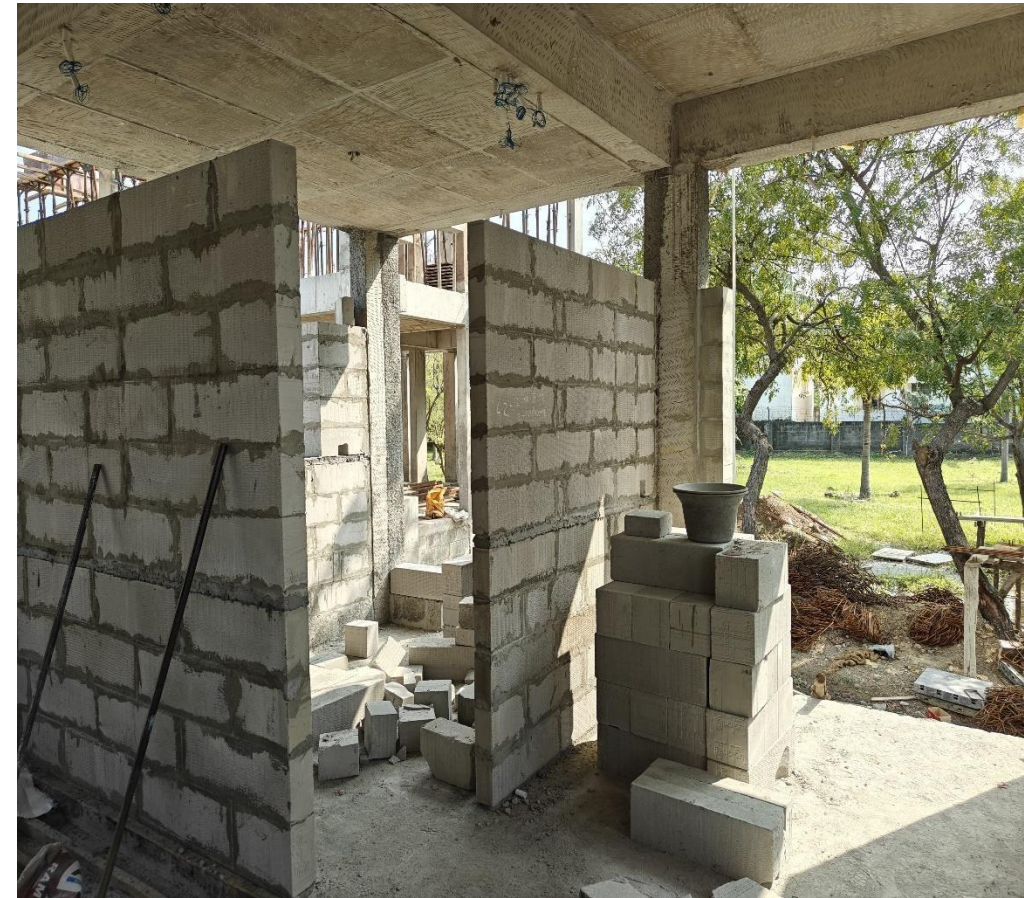
VillaNo 06 – Ground Floor Blockwork in progress

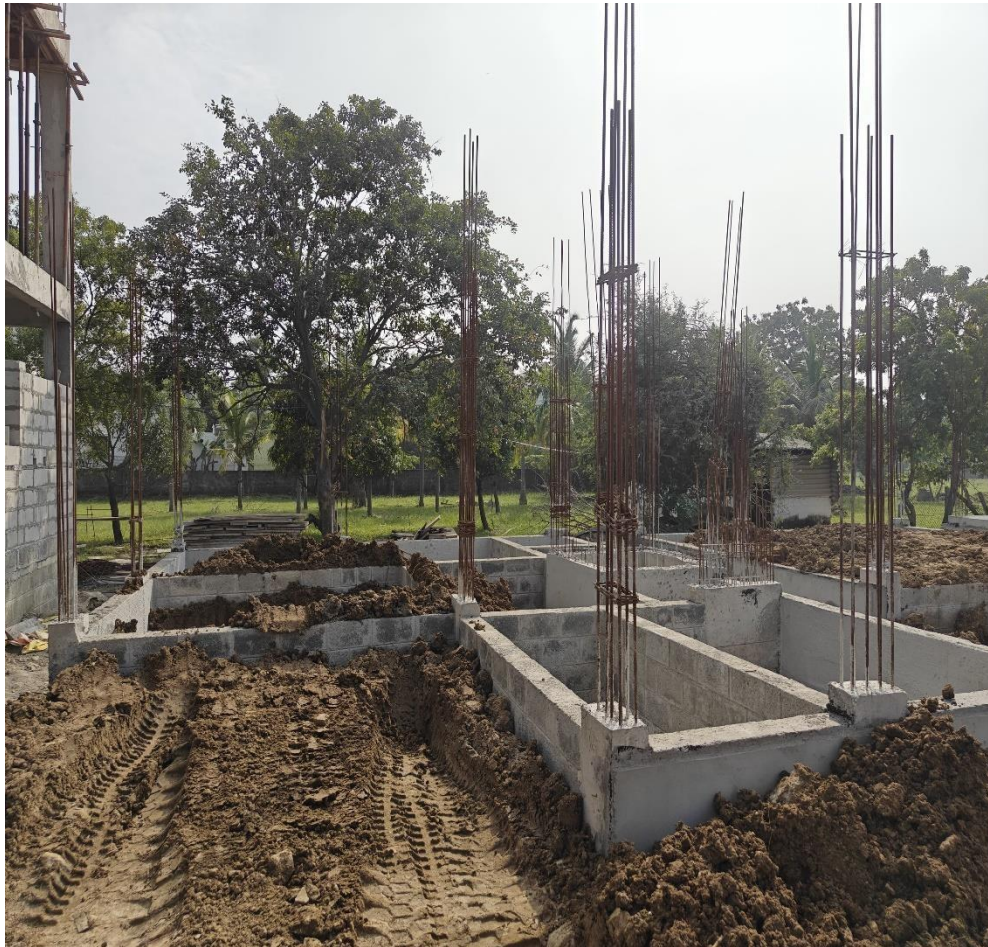
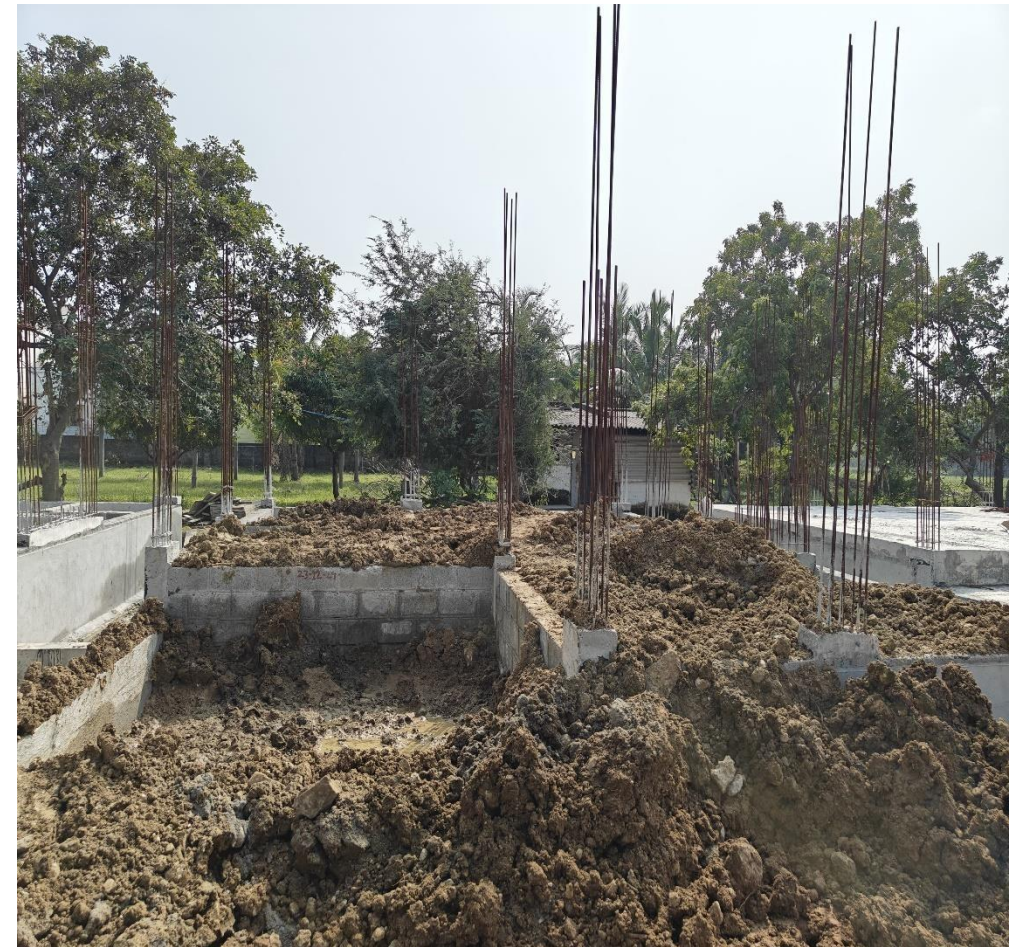
Villa no 07 , 08 – Basement Soil Backfilling work in progress

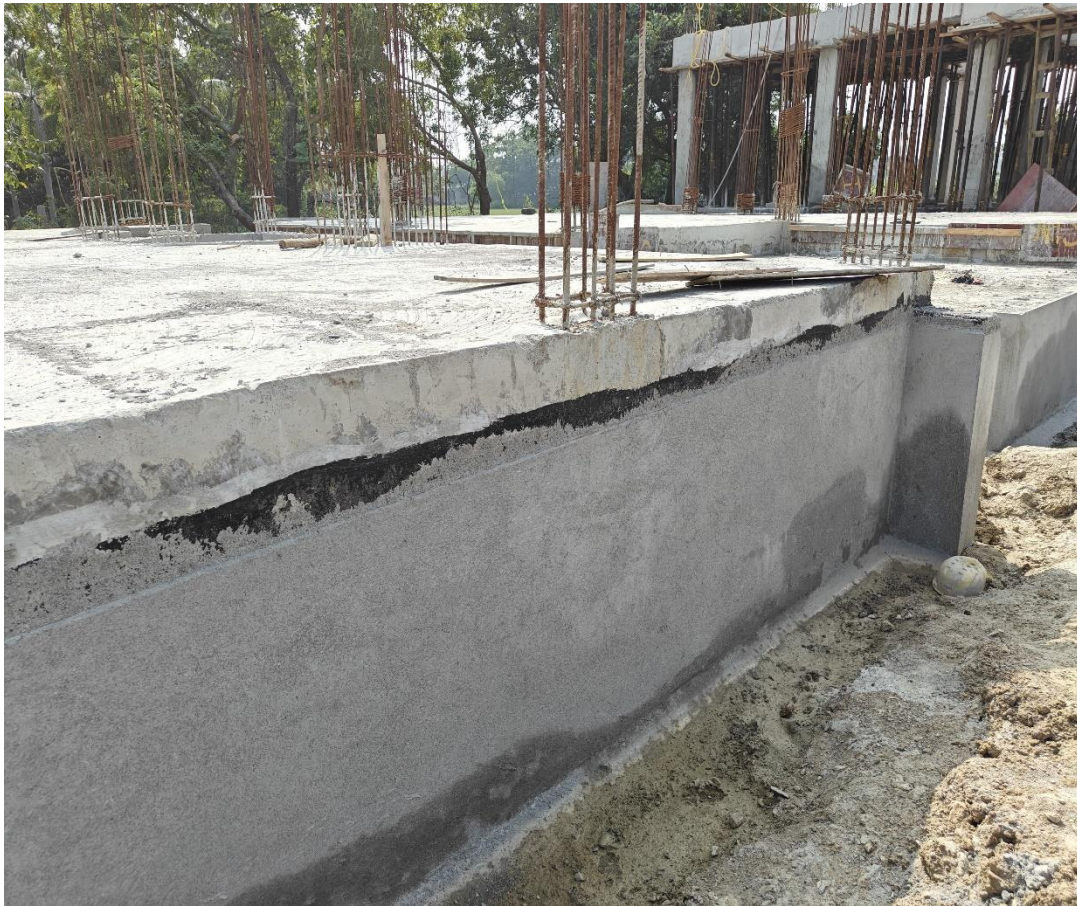
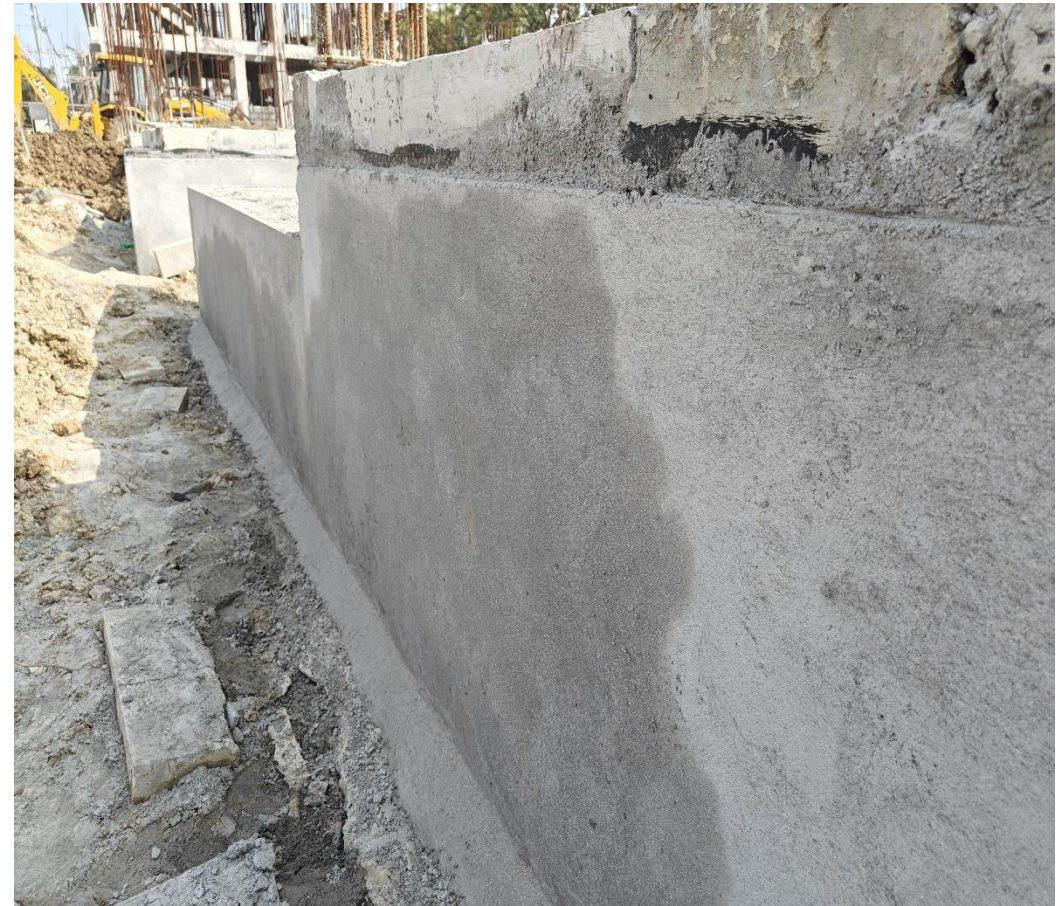
VillaNo 09 , 10 – Basement DPC Protection Plastering work completed

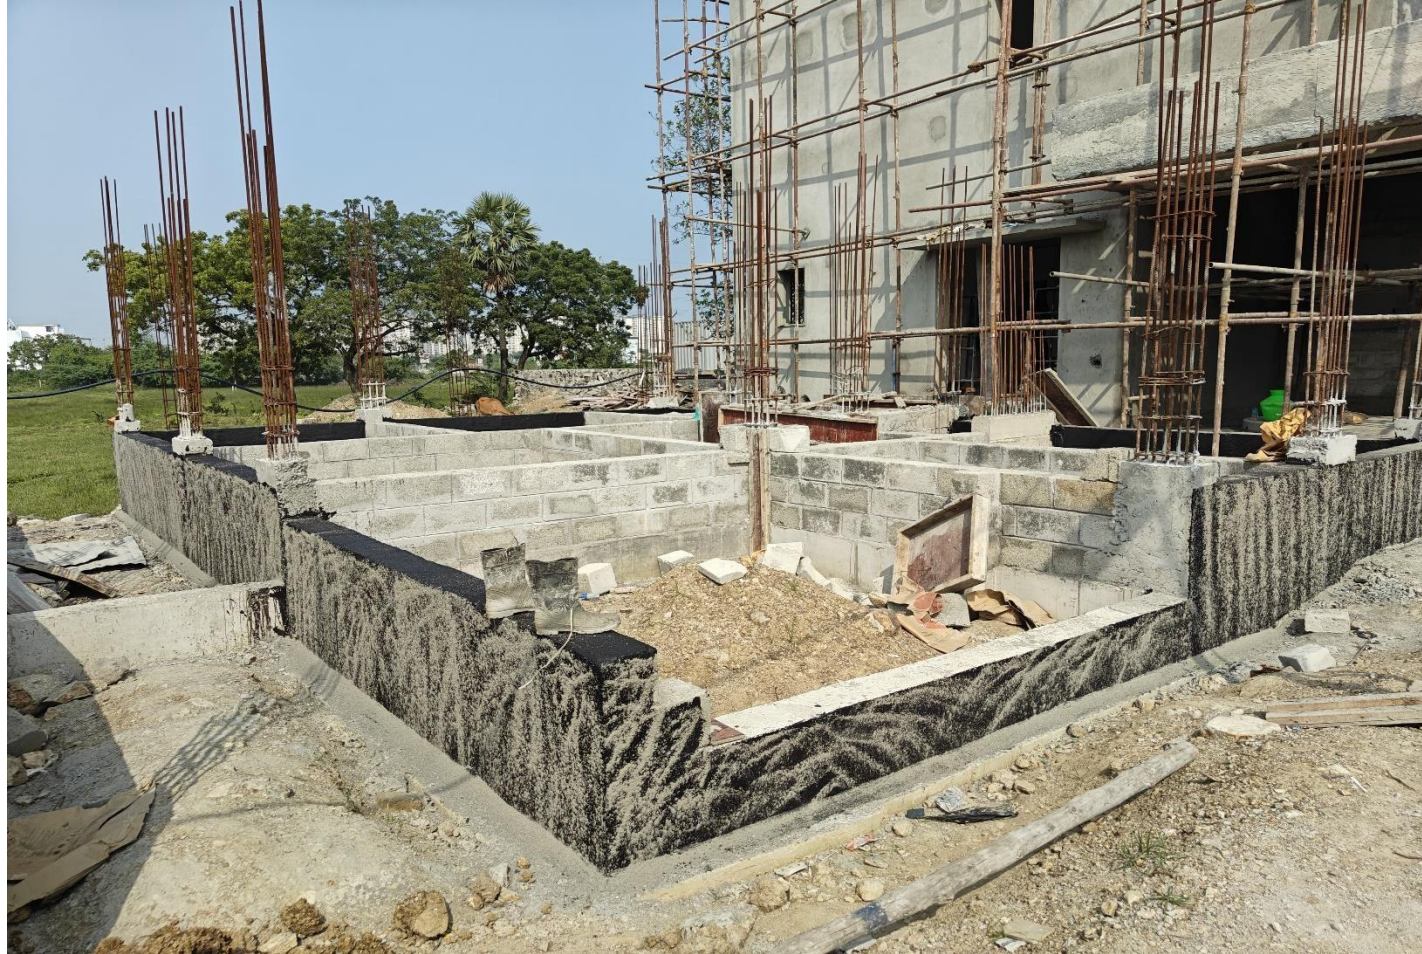
Villa no 14 – Basement DPC coating work in progress

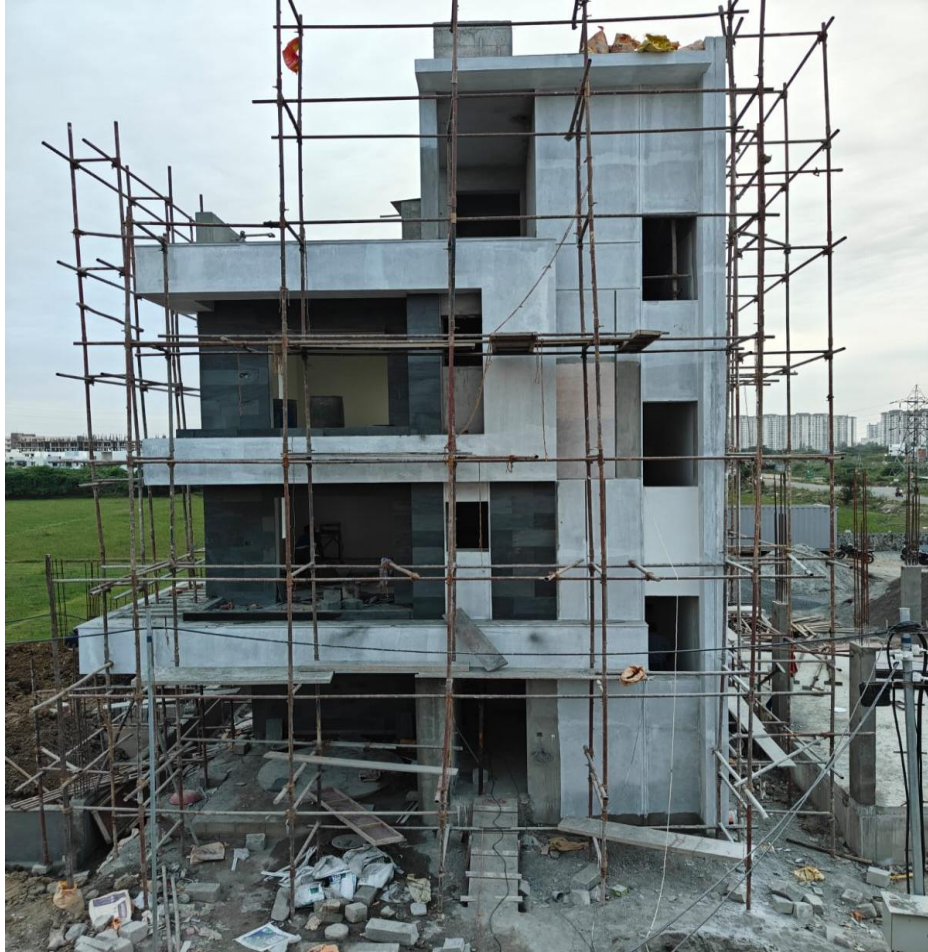
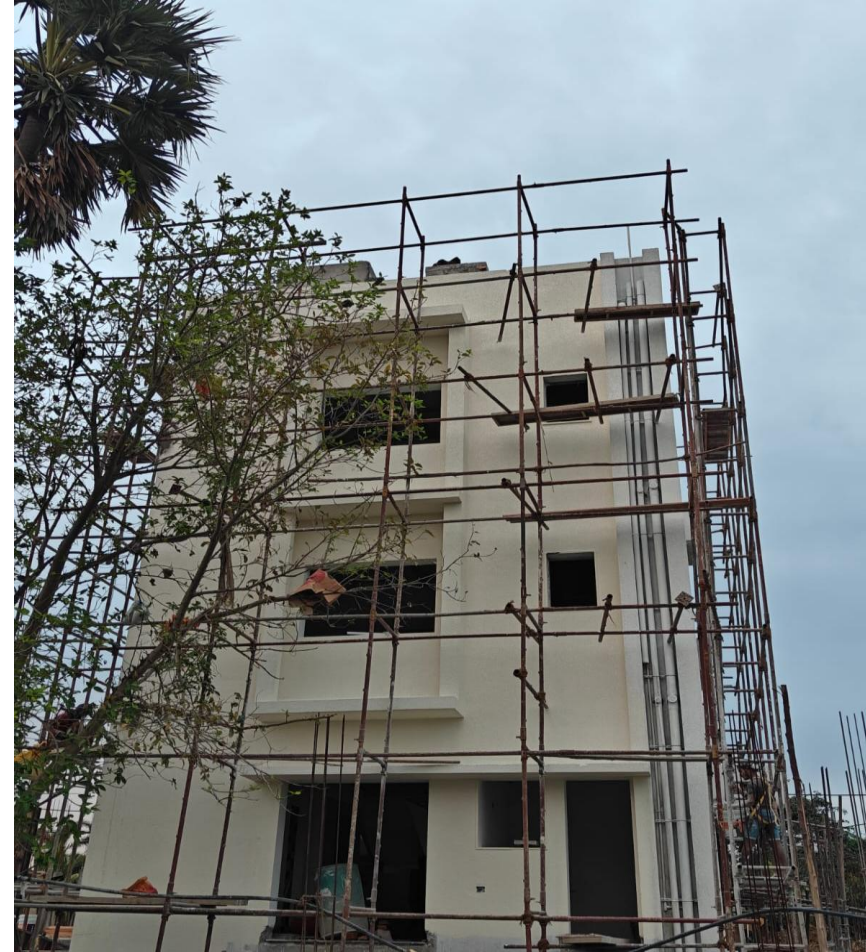
Villa no 16 – External Wall Bubble Texture and Painting work in Progress

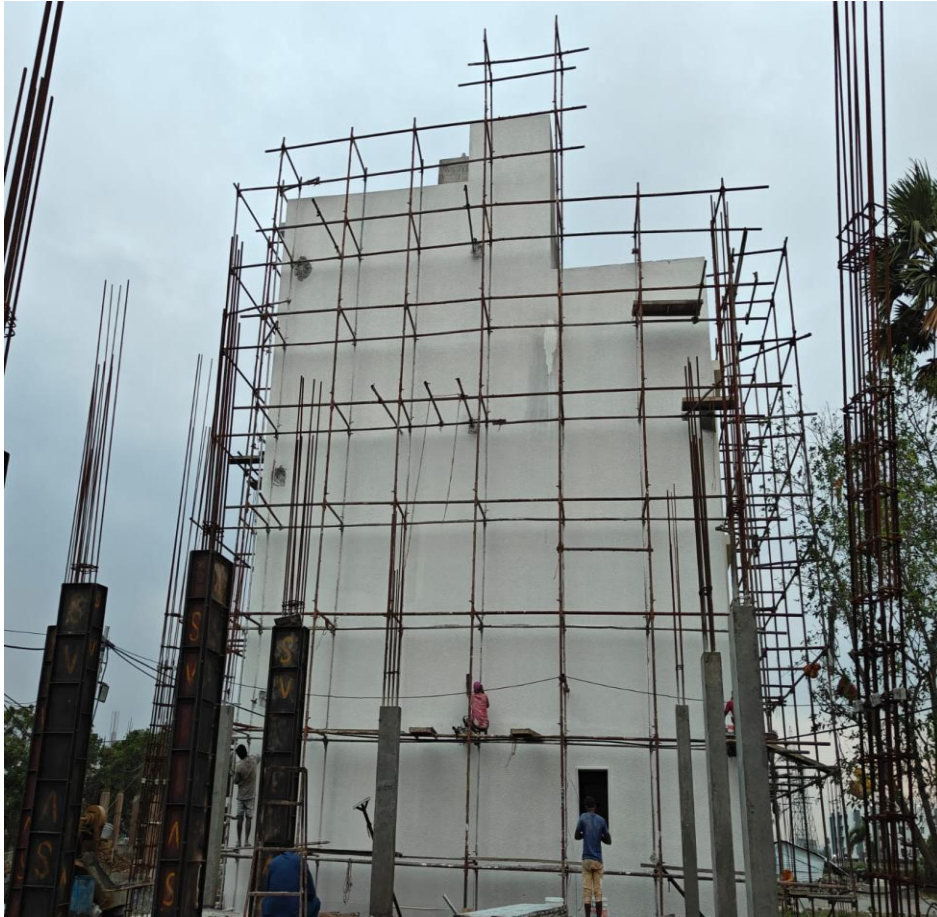
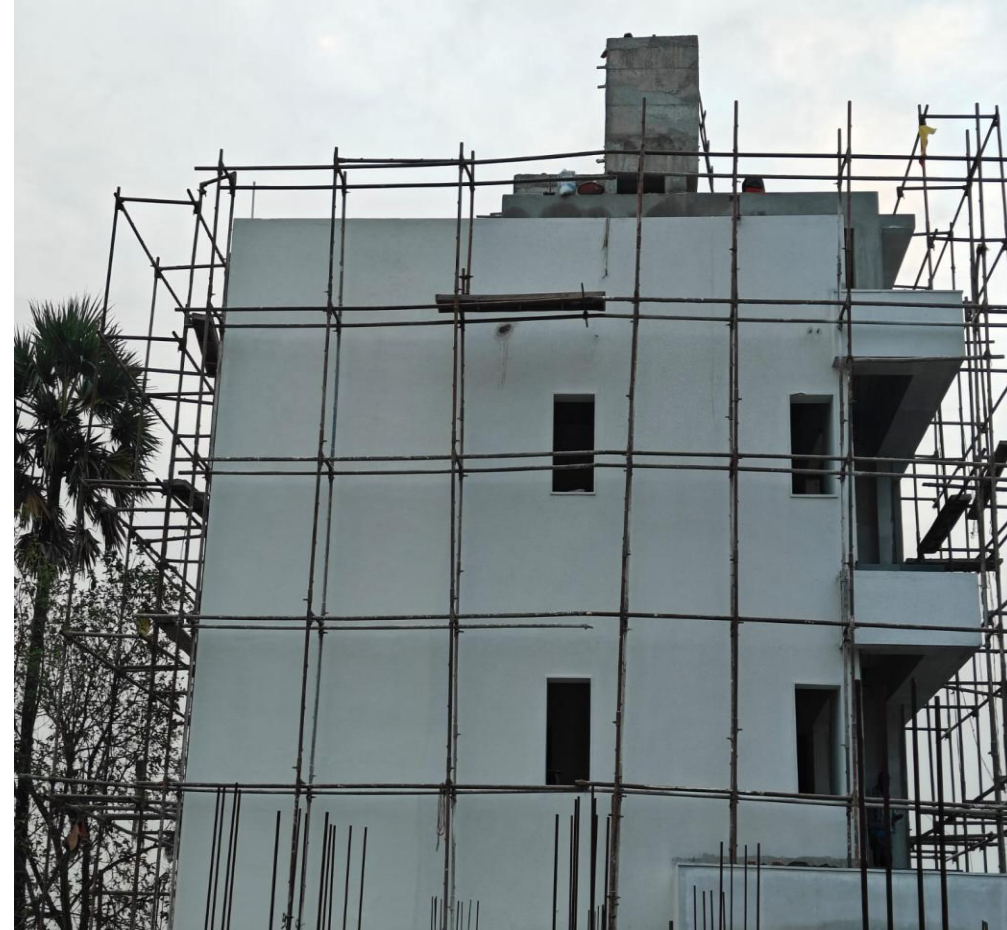
Villa no 16 - External Wall Bubble Texture and Painting work in Progress

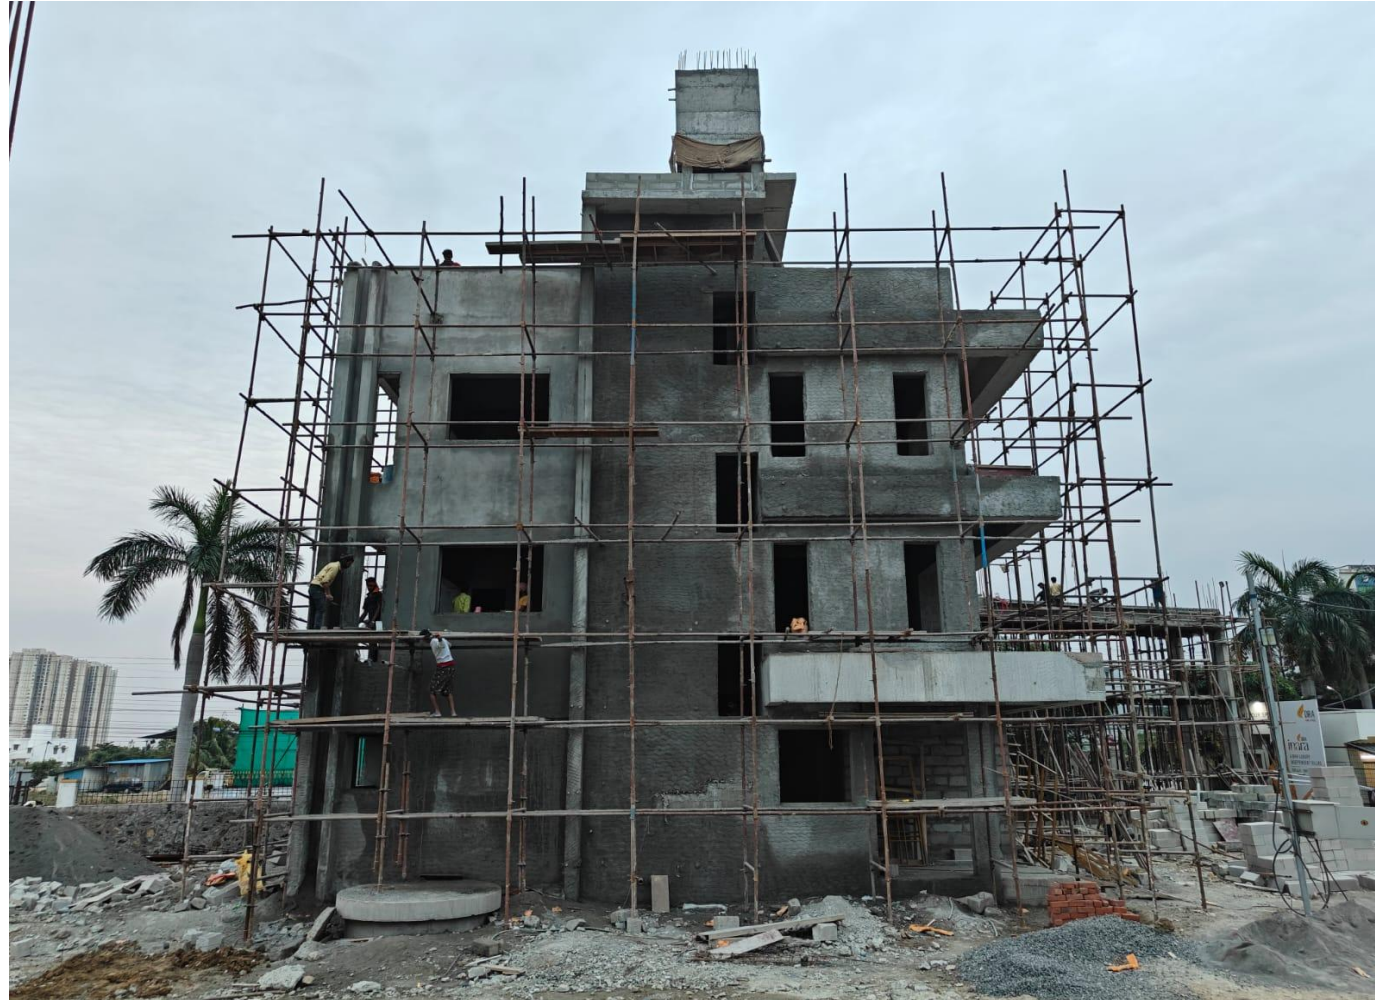
Villa No 20 – External wall plastering work in progress

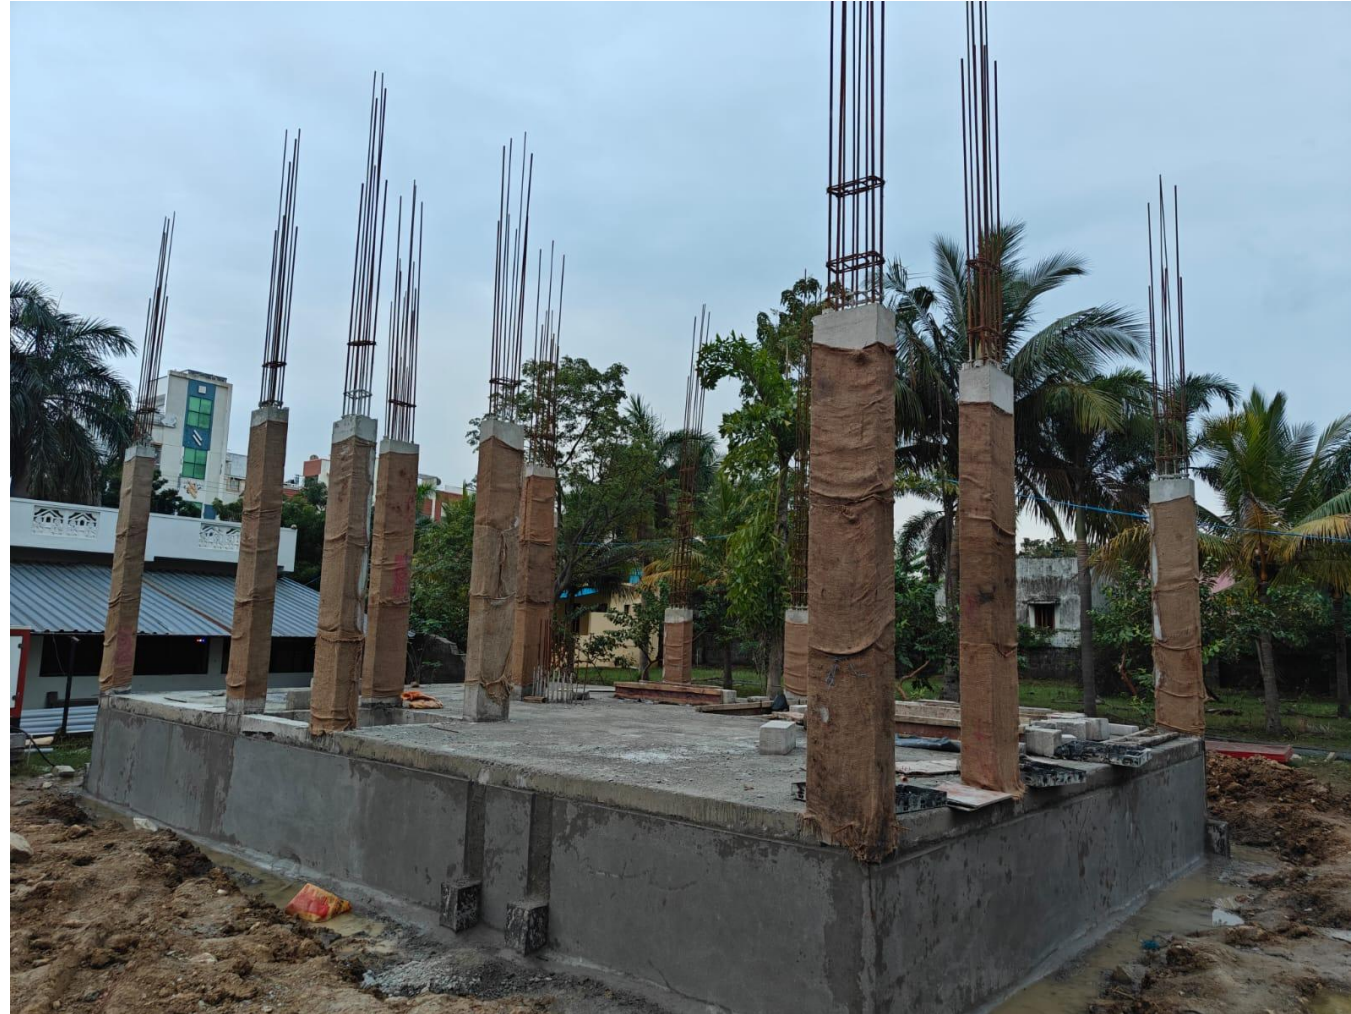
Villa no 03 – Ground Floor Column Concrete work completed
