DRA INARA
Monthly Construction Updates – January 2025

Over all percentage of Completion

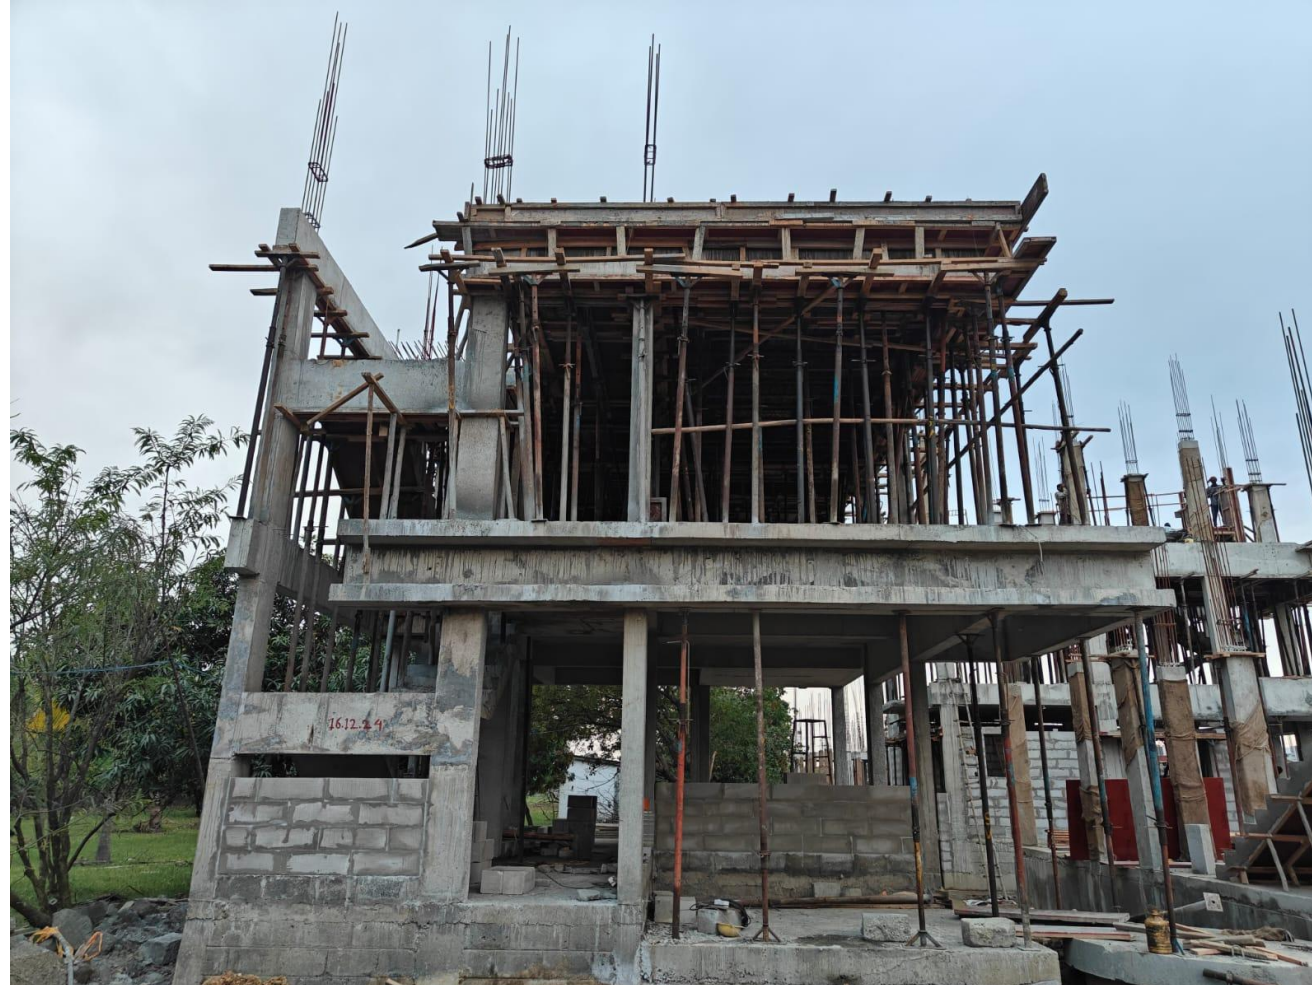
Villa No 4 – First Floor Roof Slab Concrete Completed

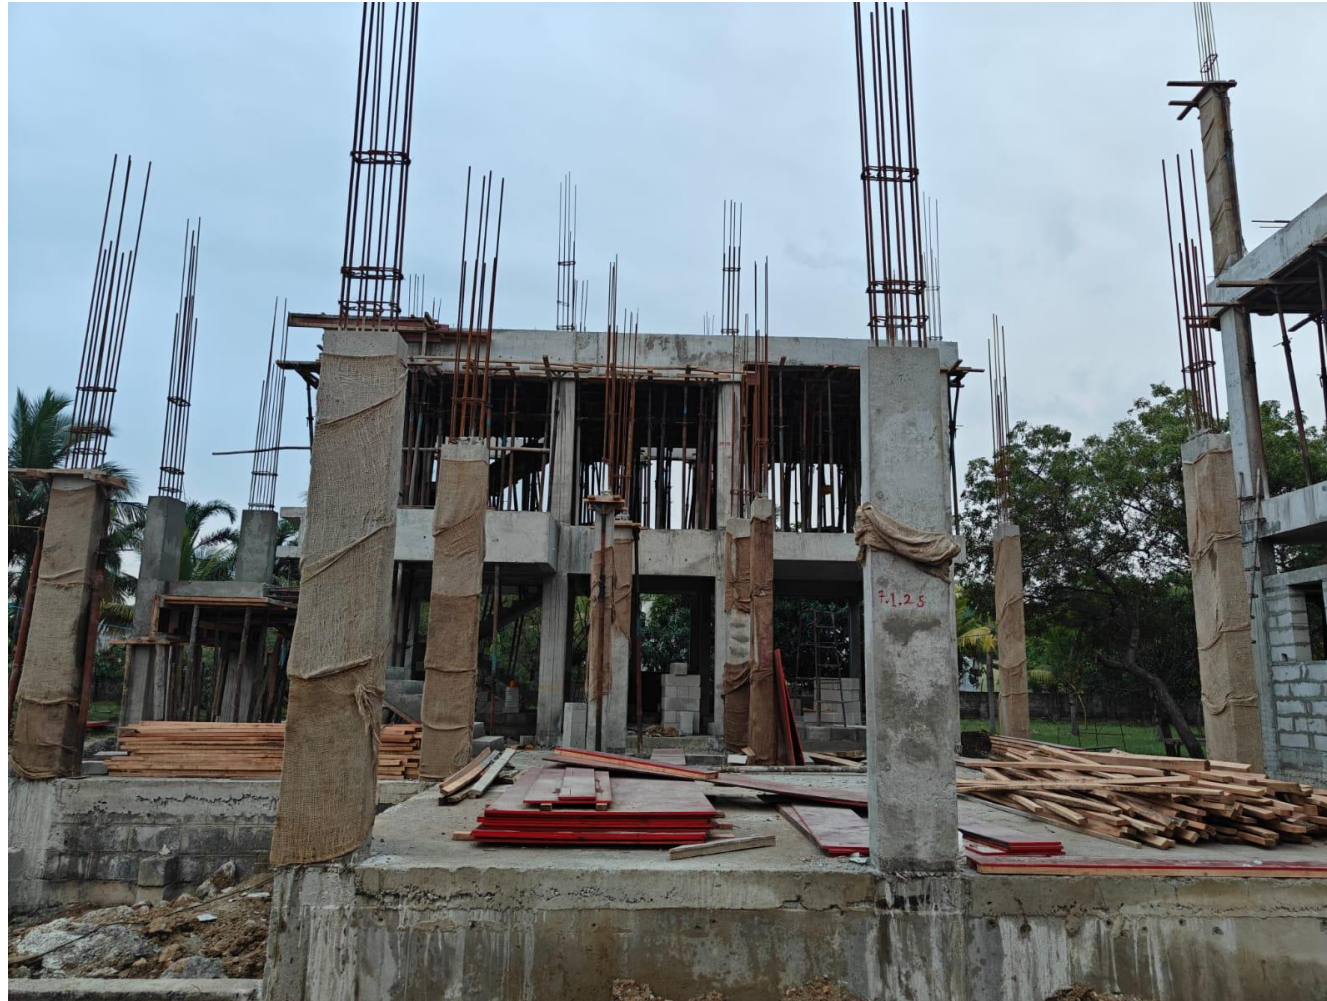
Villa No 5 – Ground Floor Column Concrete work Completed

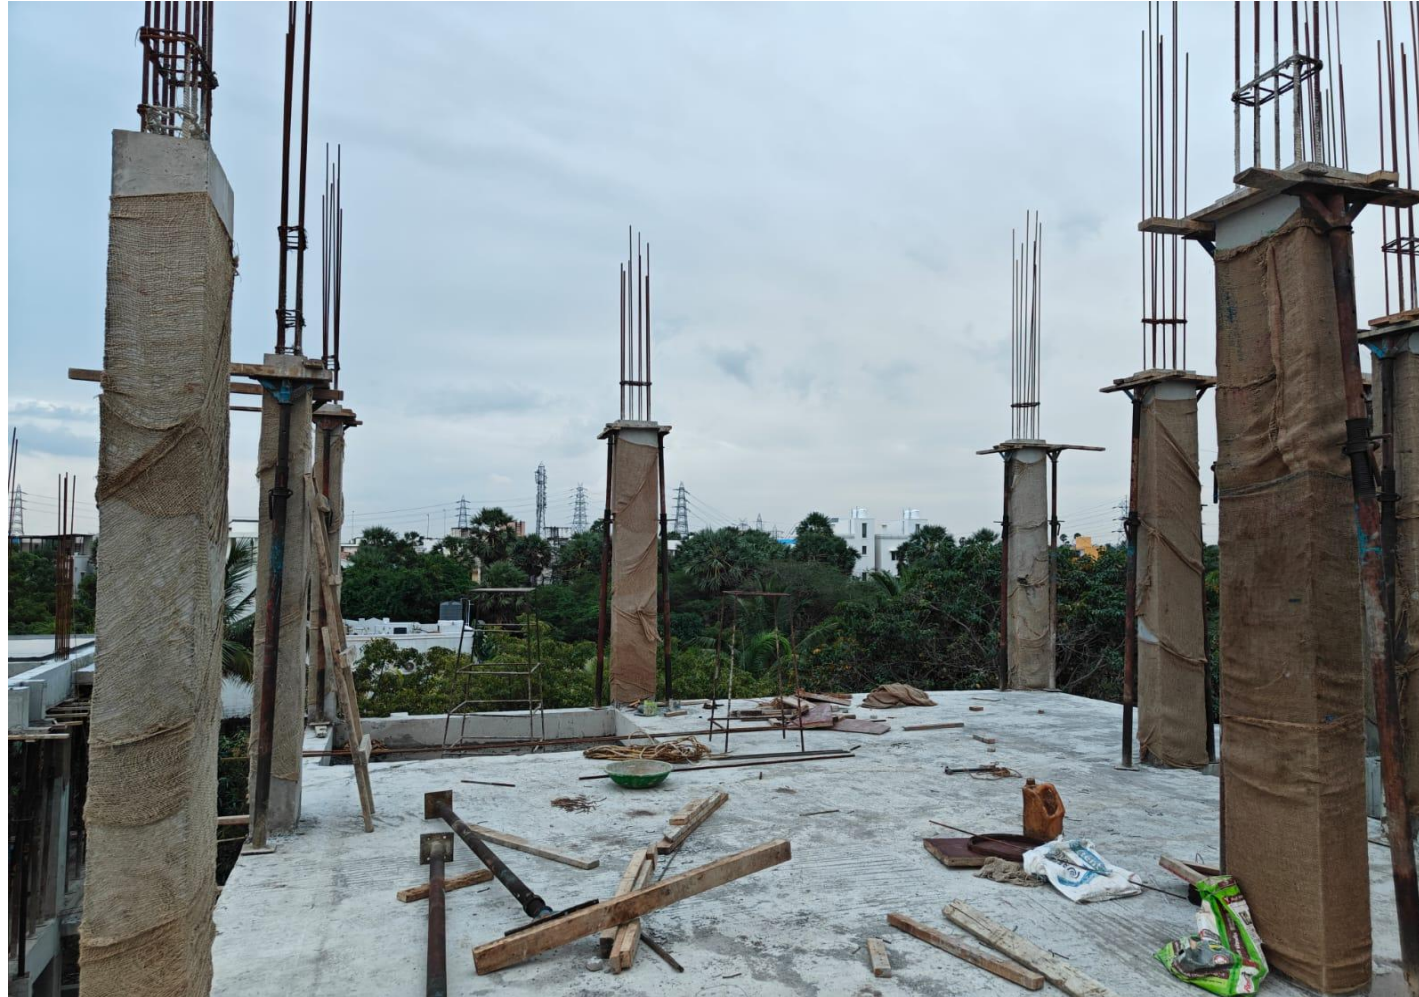
Villa no 06 – Second Floor column concrete work completed

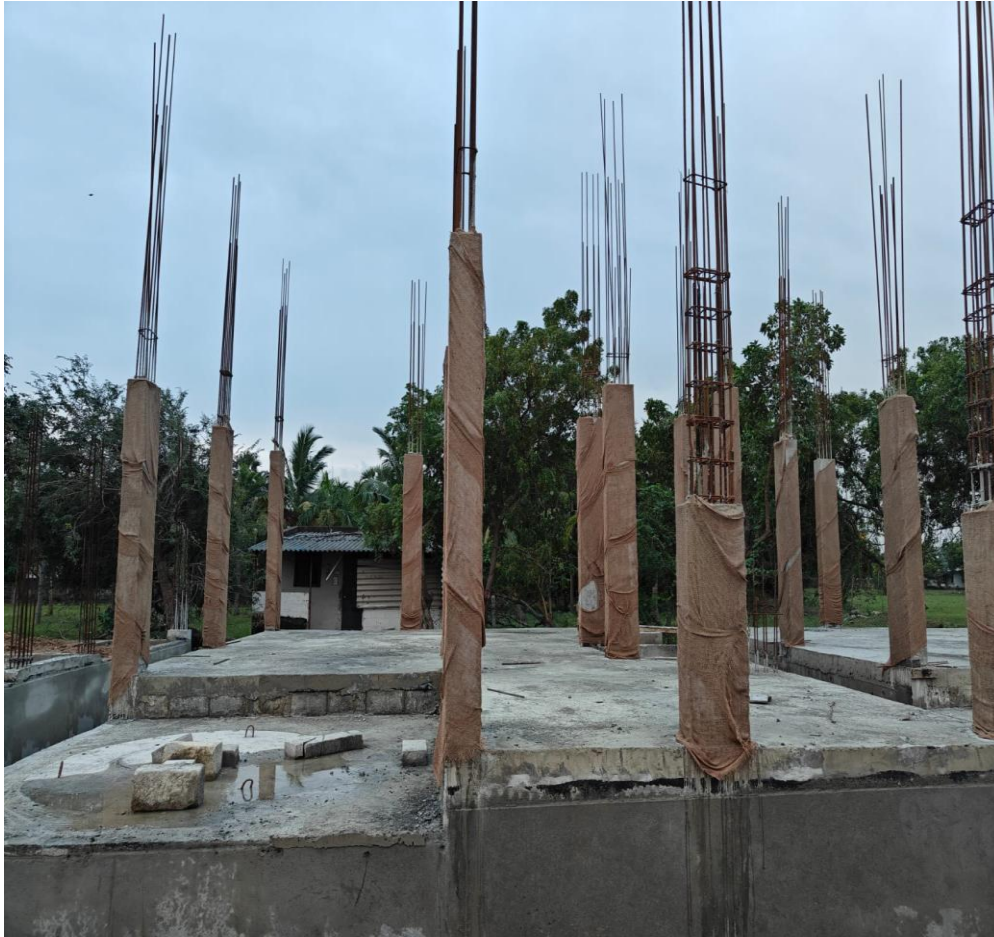
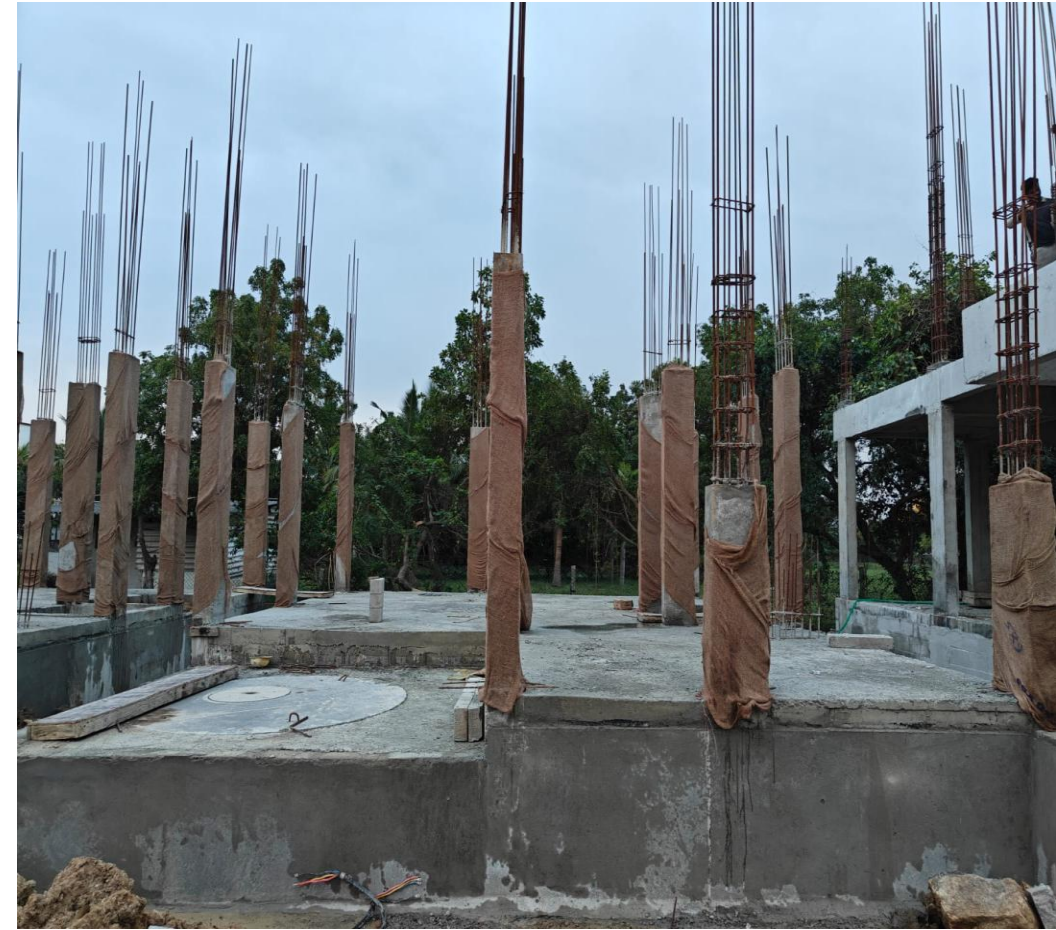
Villa No 09 , 10 – GF Column Concrete Work completed

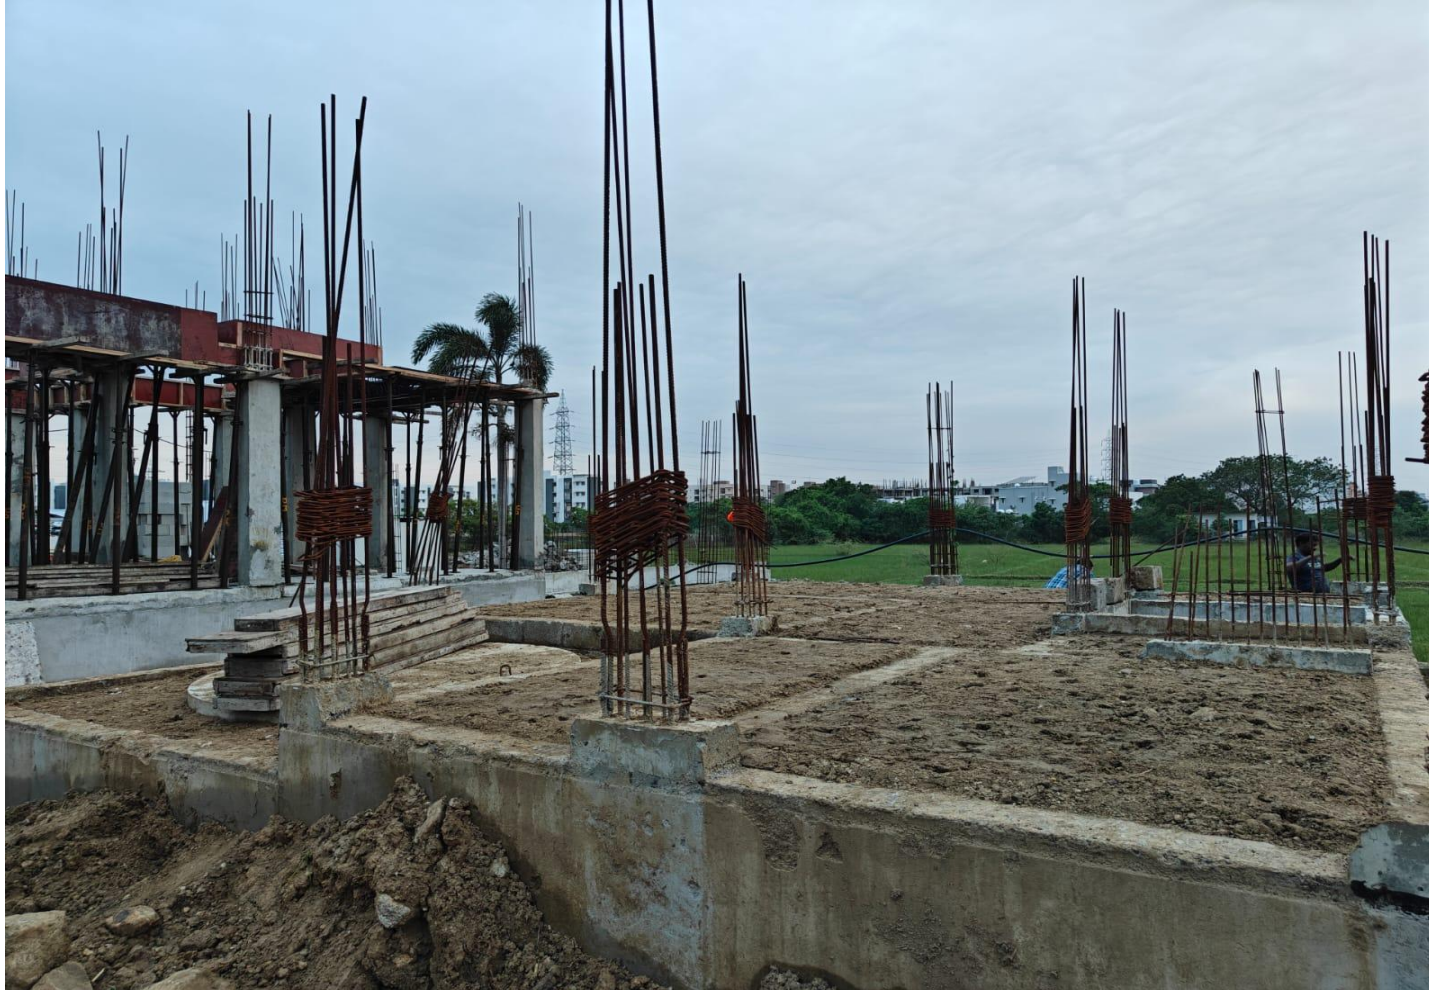
Villa No 13 – Ground Floor PCC laying Preparation work in progress

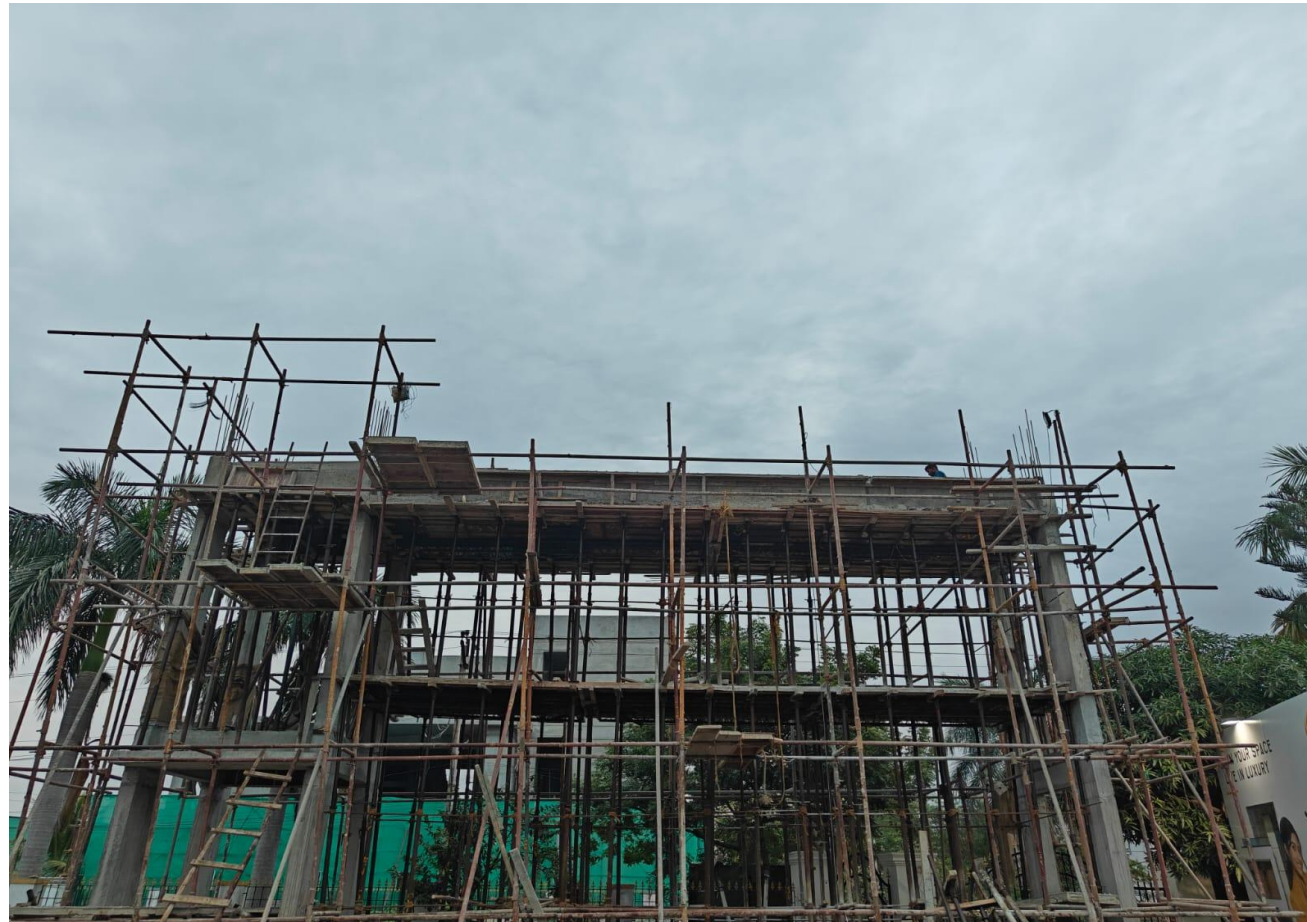
Entrance Arch Slab Concrete Completed

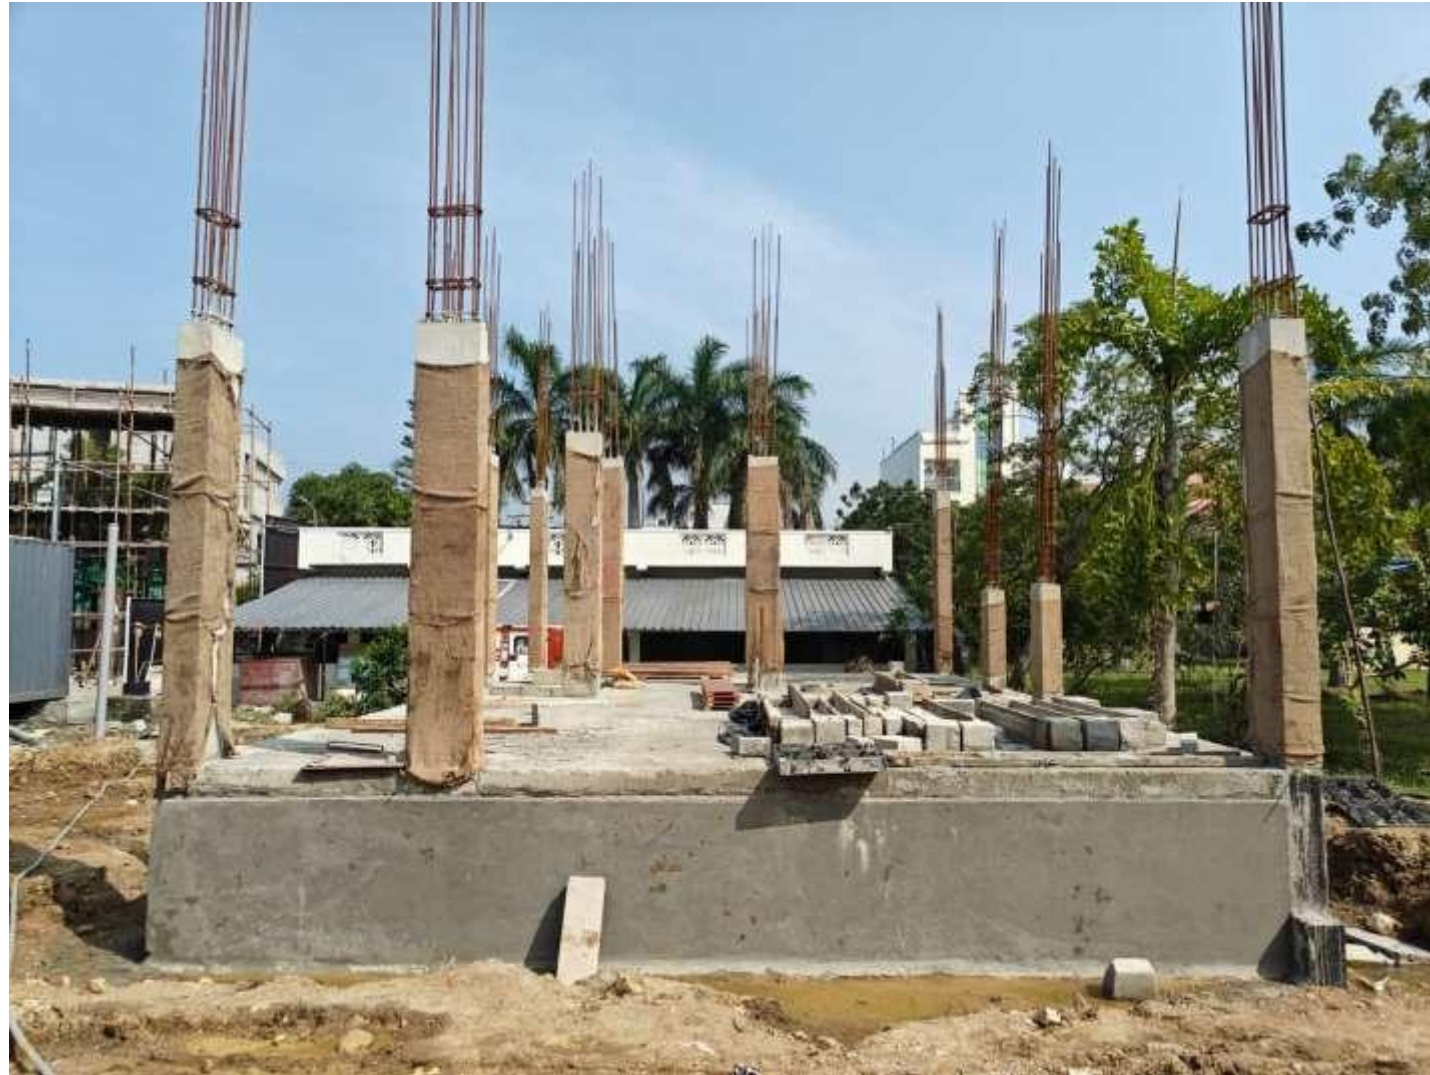
Villa no 03 – Ground Floor Column Concrete work completed

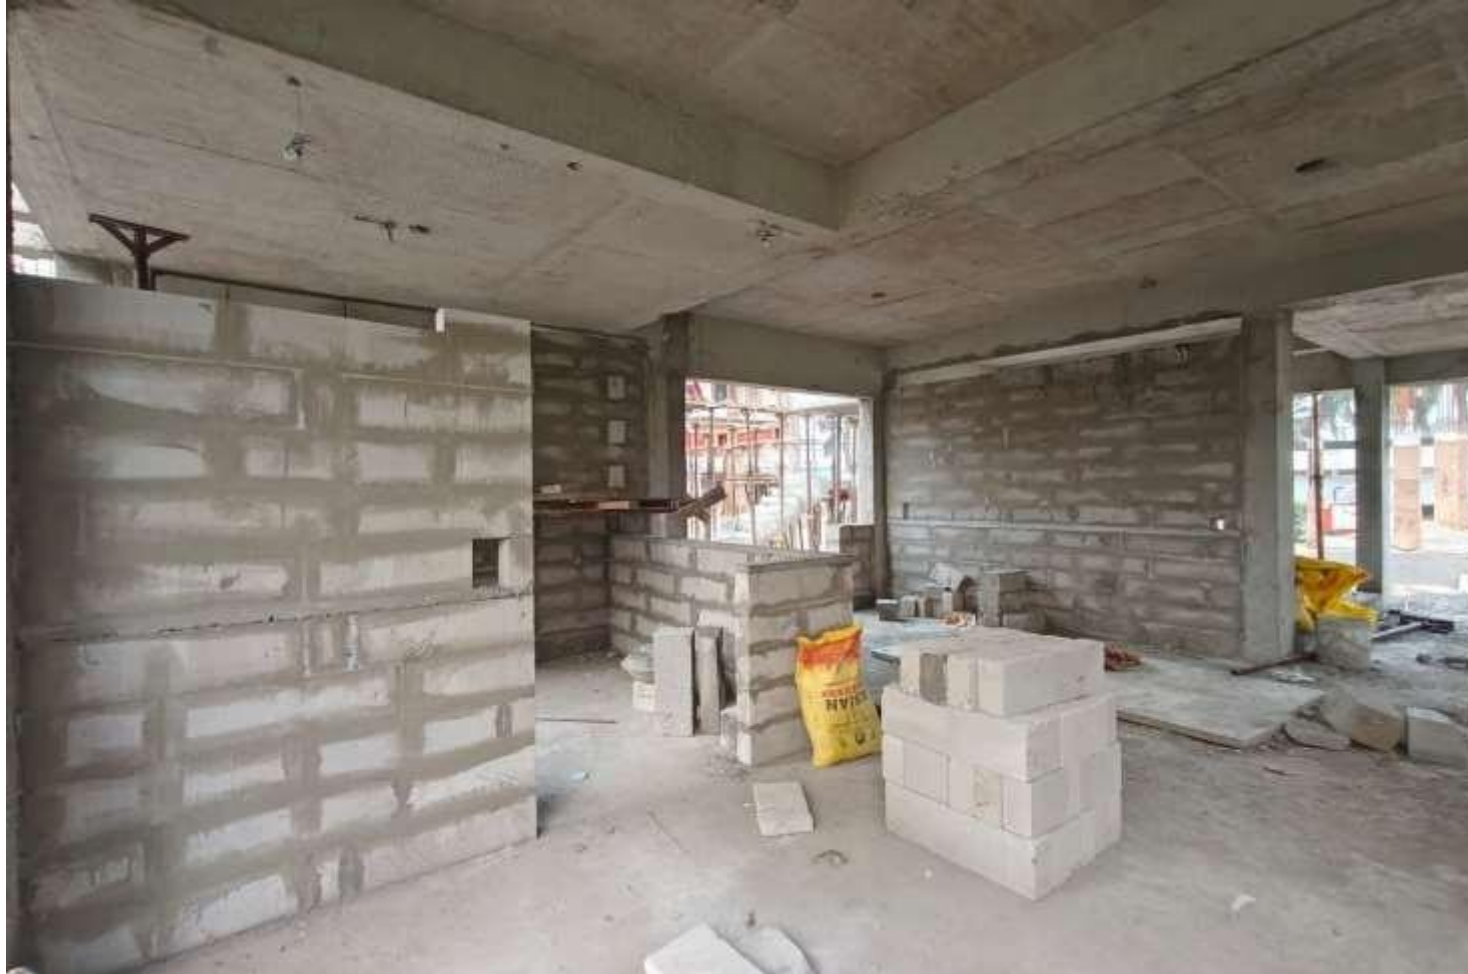
VillaNo 4 – Ground Floor Blockwork in progress

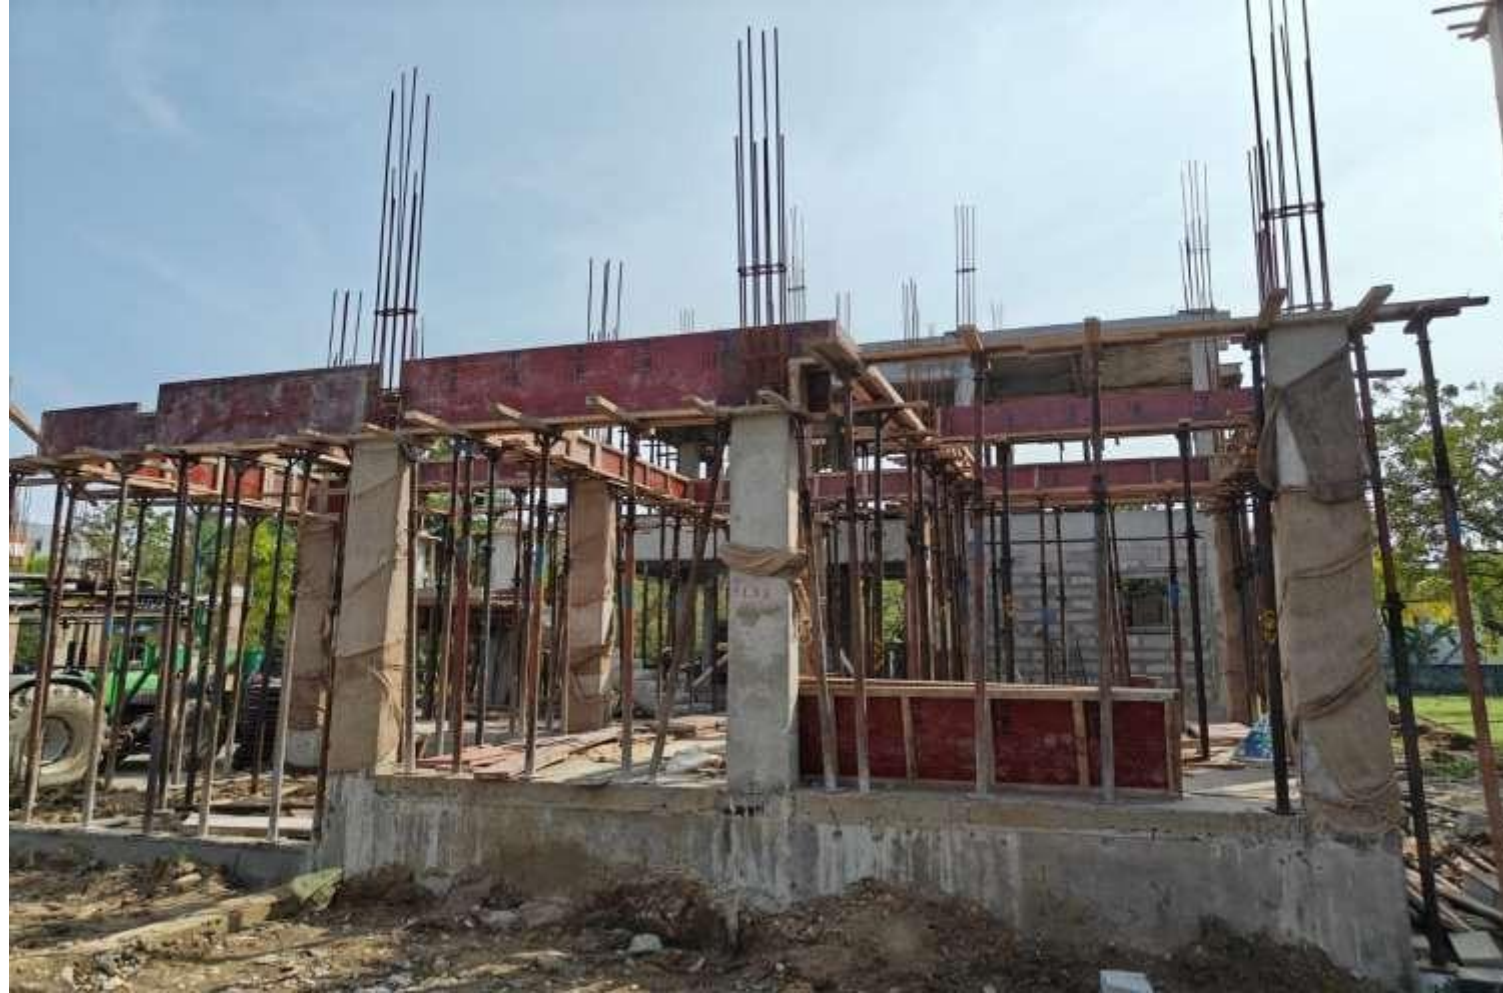
VillaNo 5 – Ground Floor Roof Slab Shuttering work in progress

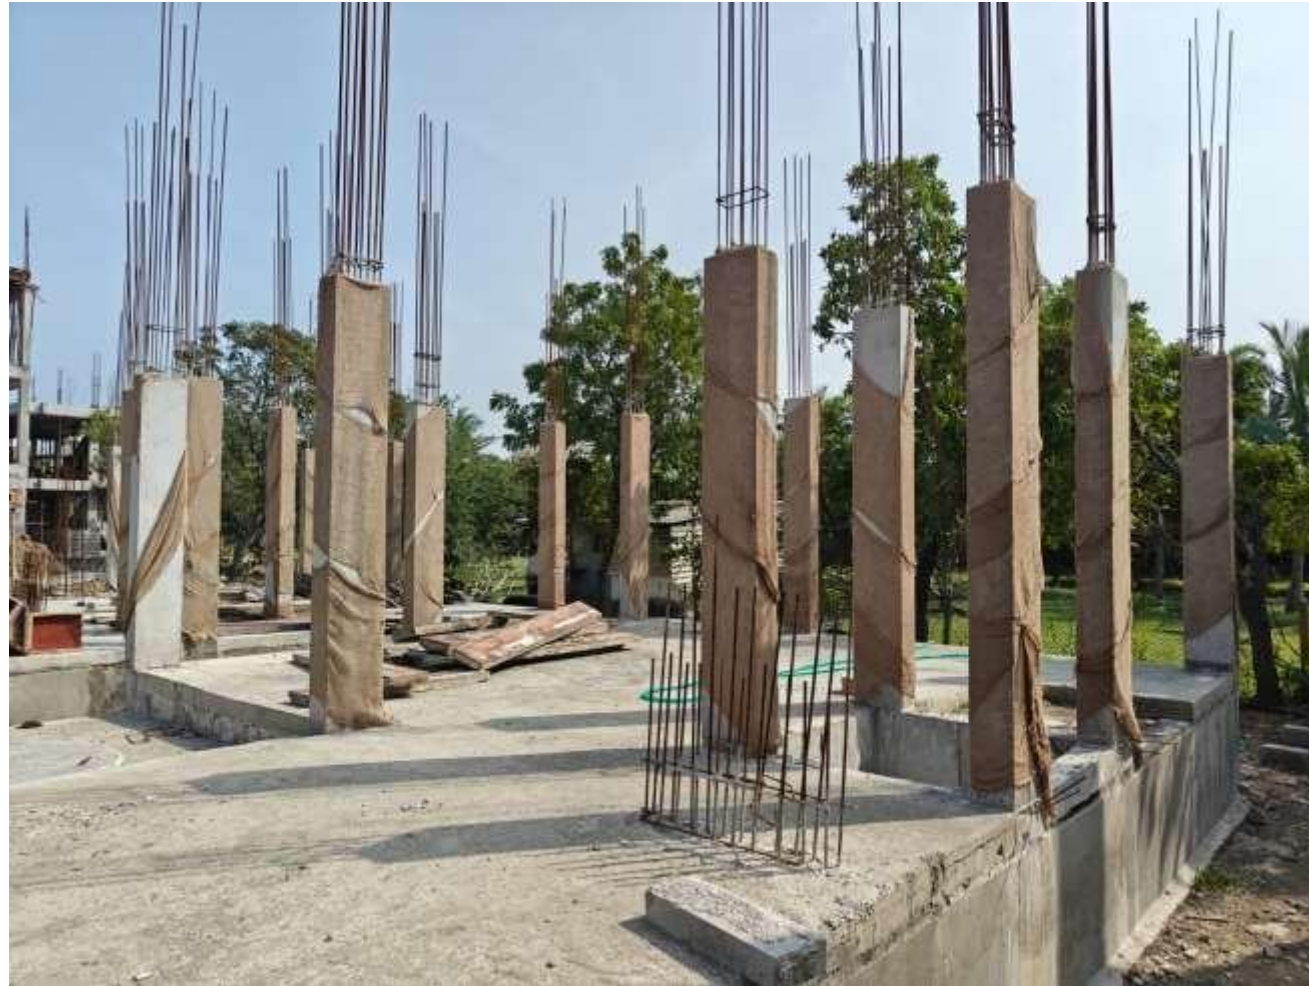
VillaNo 10 – Ground Floor Column Concrete Work completed

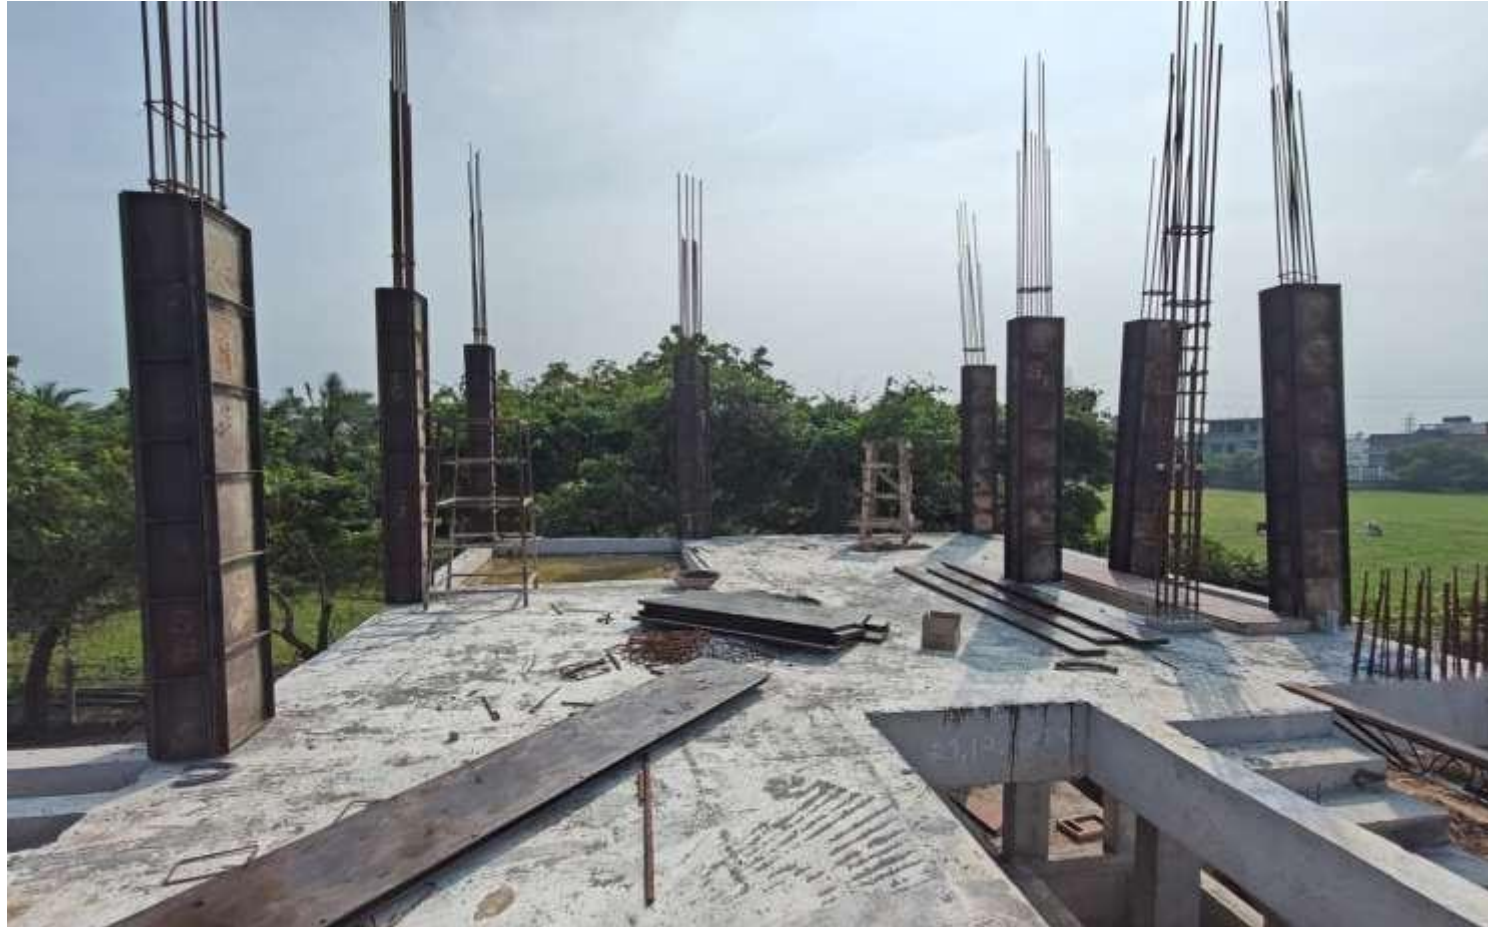
VillaNo 11 – First Floor Column Shuttering Work in progress

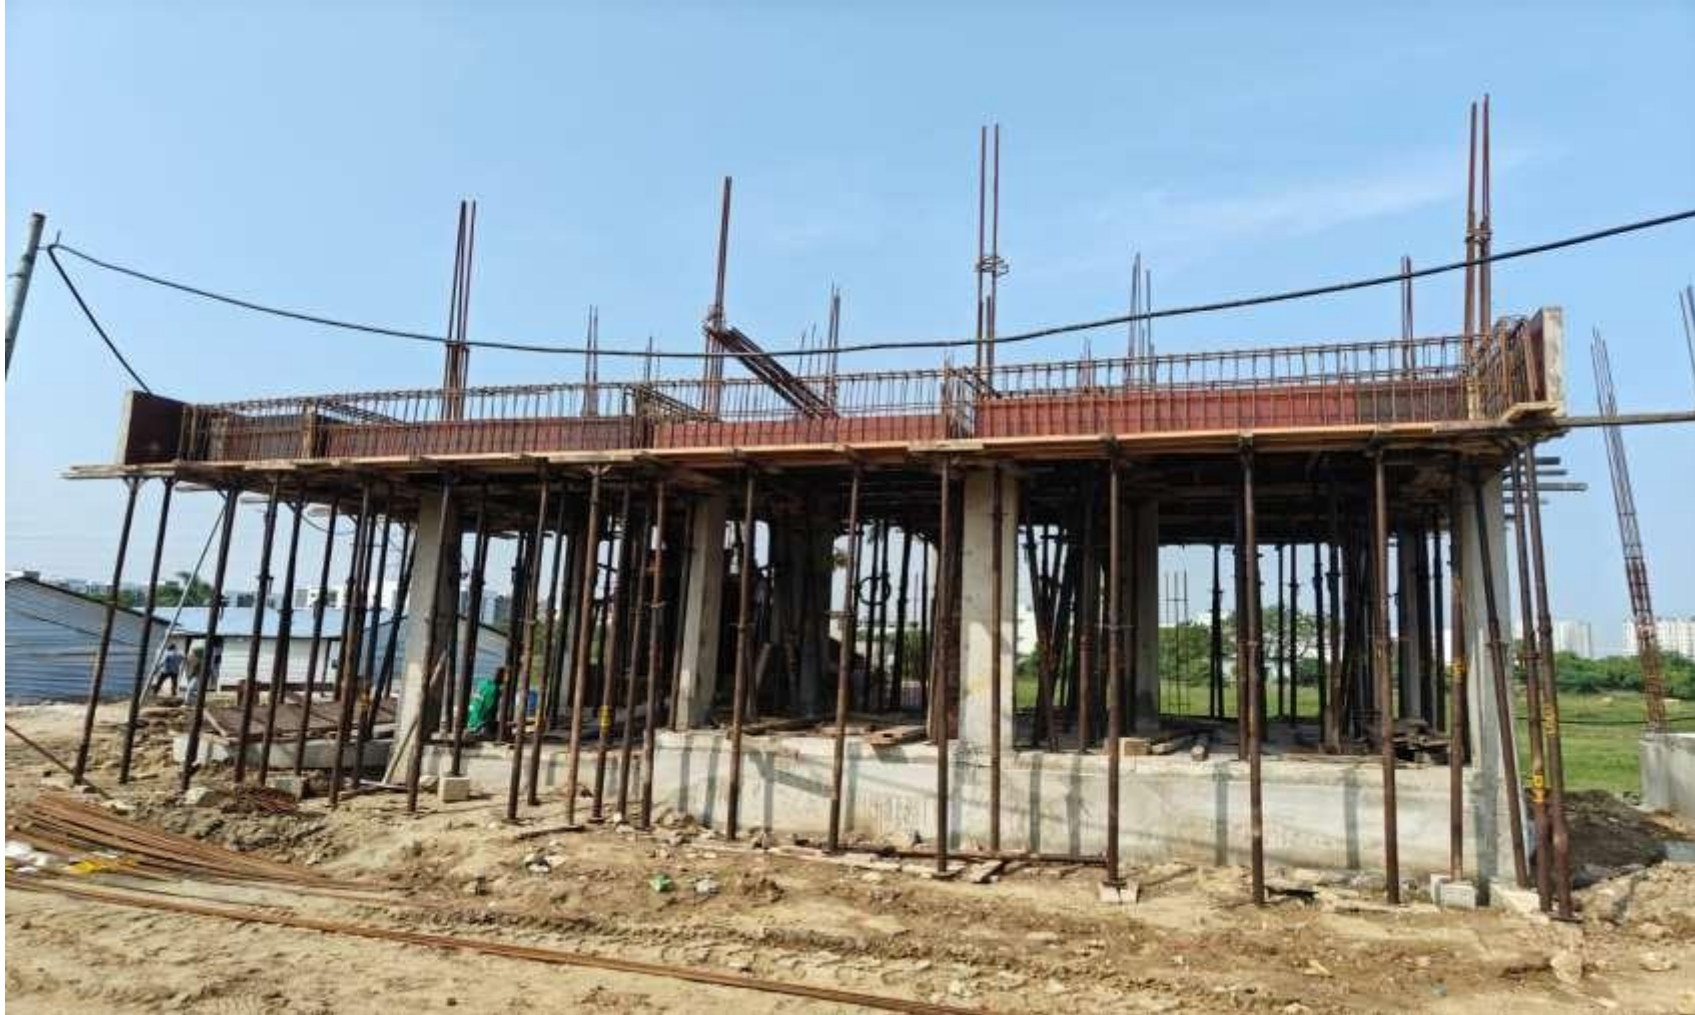
VillaNo 12 – GF Roof Slab Reinforcement work in progress

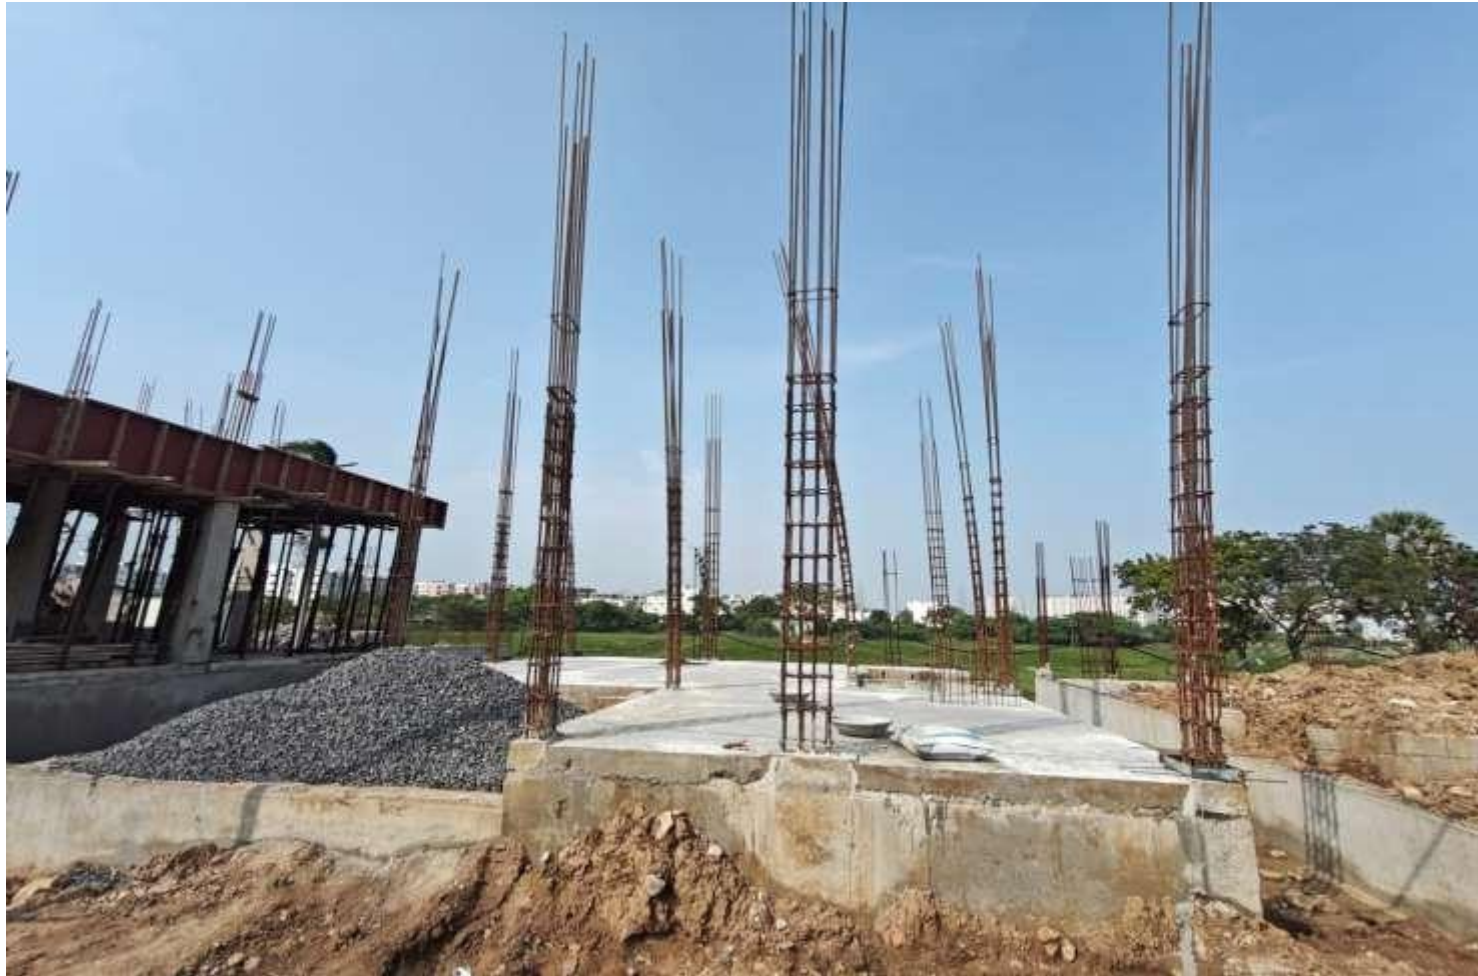
VillaNo 13 – Ground Floor PCC Concrete work completed

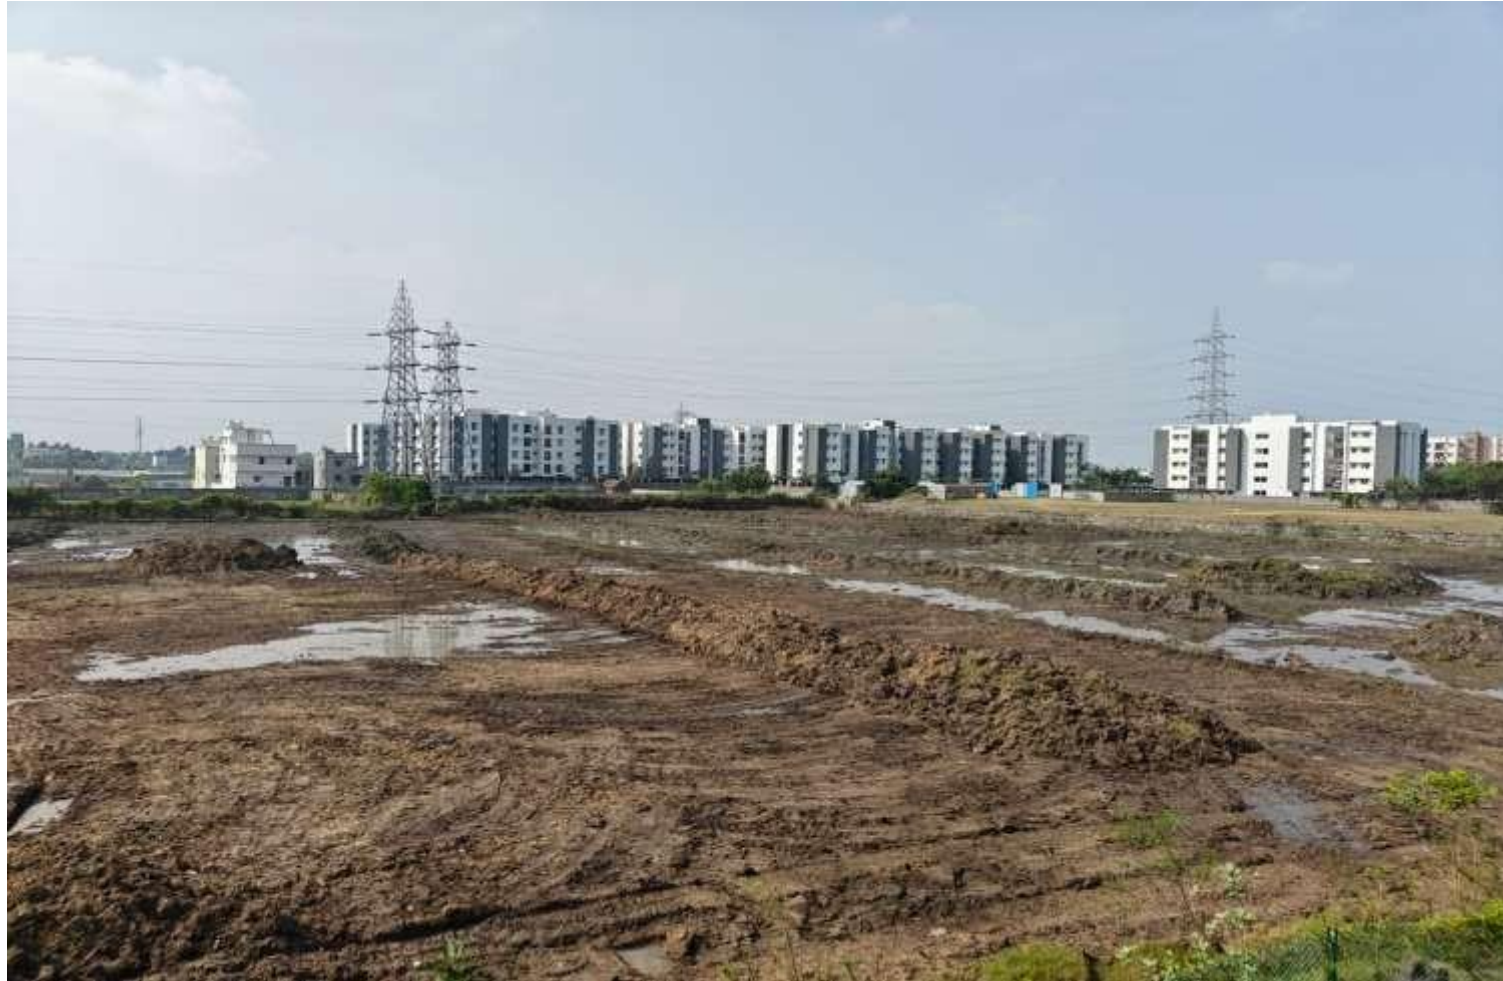
Phase 2 - Boundary bushes Cleaning work in progress

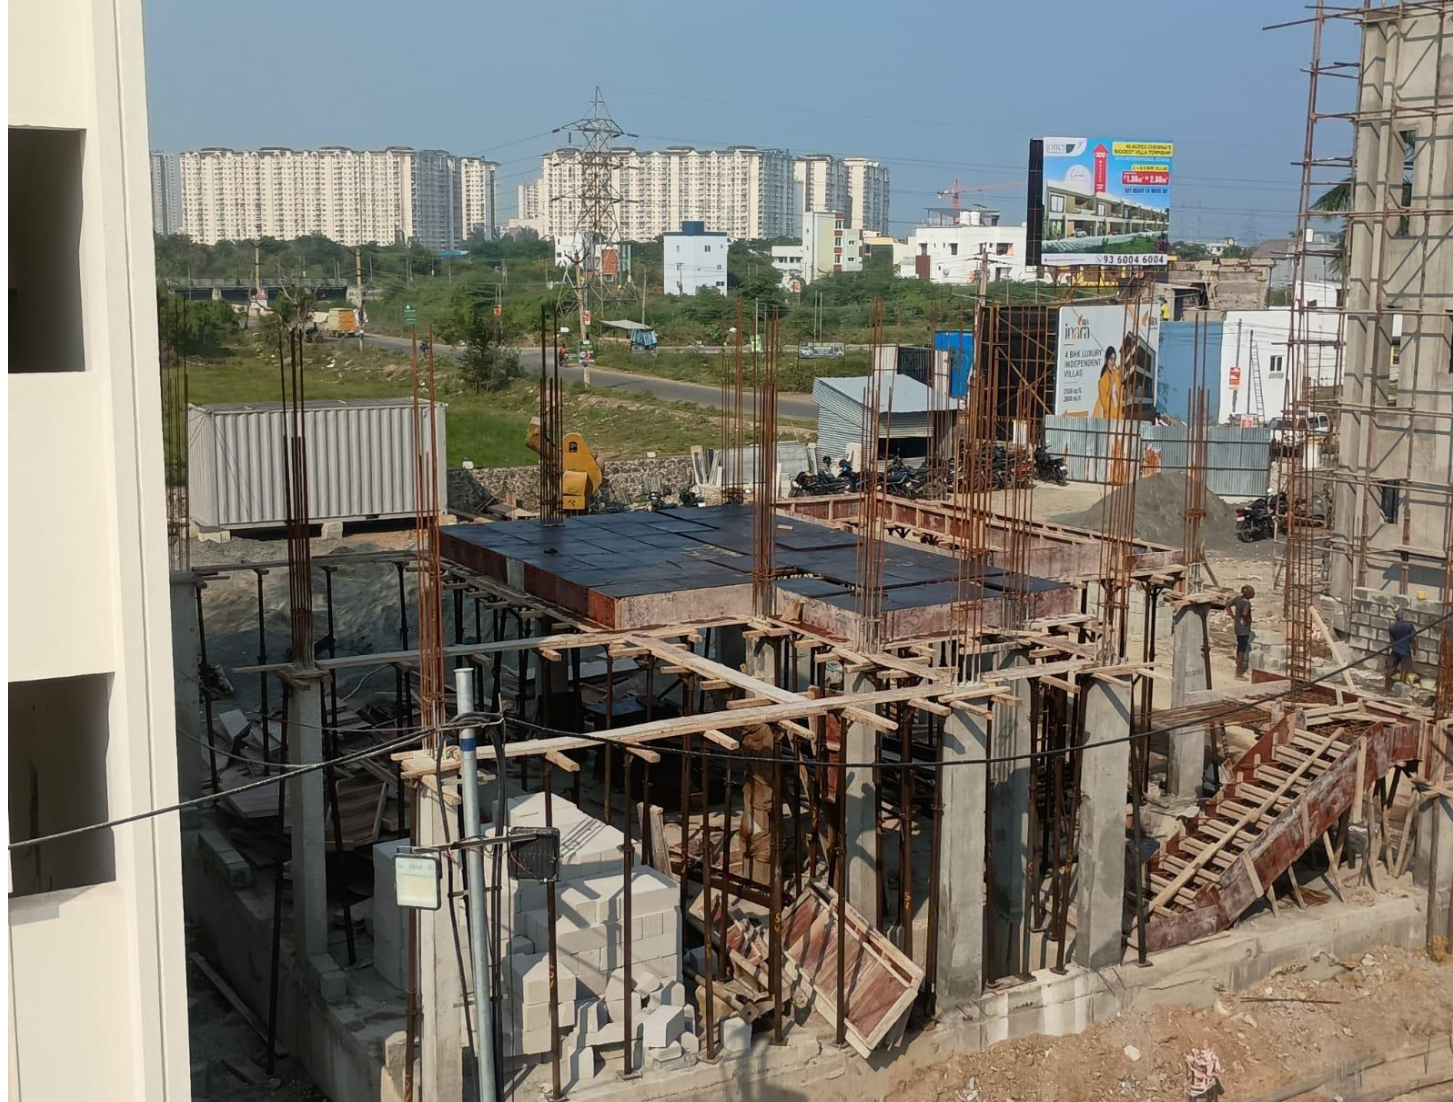
Villa 17 Ground Floor Slab Shuttering work in progress
